Mortar Battery/Harbor Defense Command Post
Ft. Hancock, New Jersey

Army Ground Forces Association (AGFA), in partnership with Gateway National Recreation Area, is beginning the rehabilitation of the WWII Harbor Defense Command Post (HDCP) that was located within Batteries McCook/Reynolds - the "Mortar Battery".

The project has several phases and will take about five years to complete. The first major phase was to secure the structure from intrusion and to remove the rust, prime and paint several doors within the structure. This portion of the project is approximately 98% complete.

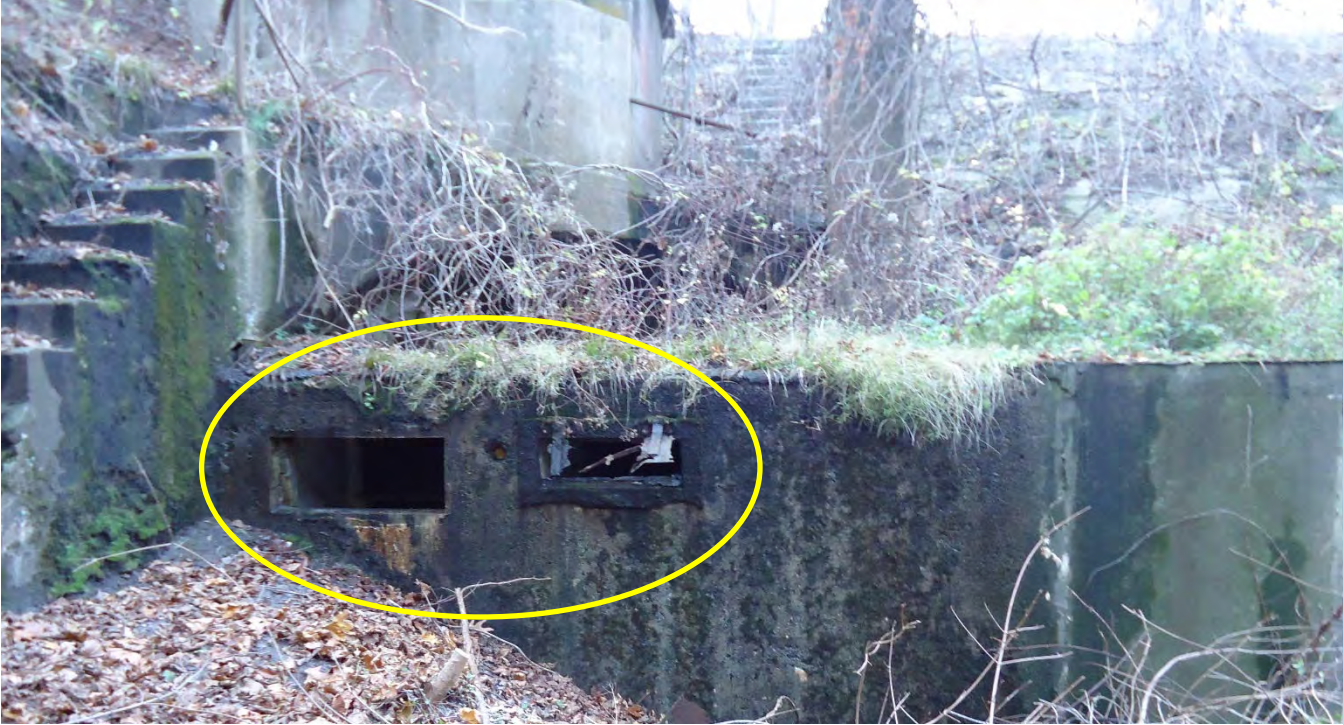
The photo below shows two window opens before they were closed. The yellow circle contains the openings. The window opening on the left has been enabling vandals to enter the structure, damage historic fabric and paint the interior with rude graffiti.

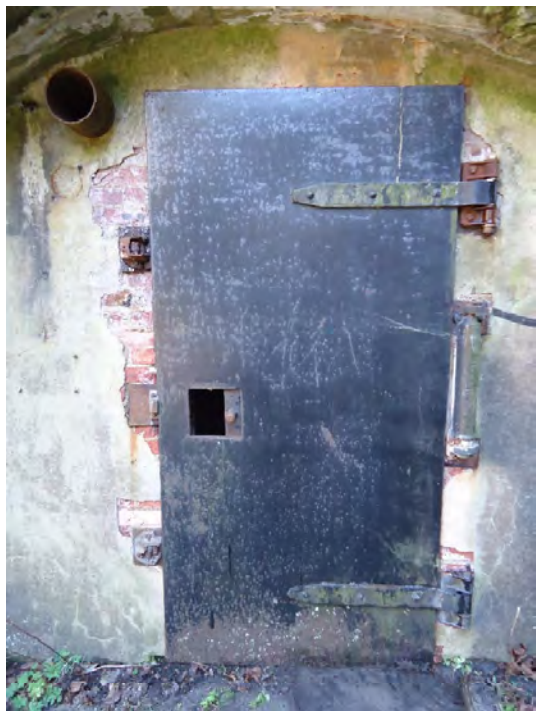
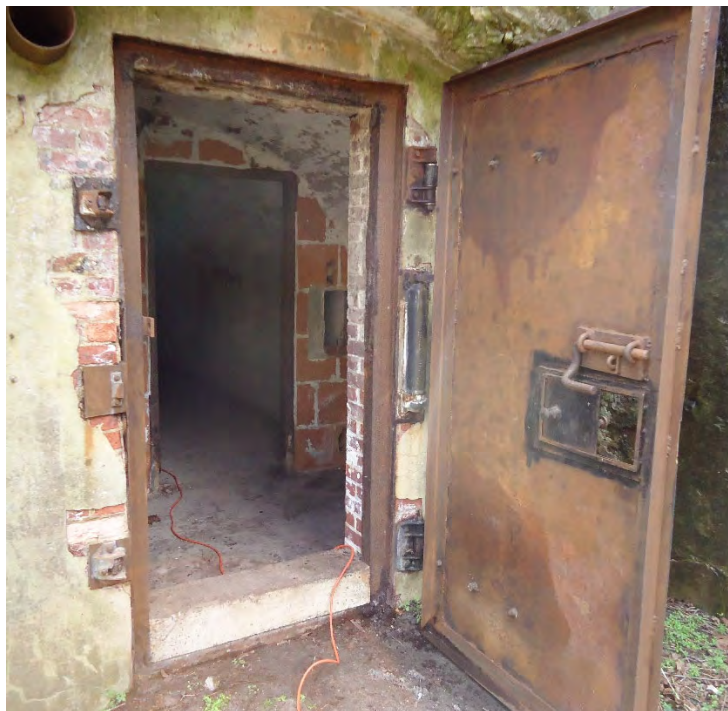
The photos below show north west pit chemical air lock door (partially rebuilt by National Park Service). The interior was never primed or paint and the exterior paint was well on the road to failure. The photo on the right is post rust reduction using drills with rotary wire brushes. The main plate of the door is a reproduction by the NPS in the 1990s.

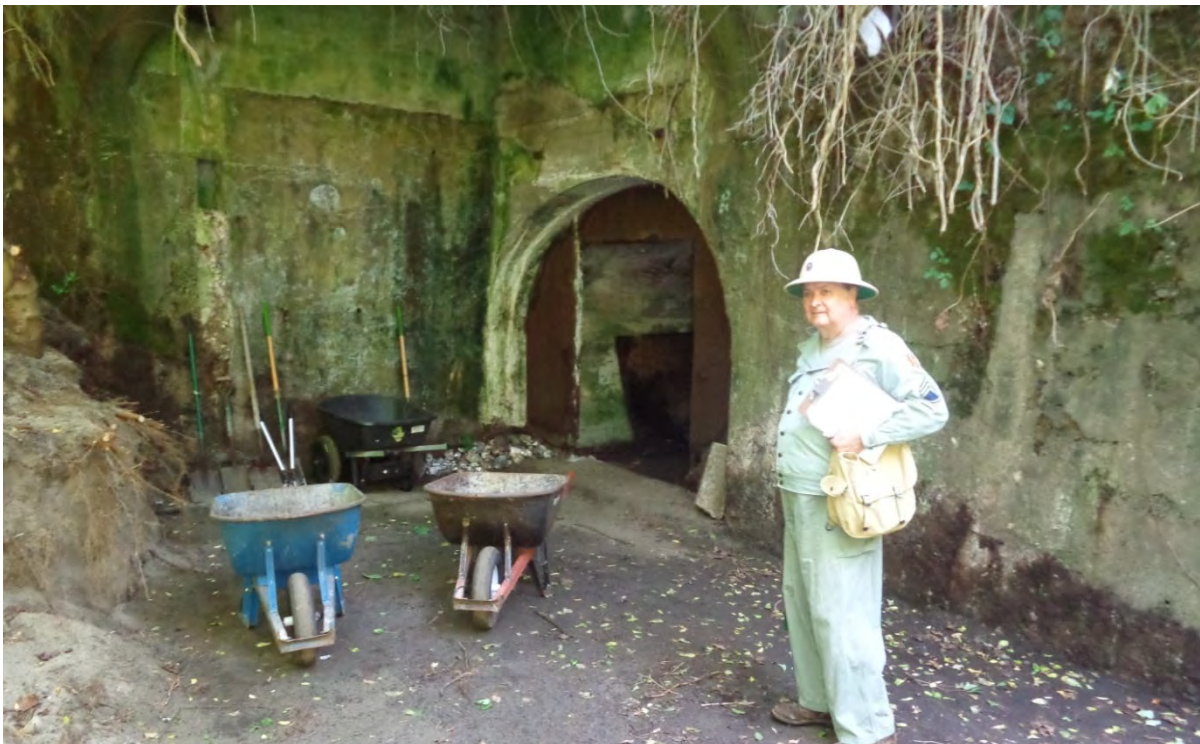
The photo below shows TSG Weaver assessing the exterior of the north east pit door in 2022. The door closure is missing. The wheel barrels are being used by an NPS team to remove sand inside the mortar pit.

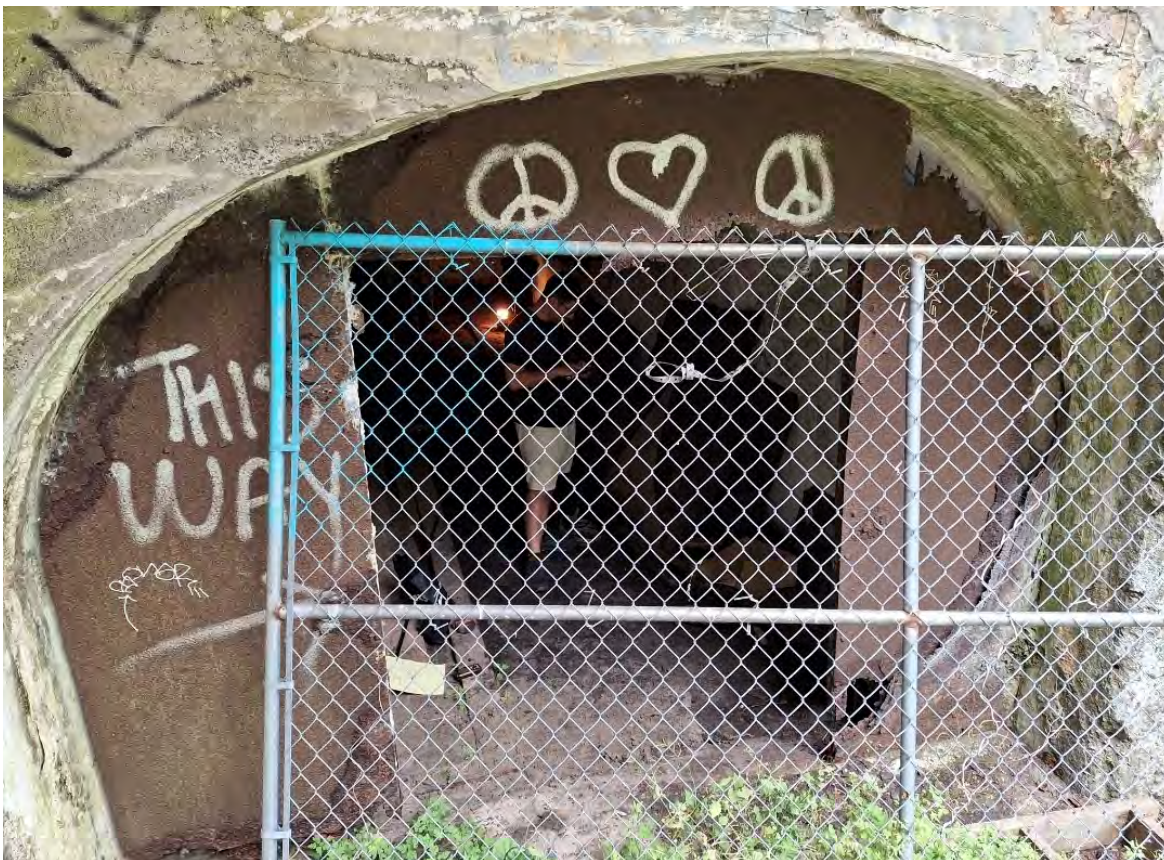
The photo below from mid-2023 shows the door frame from another angle. Notice the decayed condition of the steel plates and bars. Behind the metal plates are square bars that are rusted through in multiple places. This door is not recoverable. Notice the doors are missing. They have long ago rusted to an usable state.

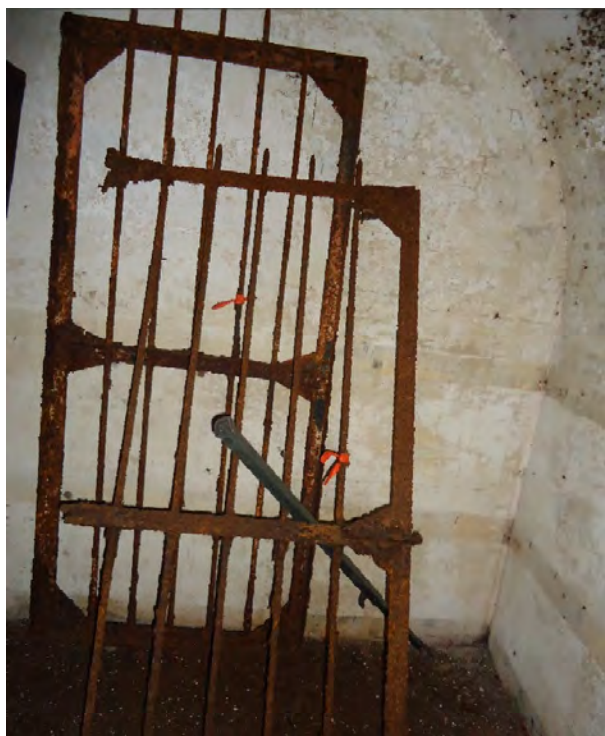
The doors that fit inside the frame are shown below - rusted and unusable and not restorable.

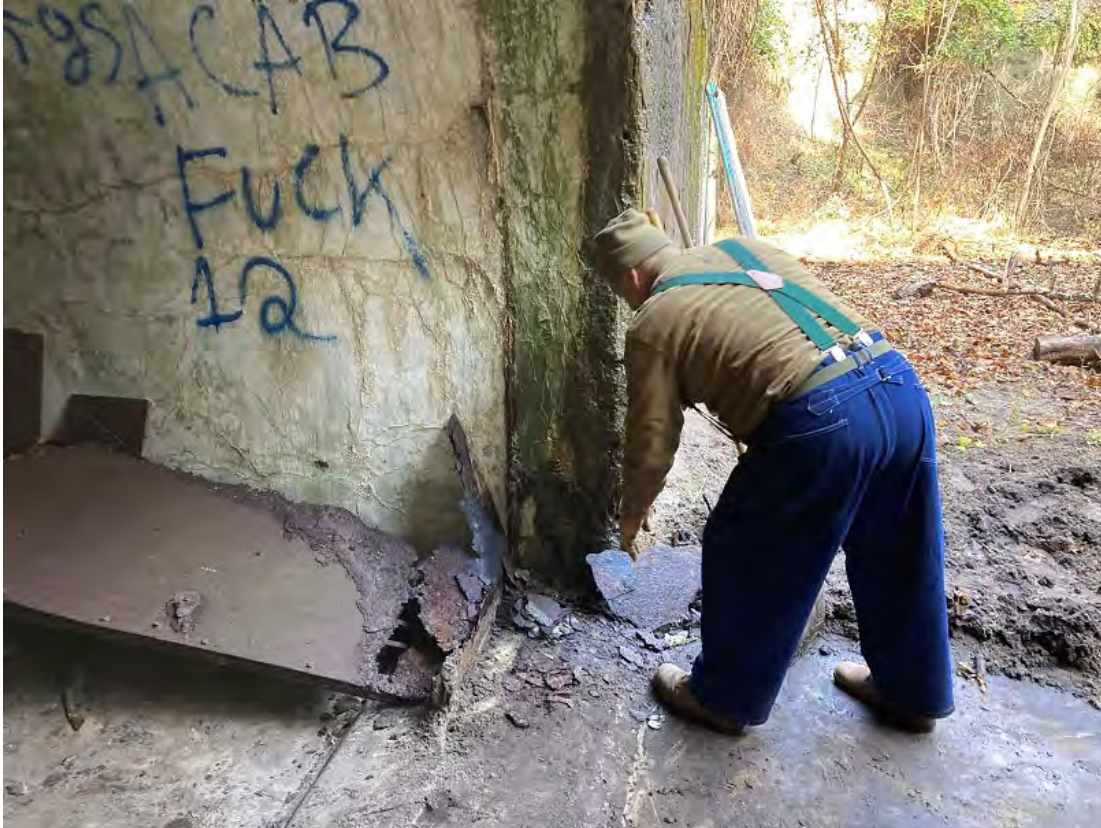
Below T-5 Antonucci continues the demolition of the existing and rotted door frame. The frame and bar material has been retained for NPS archeologists.

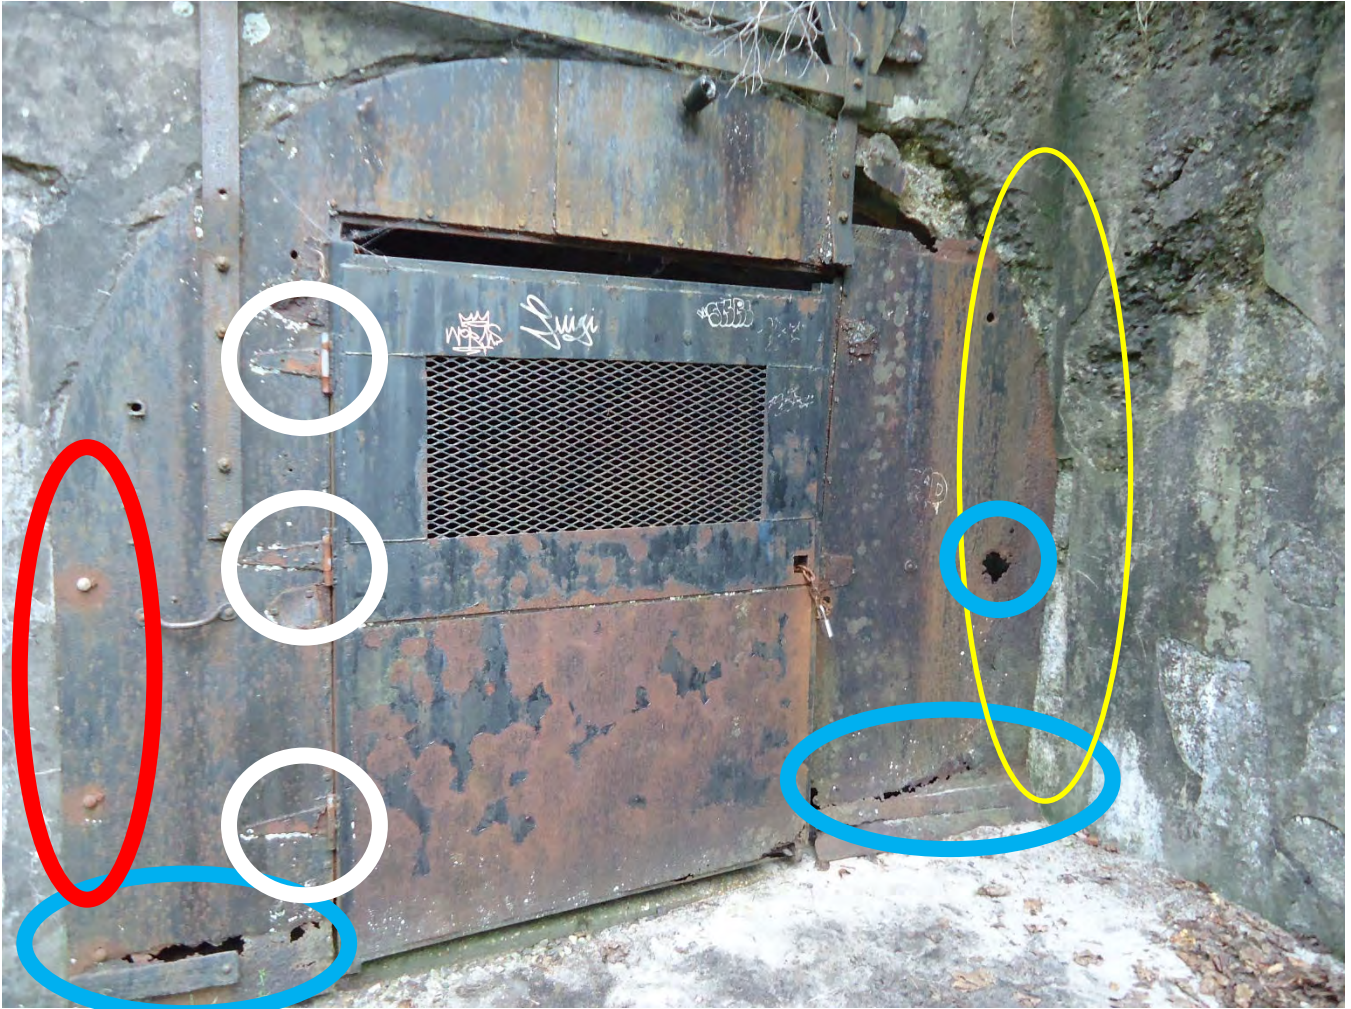
The next step was to reinforce the southwest pit blast door. Below is the as it existed in August 2023. The area covered by the yellow oval is connected to the wall by one small piece of steel. This area within the yellow oval is the most important to reinforce. The door that exists inside the "blast door" is likely a Park Service creation, post 1975.

The left side of the door covered by the red oval is well secured on the inside of the tunnel by a three-foot-tall piece of angle iron. The two bolt heads showing in this picture are the method of securing this portion of the door to the angle iron. These are modern galvanized carriage bolts.

The three white circles show the three hinges for the door. The bottom hinge is broken. The broken hinge will be repaired by welding.

The deteriorated areas inside the blue circles will be reinforced with steel plate to enable a firm connection to the proposed angle iron in the interior of the tunnel.

The stabilization of this door is intended to strengthen it from forced entry and provide a higher level of confidence that it will not be breached except by use of heavy industrial tools or torch cutting.

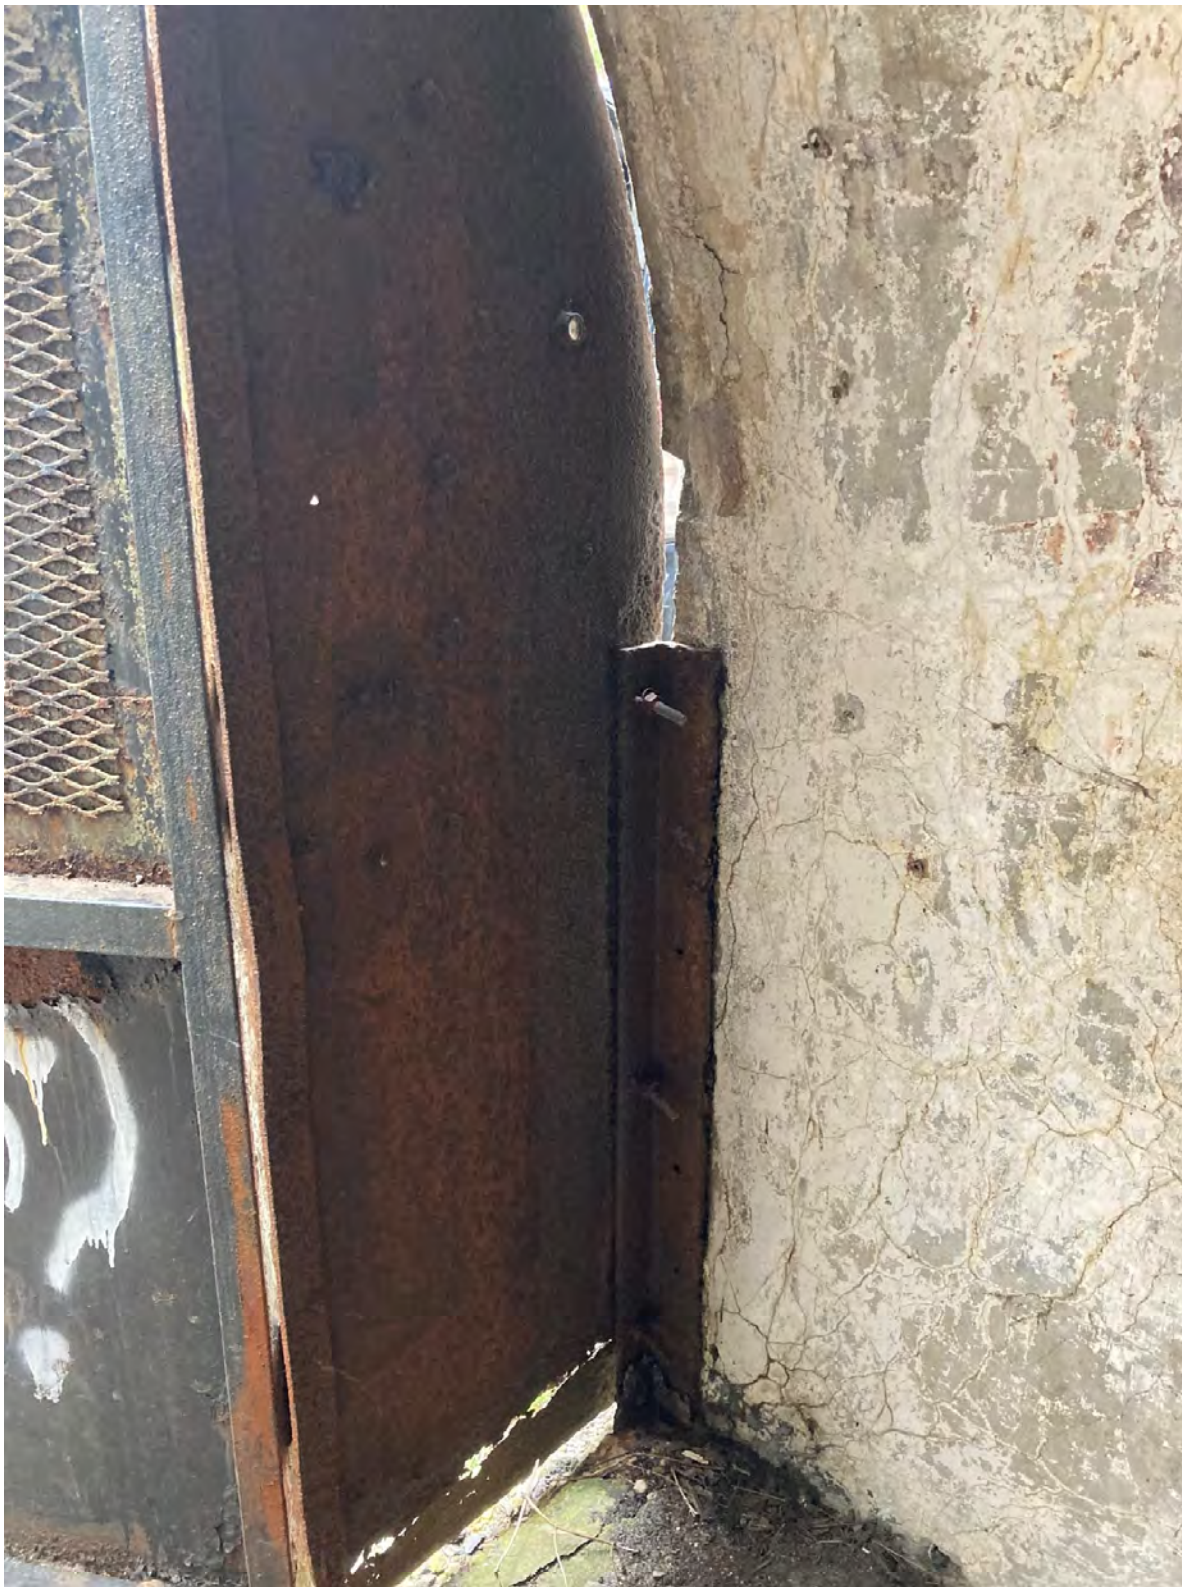
The photo below shows the existing angle iron that secures the north side of the southwest pit door. The iron is secured with three anchors into the concrete wall of the tunnel. Two bolts are visible securing the door frame to the angle iron. The nuts are modern hexagonal nuts. We believe this was installed by the NPS sometime in the 1990s.

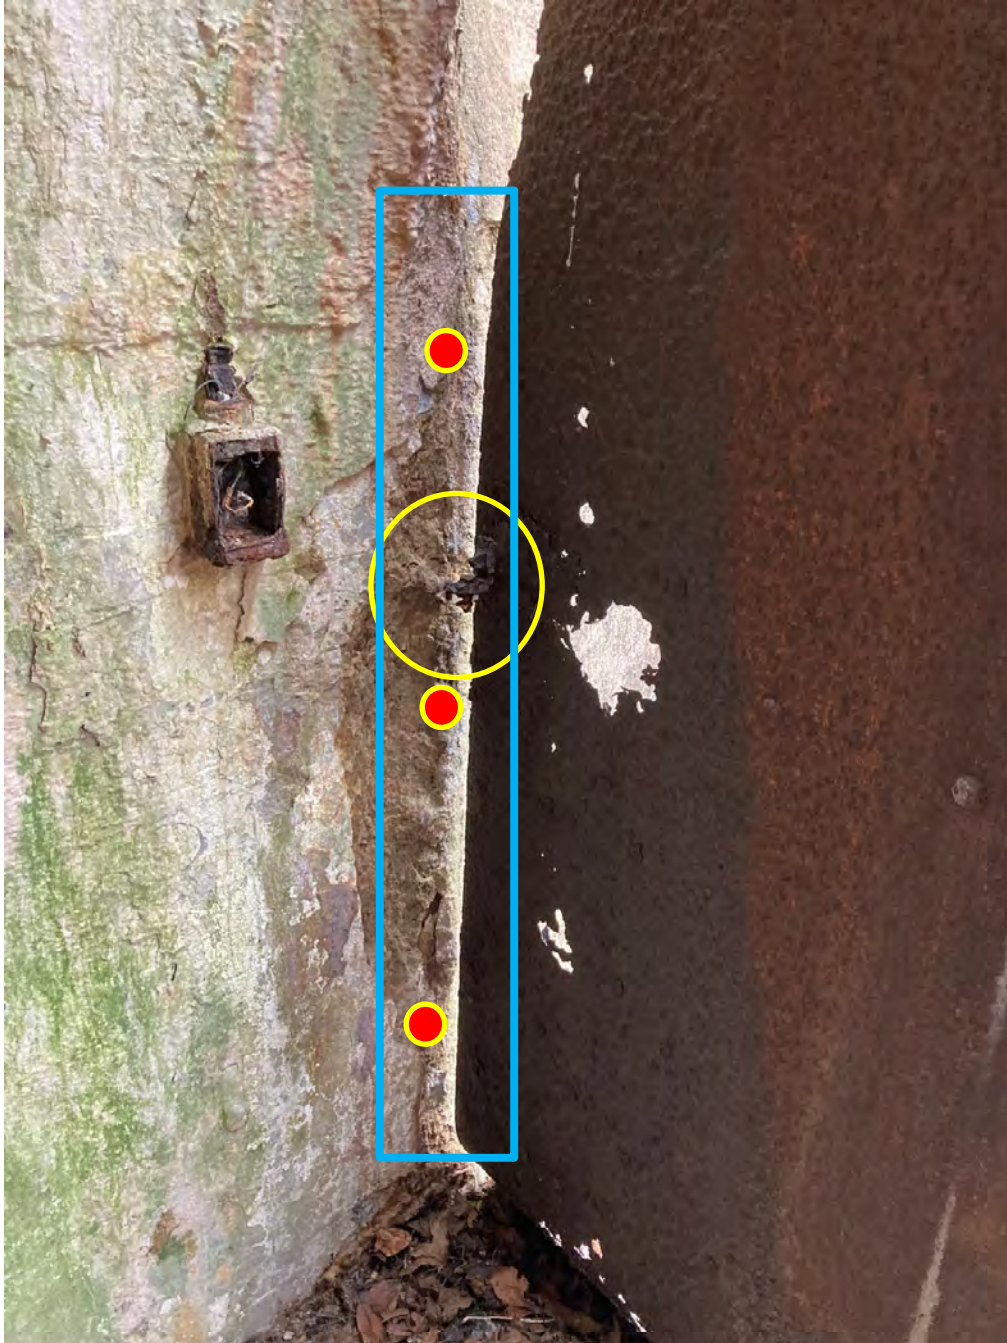
The photo below shows the left (south) side of the door and the proposal before the start of work. The small piece of steel inside the yellow circle is all that is securing the left side of the door to the tunnel wall. This vintage connection will be preserved. This portion of the door was easily defeated with heavy hammers.

The door will be reinforced with an angle iron attachment anchored into the concrete wall and a 1/8 thick piece of modern steel that is four feet tall and three feet wide bolted to the existing steel plate..

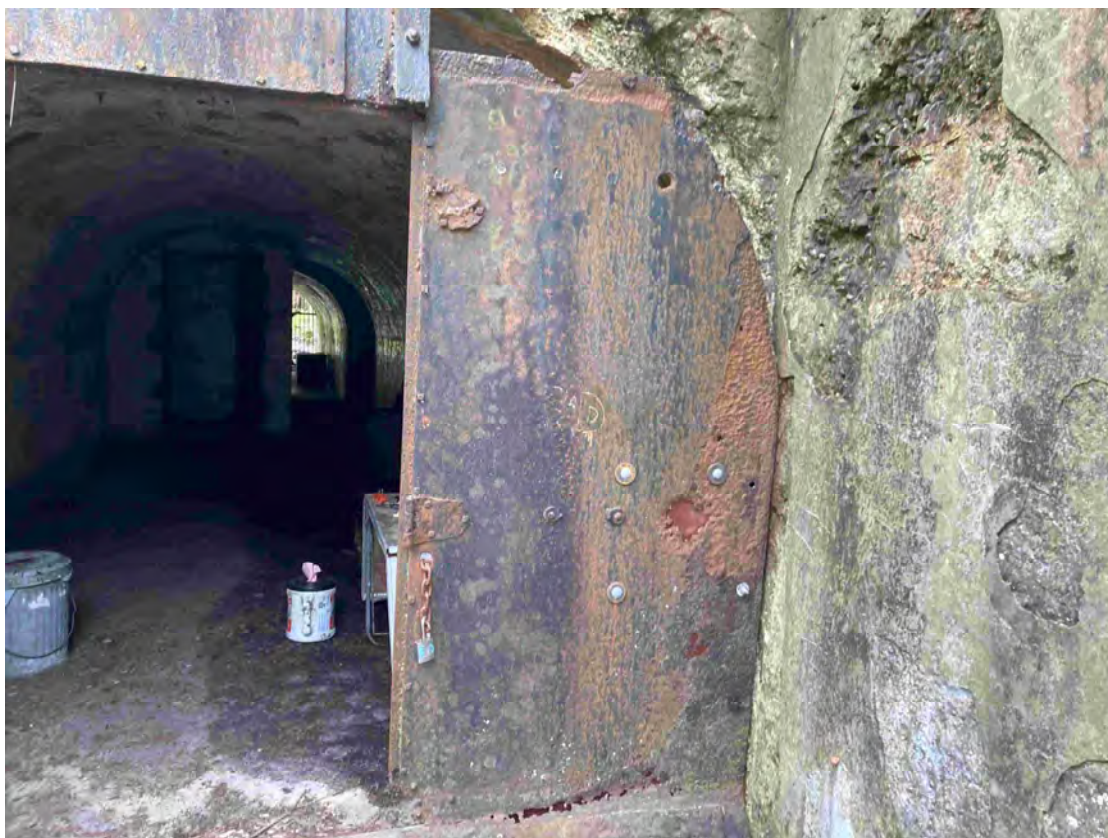
The photo below shows the steel bar door with the 1/4-inch thick plate on the inside and four bolt heads locking it into place as a test. The rust on the outside has yet to be removed for priming.

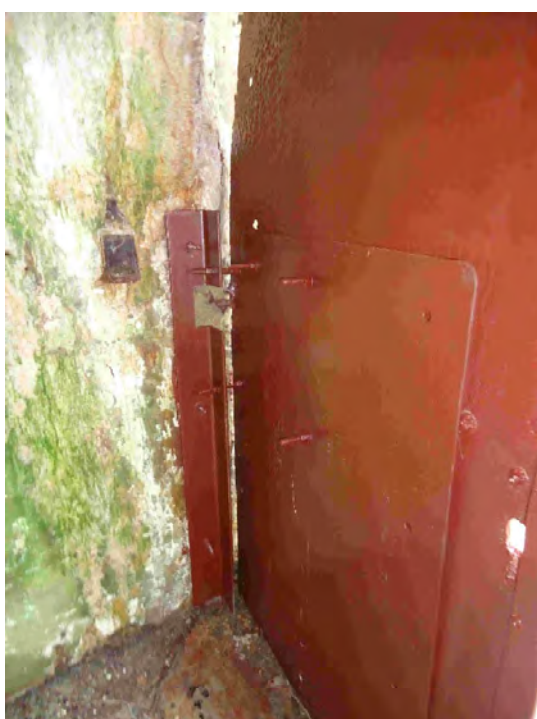
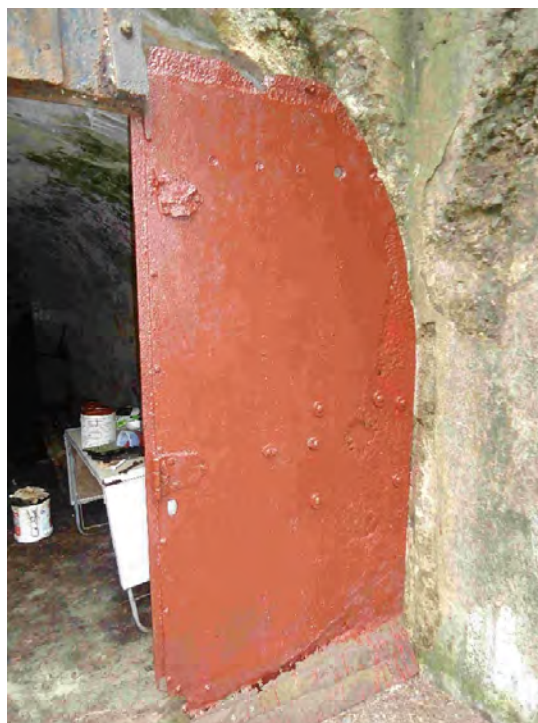
The photo below shows the south panel of the southwest pit door with the 1/4-inch thick plate affixed on the inside of the steel door plate and the entire door plate assembly bolted to the angle iron with two bolts. The angle iron is secured to the concrete wall with three 8-inch long anchors.

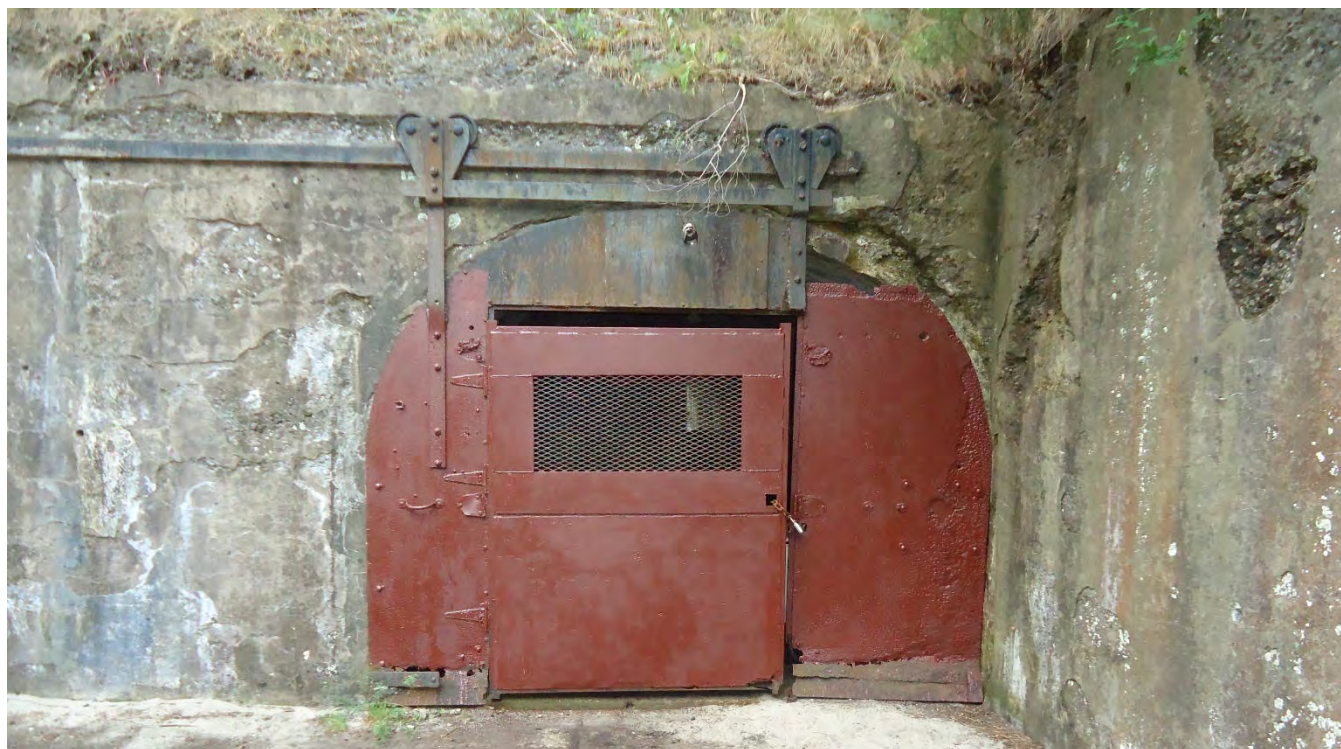
The photo below shows the two sides of the door frame and the exterior of the door with the rust removed and primed. The lower portions of the two panels are firmly anchored and do not require additional reinforcement.
