Re-install expansion joint on Gun #1 platform
at Battery Gunnison/New Battery Peck
Ft. Hancock, New Jersey

Army Ground Forces Association received permission to re-install the expansion joint on the Gun #1 platform as originally designed in 1943. This project was completed on 11 October 2020.

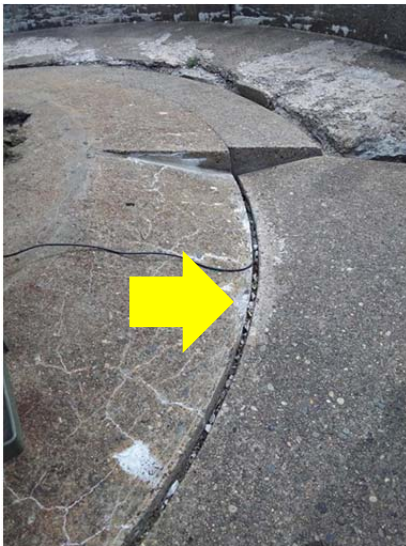
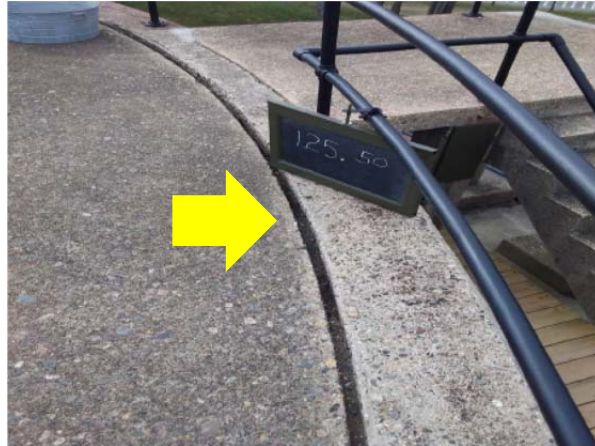
The photos below show the expansion joint in two separate locations of the Gun #1 platform. The arc on the left is the small 36 foot arc and the arc on the right is 85 feet long.

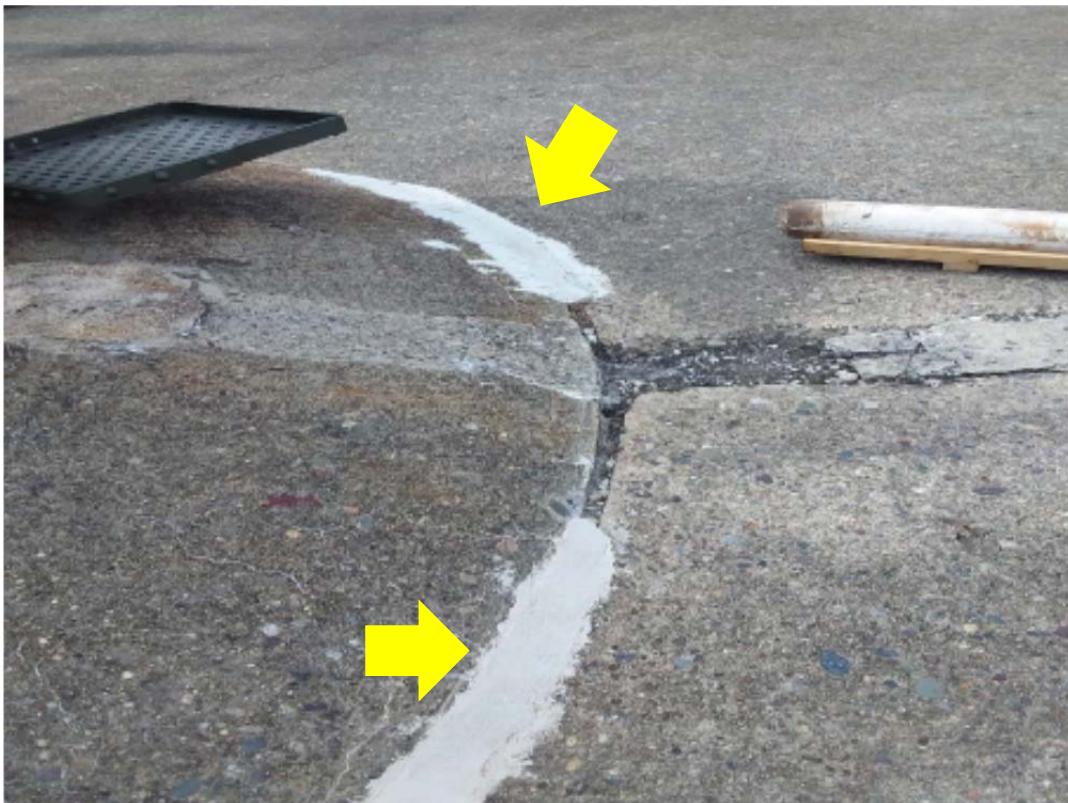
The photo below at the base of Gun #1 shows the concrete patch on the small arc that has been applied in contrivention to the original drawings. This patching will be removed and replaced by expansion joint material. We have no idea who placed this patching material in this location. The original drawings make it clear it does not belong.

AGFA recommended installing quarter inch expansion joint (layered) to fill the expansion crack. This area is between a half inch to one and a half inch wide. We recommend roll expansion joint in half inch thicknesses. The expansion joint material will be placed in double and triple thicknesses based on width of the joint, joined with black sealer and cold asphaltic sealer.

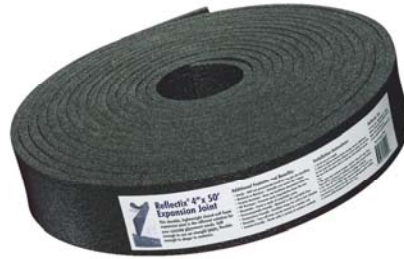
NPS purchased Reflectix 4"X50' Expansion Joint EXP004050 at 0.5 inch wide by 4 inches tall - 50 foot roll. Eight rolls were purchased. The source was as follows: <https://www.eastcoasthardware.com/111504-reflectix-inc-expansion-joint-expo04050.html>

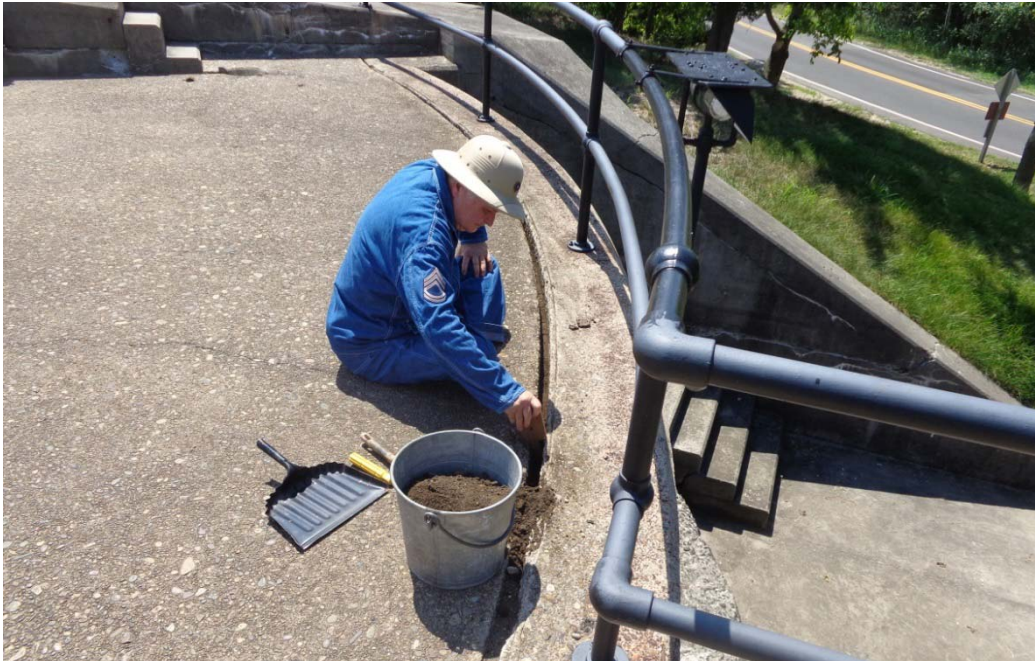
The first day of work was 27 August 2020. TSG Weaver was the primary installer. He used hand tools to dig out the trough along the large arc. The downside of this is difficulty getting some of the larger rocks that were wedged into place. Hammers and chisels did not work to dislodge them.

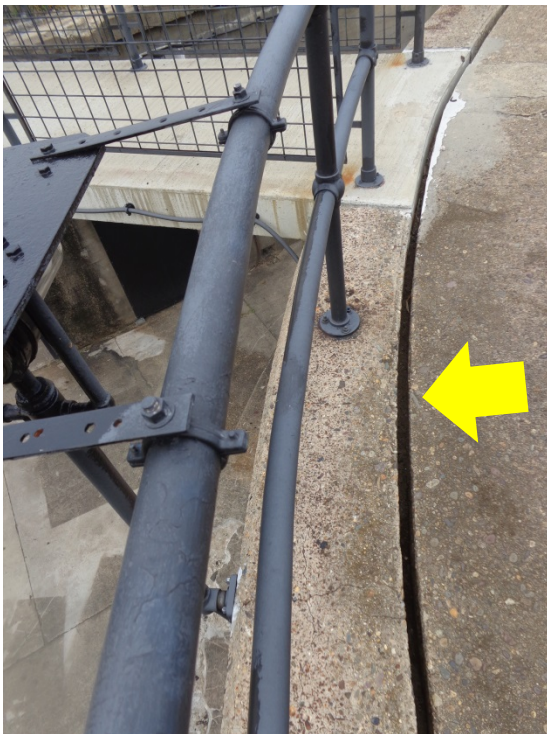
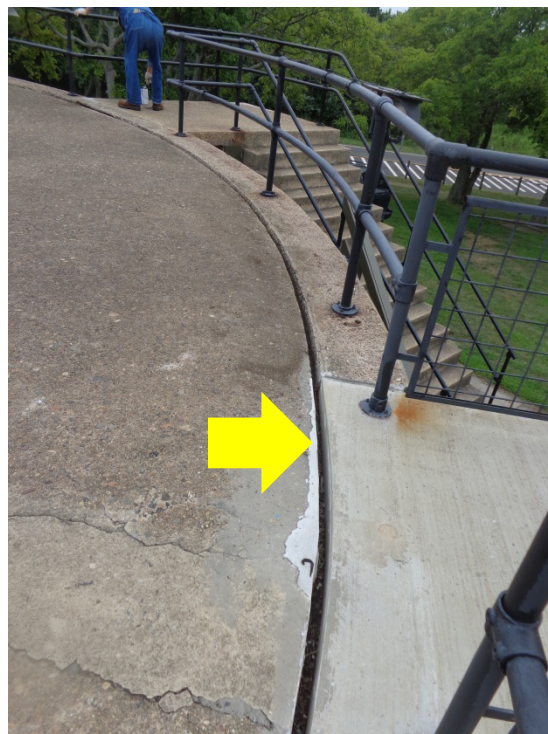
The photo below shows the work done by TSG Weaver to clean out the large arc. However, a number of jammed stones resulted in some portions of the expansion joint only being about 3 inches thick instead of four inches.

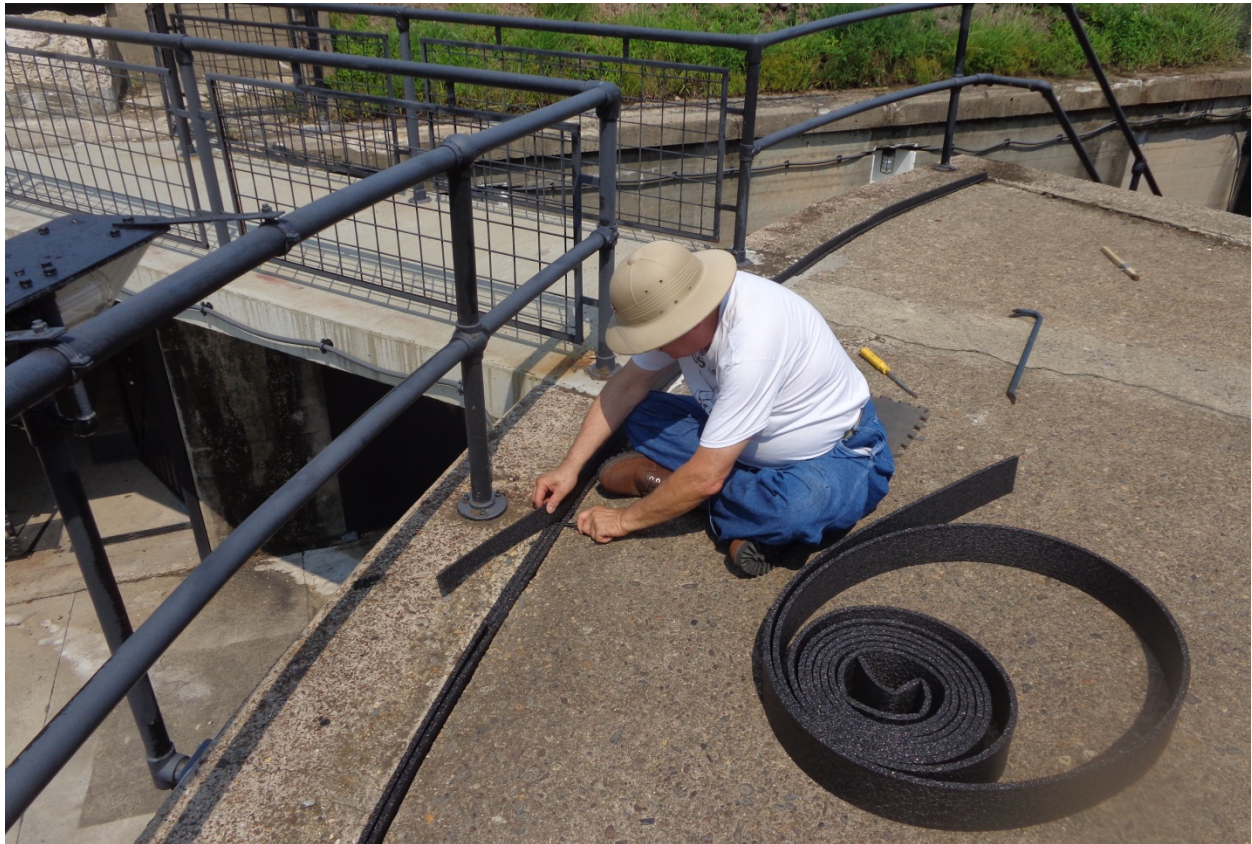
Below TSG Weaver is installing the expansion joint near the ammunition bridge.

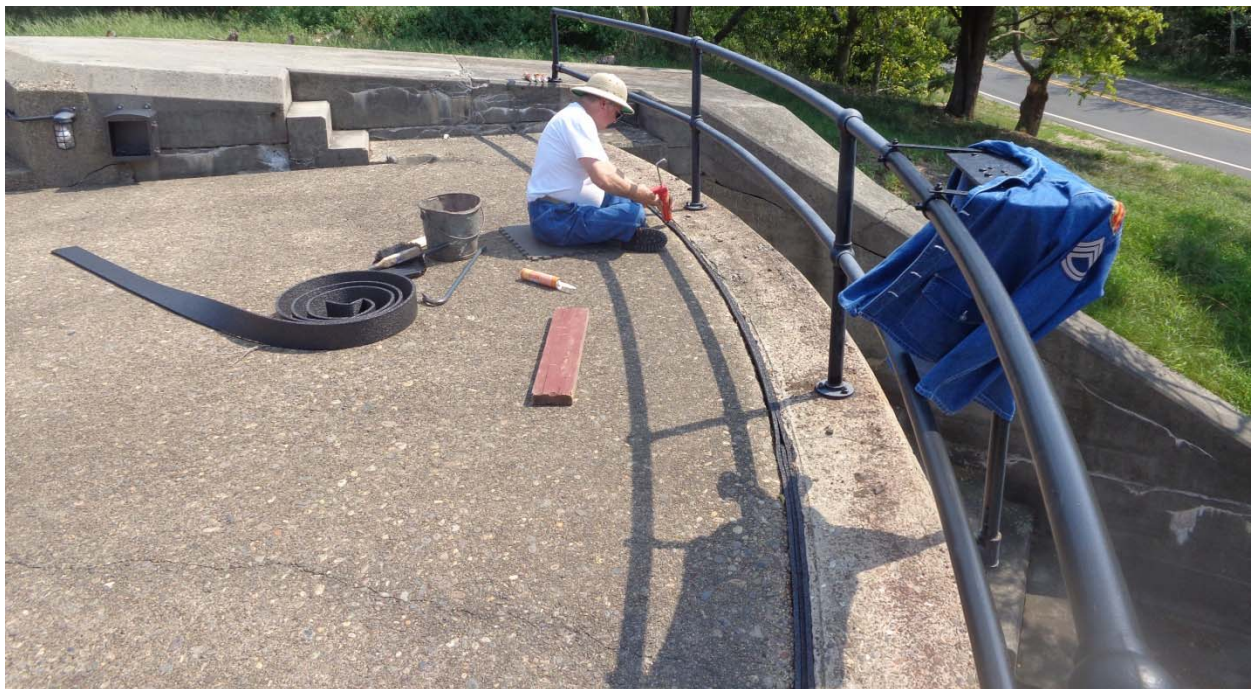
The photo below shows TSG Weaver applying sealing caulking.

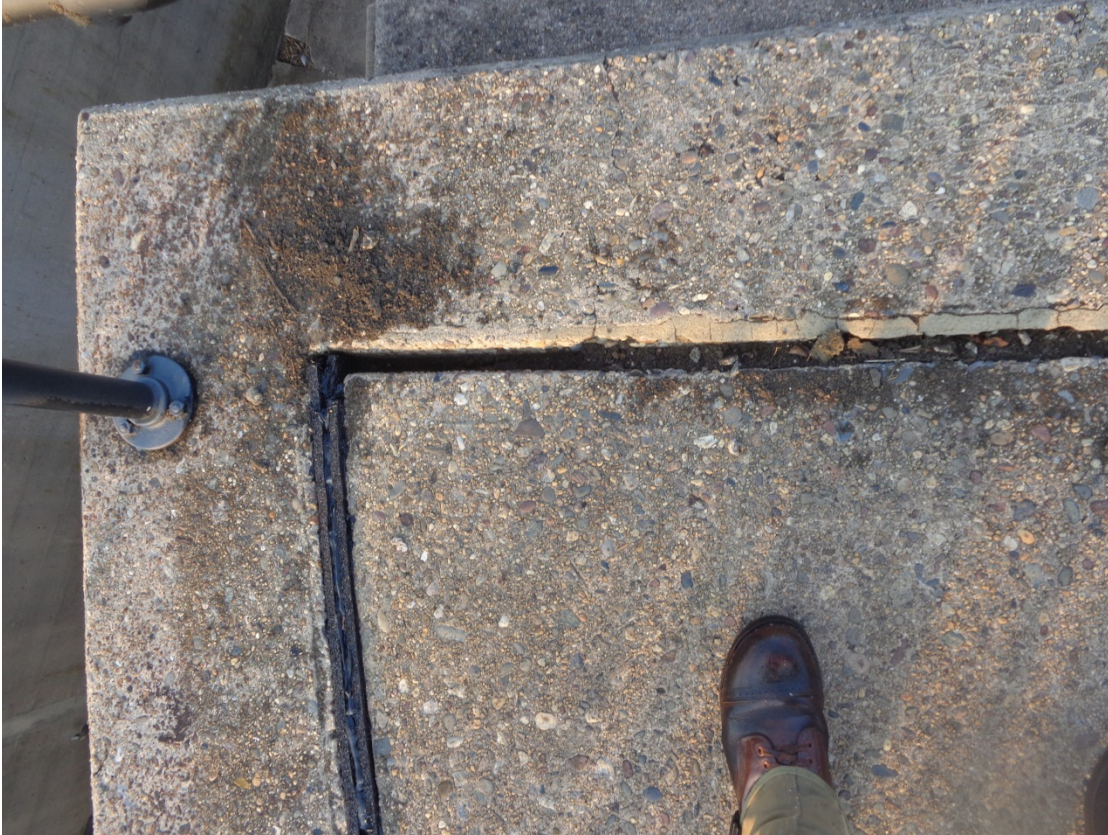
The photo below shows the large arc terminating point with expansion joint in place prepared for sealing. The horizontal expansion trough (top of powder passage stairs) is still filled with dirt and debris that must be removed prior to joint placement.

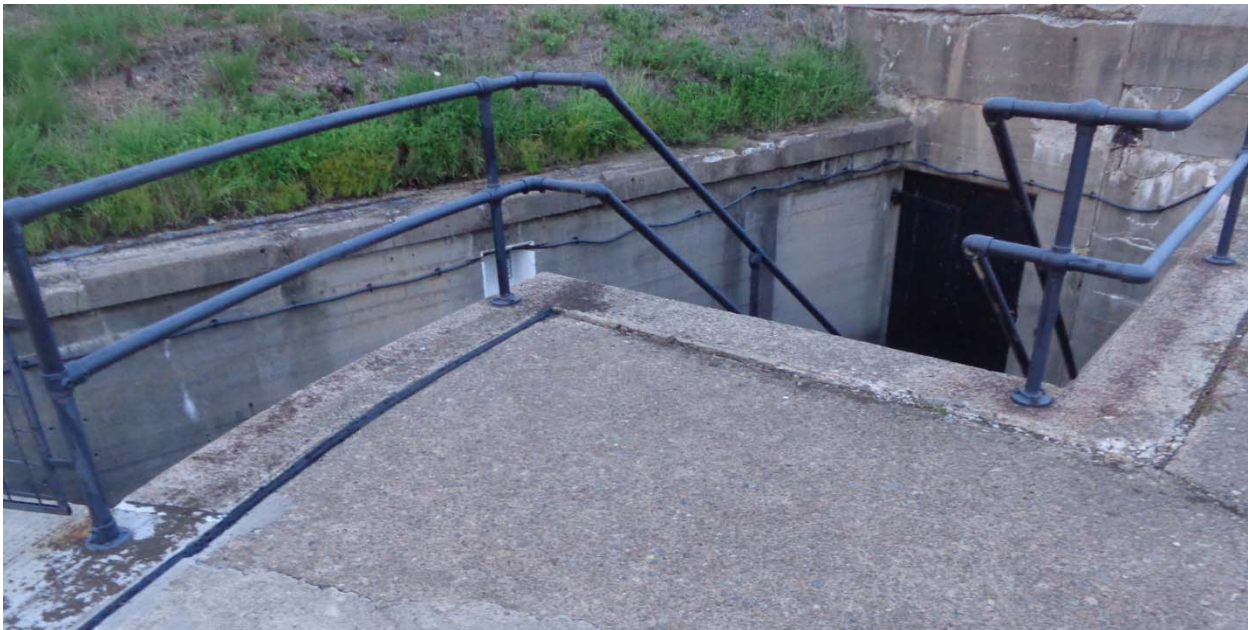
The photo below shows a wider view of the area above. Completed expansion joint is on the right. This was as far as the work proceeded on 27 August.

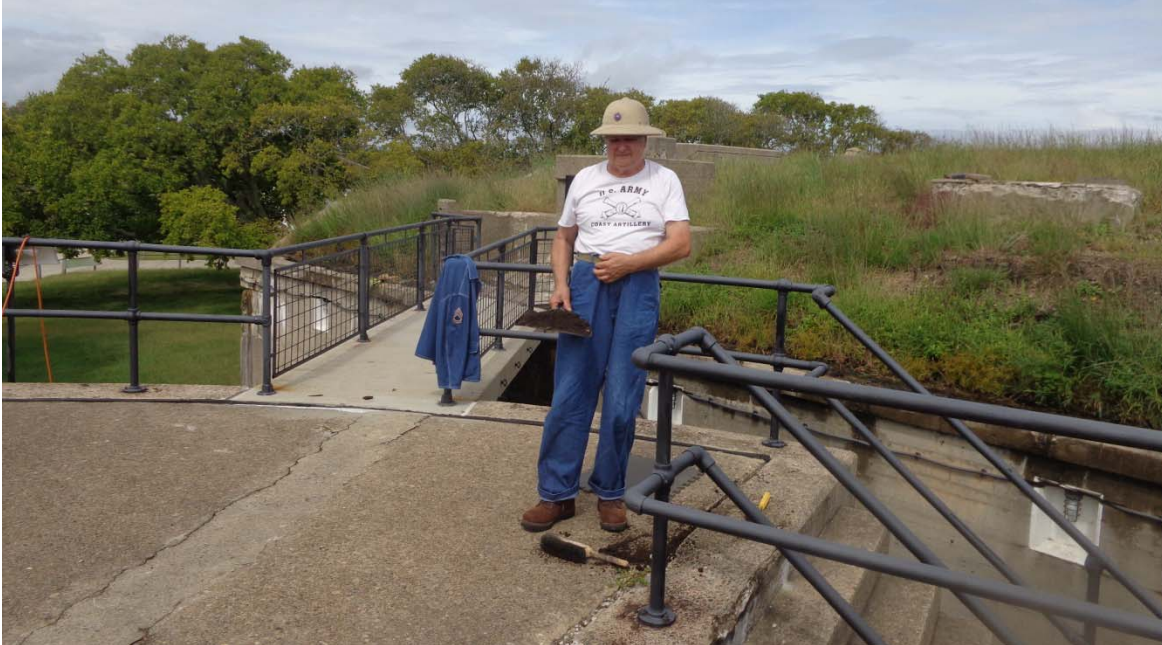
The next workday was 10 September. Below TSG Weaver prepares to remove spoil from the trough at the top of the powder passage stairs.

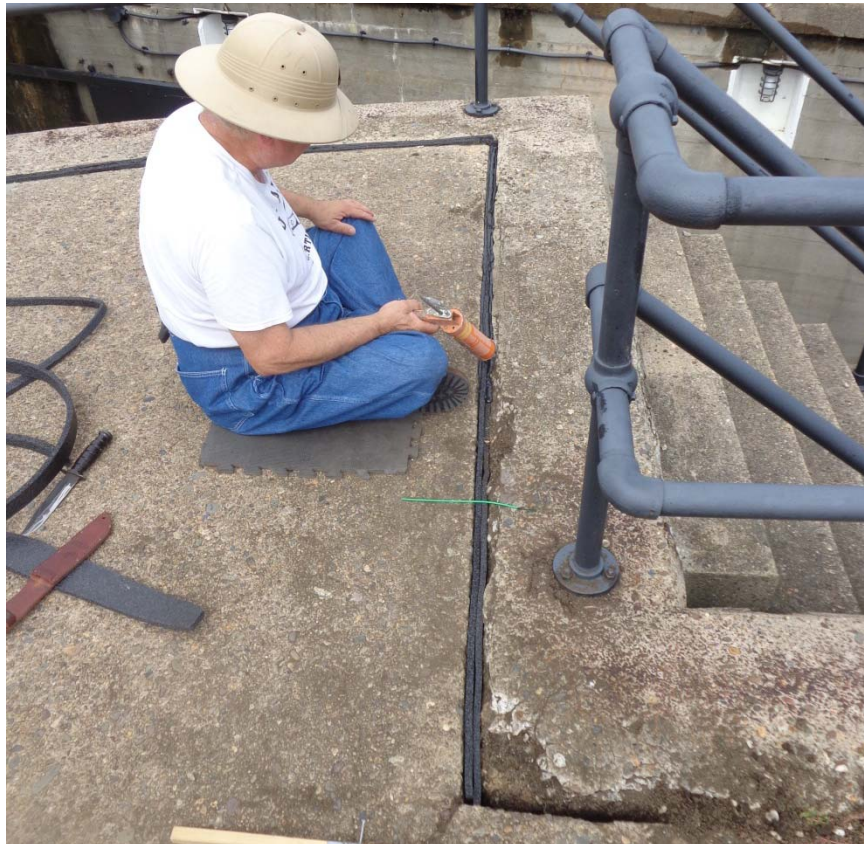
The photo TSG Weaver applies the sealant between the layers of expansion joint.

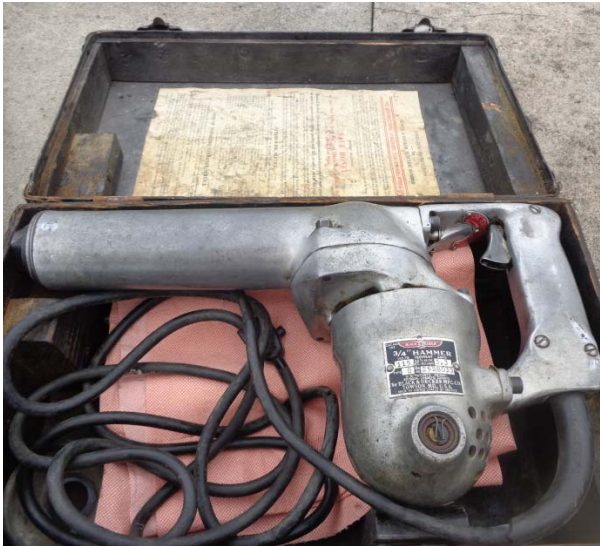
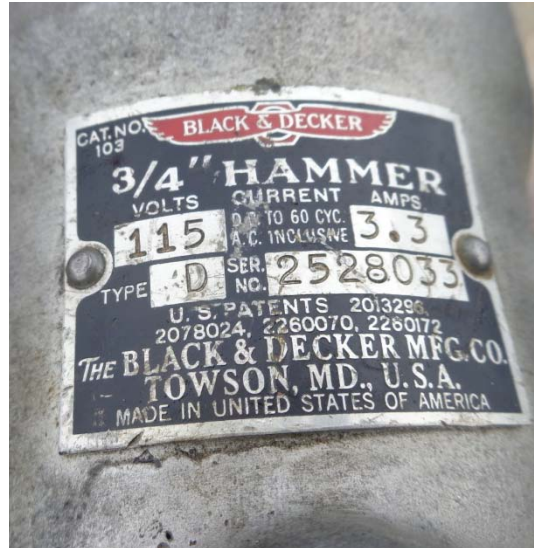
Removing the "patching cement" from the short arc next to the gun proved to be impossible by hand. The answer was a 1941 Black and Decker electric hammer shown below. This hammer was perfect for the job - just strong enough to remove targeted material without disturbing original concrete fabric.

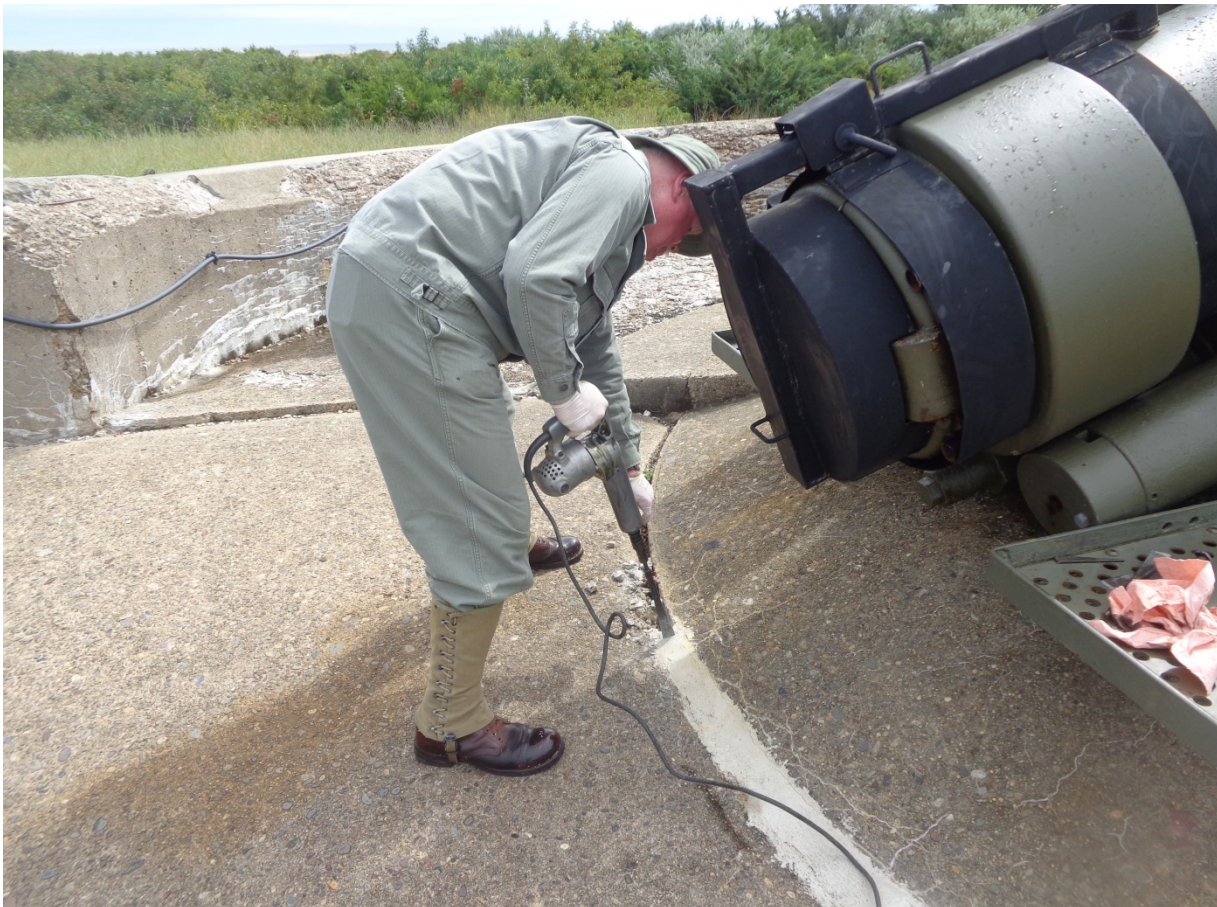
The photo below shows LTC Welch using the Black and Decker hammer to remove the concrete patch around the small arc.

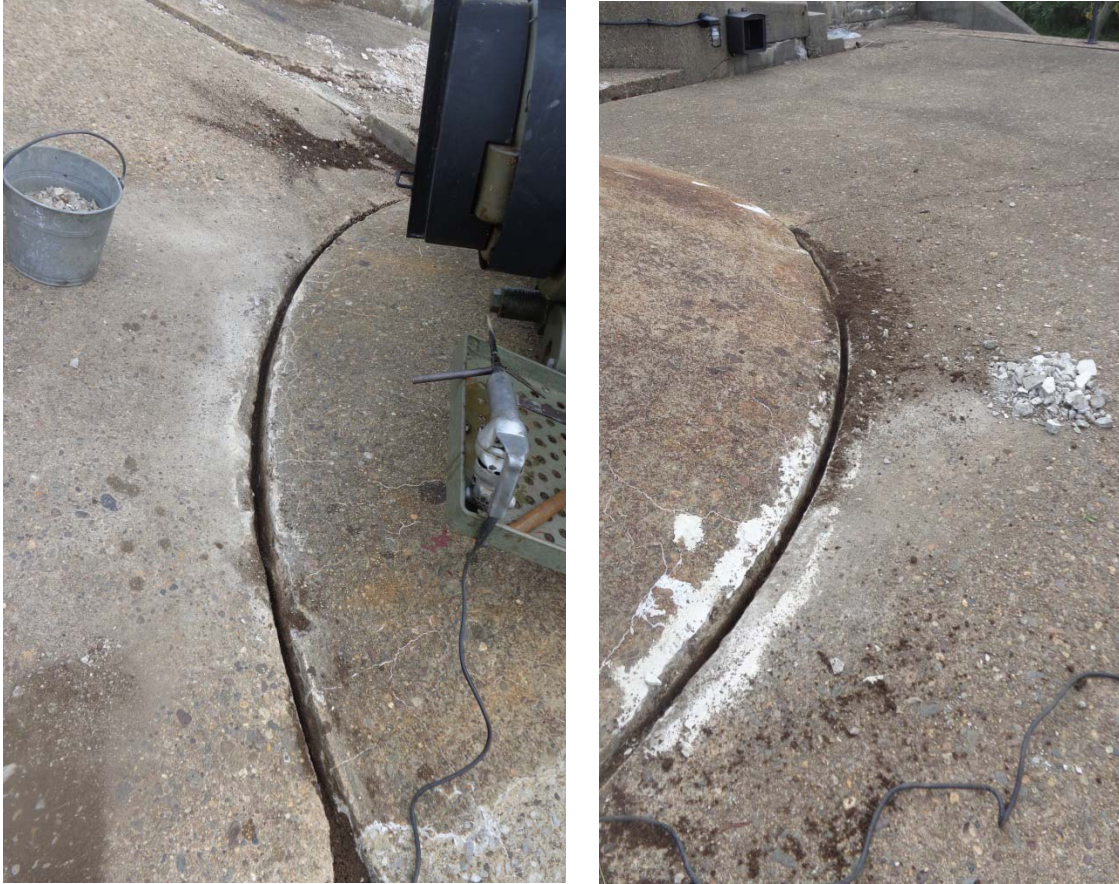
The two photos below show the arc after removal of the patching material and debris that were underneath that material.

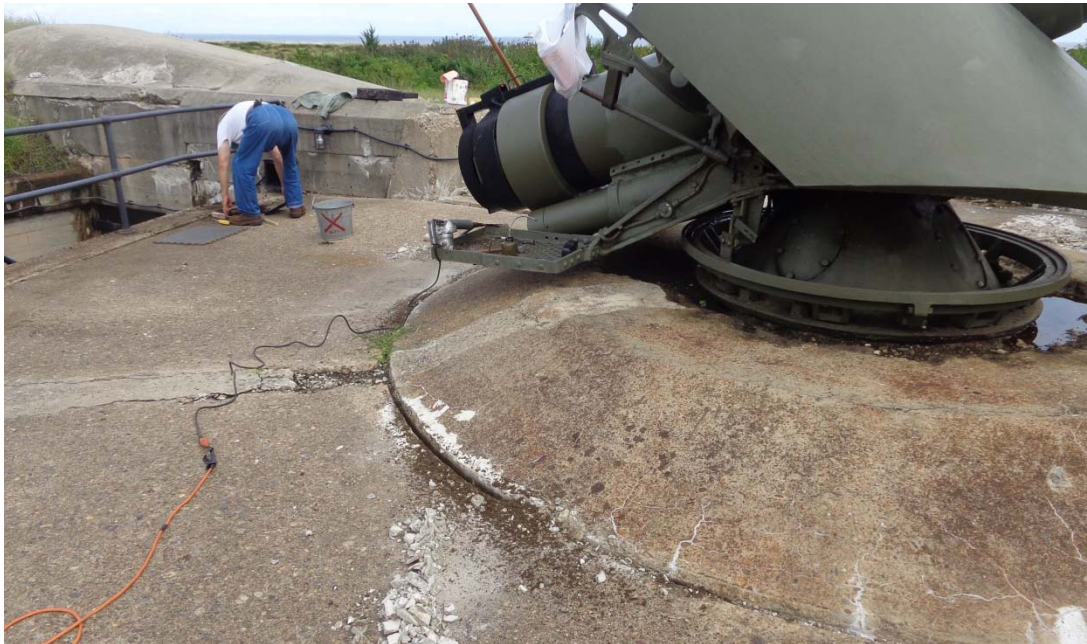
The photo below shows more of the dirt and debris removal around the small arc at the base of Gun #1.

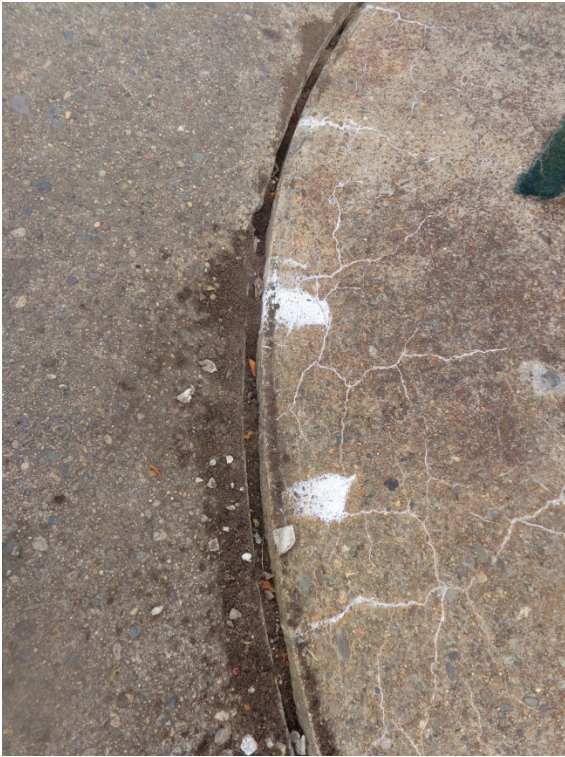
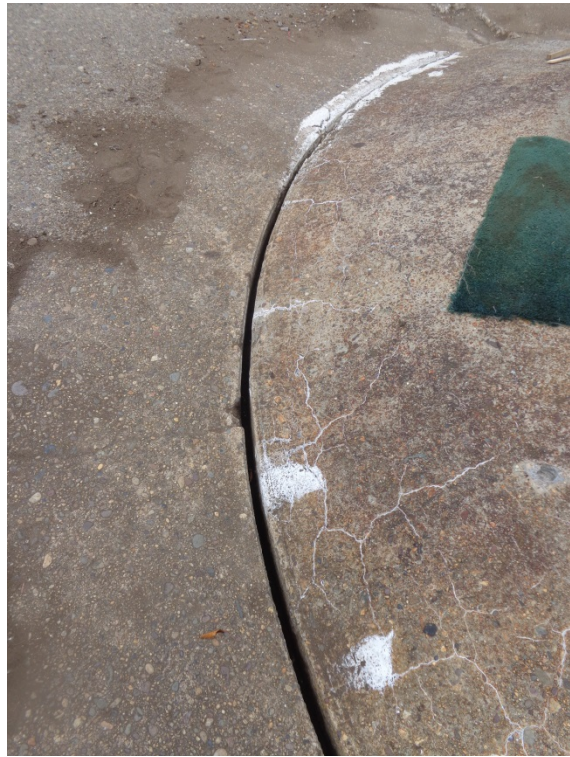
The final work was undertaken on 10 October. All that remained to be done was clean out all the remaining debris in the small arc and install the expansion joint. The 1941 Black and Decker Electric Hammer proved perfect for this task. The photo on the left is during the work and the right after.

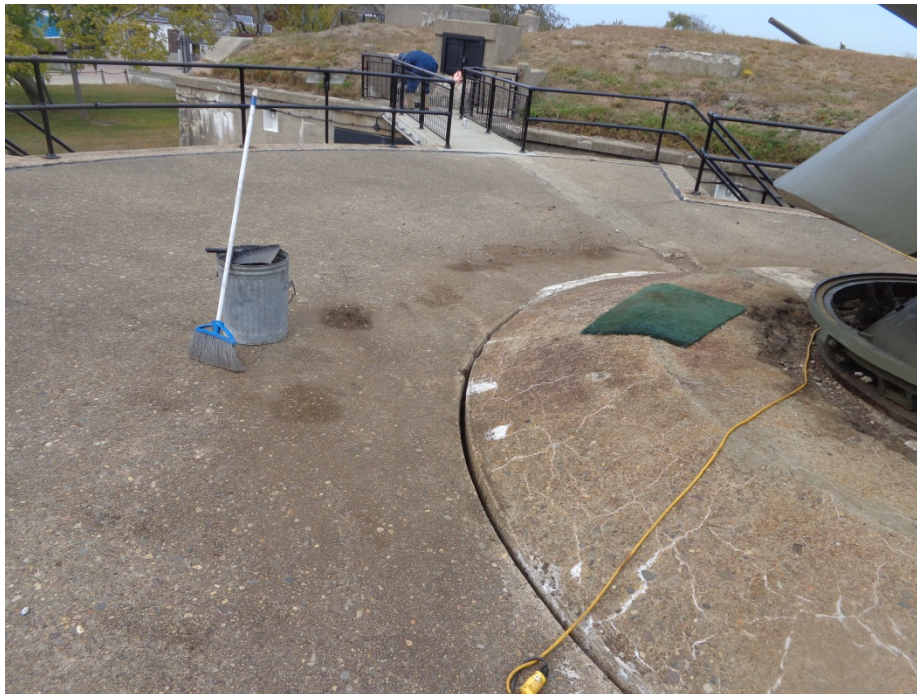
The photo below shows the final cleanup of the arc before installation of the expansion joint.

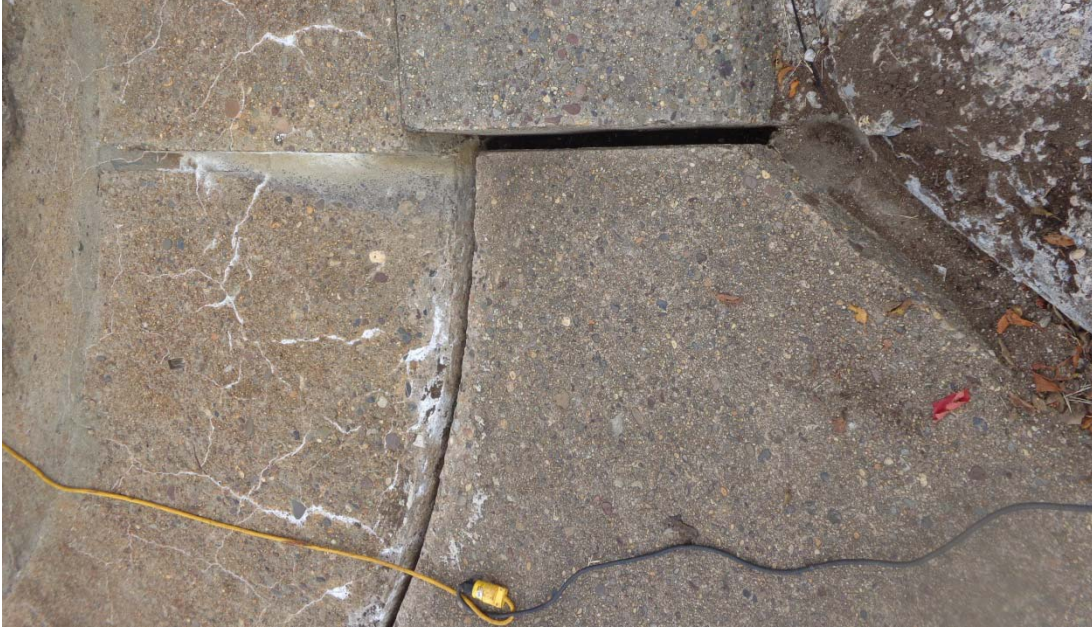
The photo below shows the small arc and short run to the drainage trough completely cleaned out and ready for expansion joint.

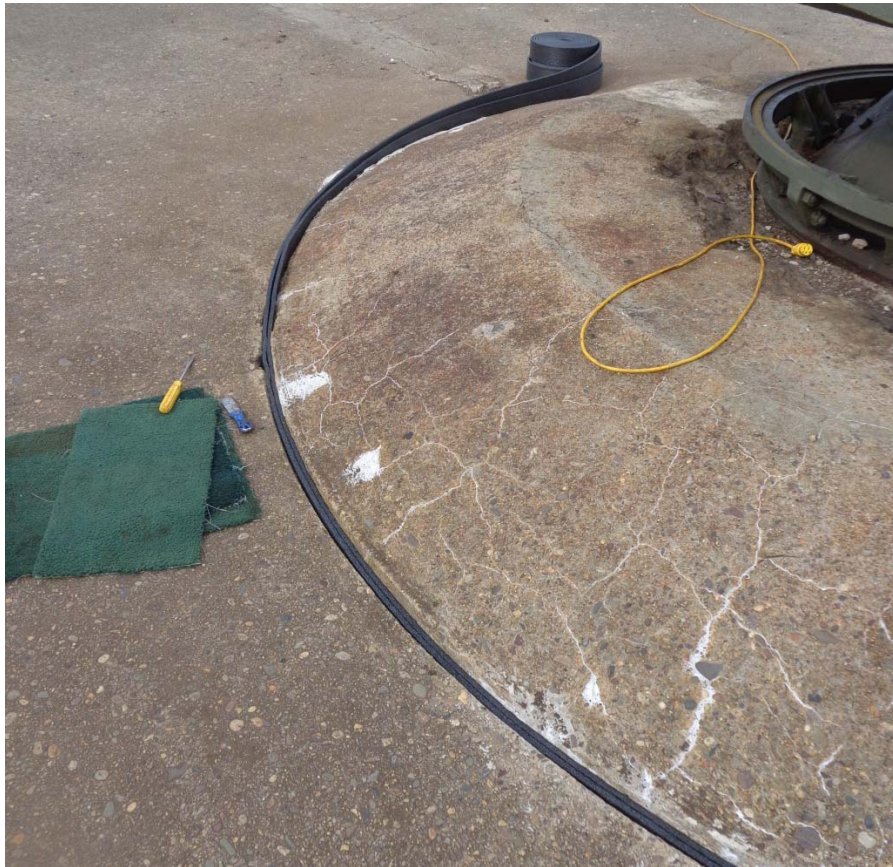
The photo below shows the installation of two strips of expansion joint around the small arc. The removal of debris was quite effective and it was deep enough to enable the entire run of expansion joint to be 4-inches deep.

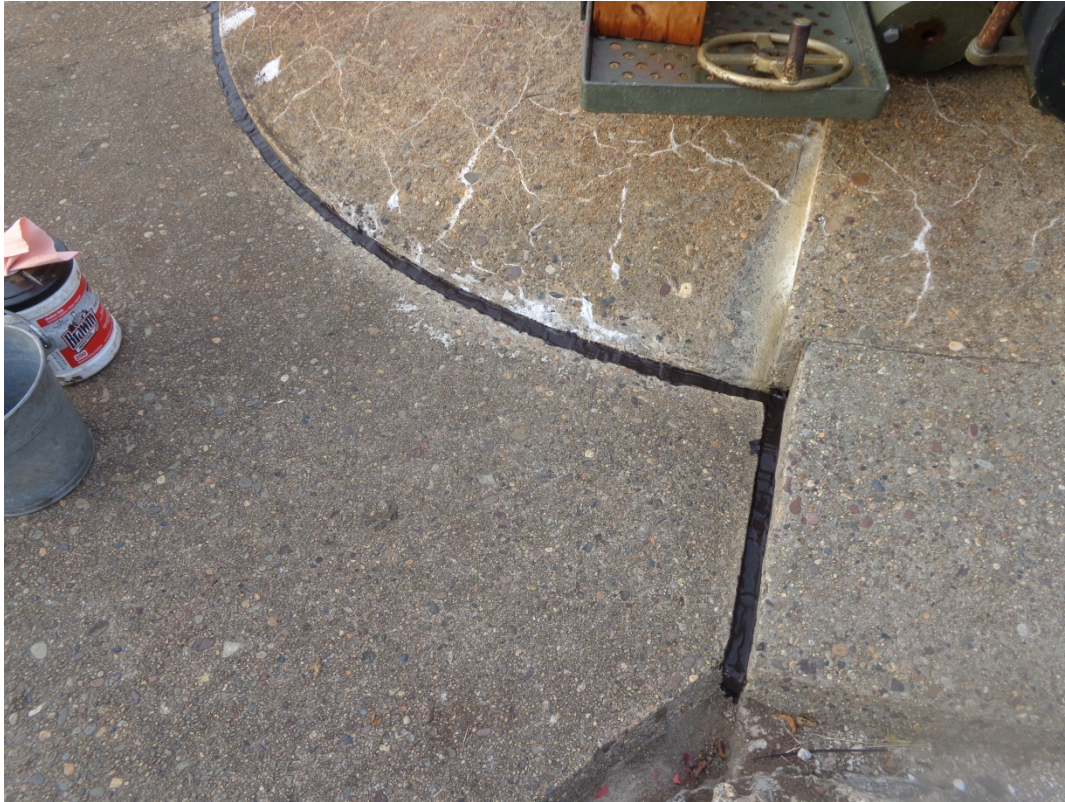
The photo below shows the expansion joint with full sealing treatment applied to about half of the short arc up to the drainage trough.

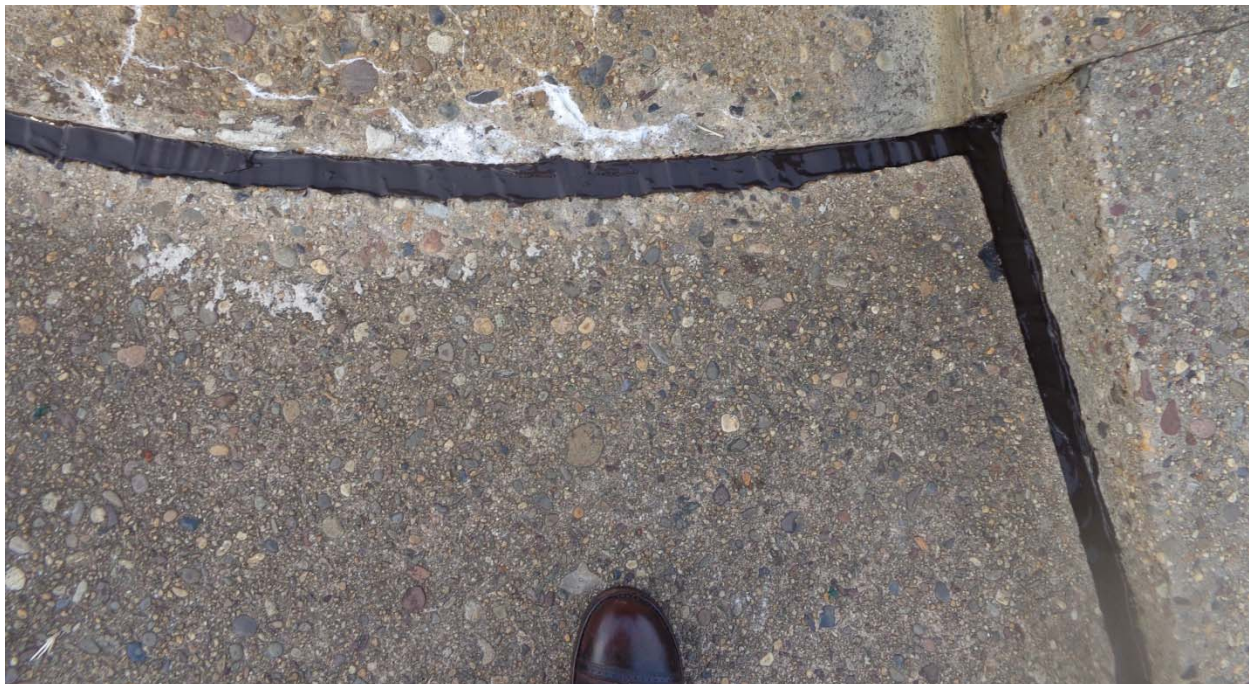
The photo below shows the end of the arc and the short run to the drainage trough fully installed and sealed with KoolSeal asphaltic sealer.

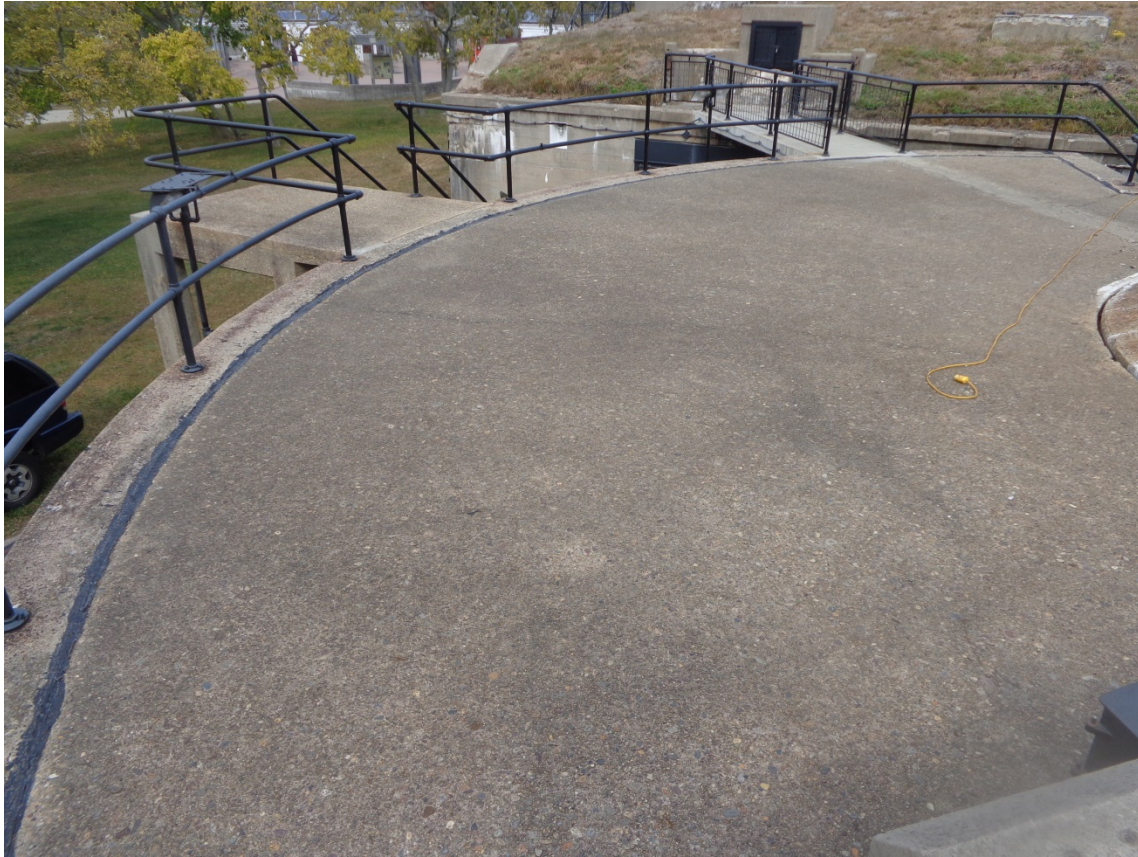
The photo below shows the cover mounted and flush with the face of breach.

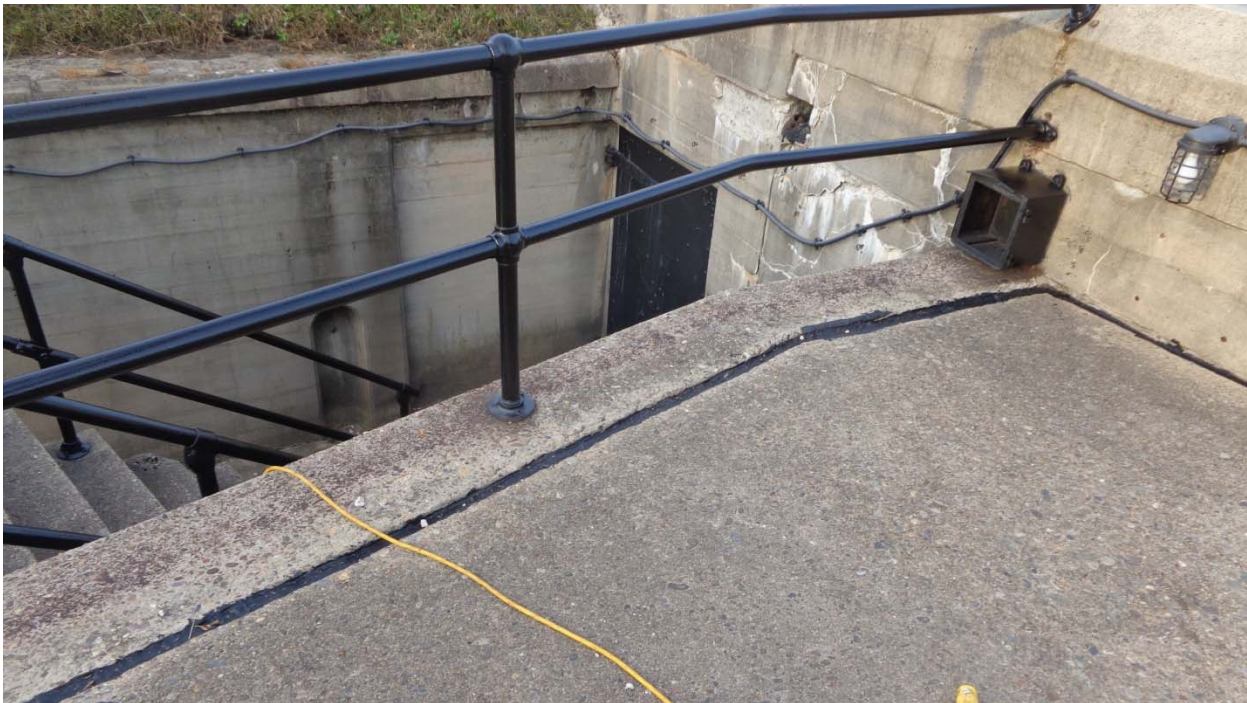
The photo below shows the section near the powder passage and stairs as completed and sealed.
