Restoring Electric System at Battery Gunnison/New Battery Peck *Ft. Hancock, New Jersey*

The reintroduction of electrical service to Battery Gunnison/New Battery Peck began in 2003 when the National Park Service introduced a 20 amp circuit with approximately nine modern interior lighting fixtures and two standard 15 amp outdoor standard receptacles. This very basic service was the starting point. Fifteen years later the system is essentially completed both interior and exterior lighting using predominantly restored and the correct historic fixtures and fittings.

This paper begins with the current status of the Electric Installation at Battery Gunnison/New Battery Peck as of May 2018. As of that date, the installation is over ninety five percent complete. The next part will give a brief chronology of the improvements beginning with NPS electrification in 2003 up to May 2018.

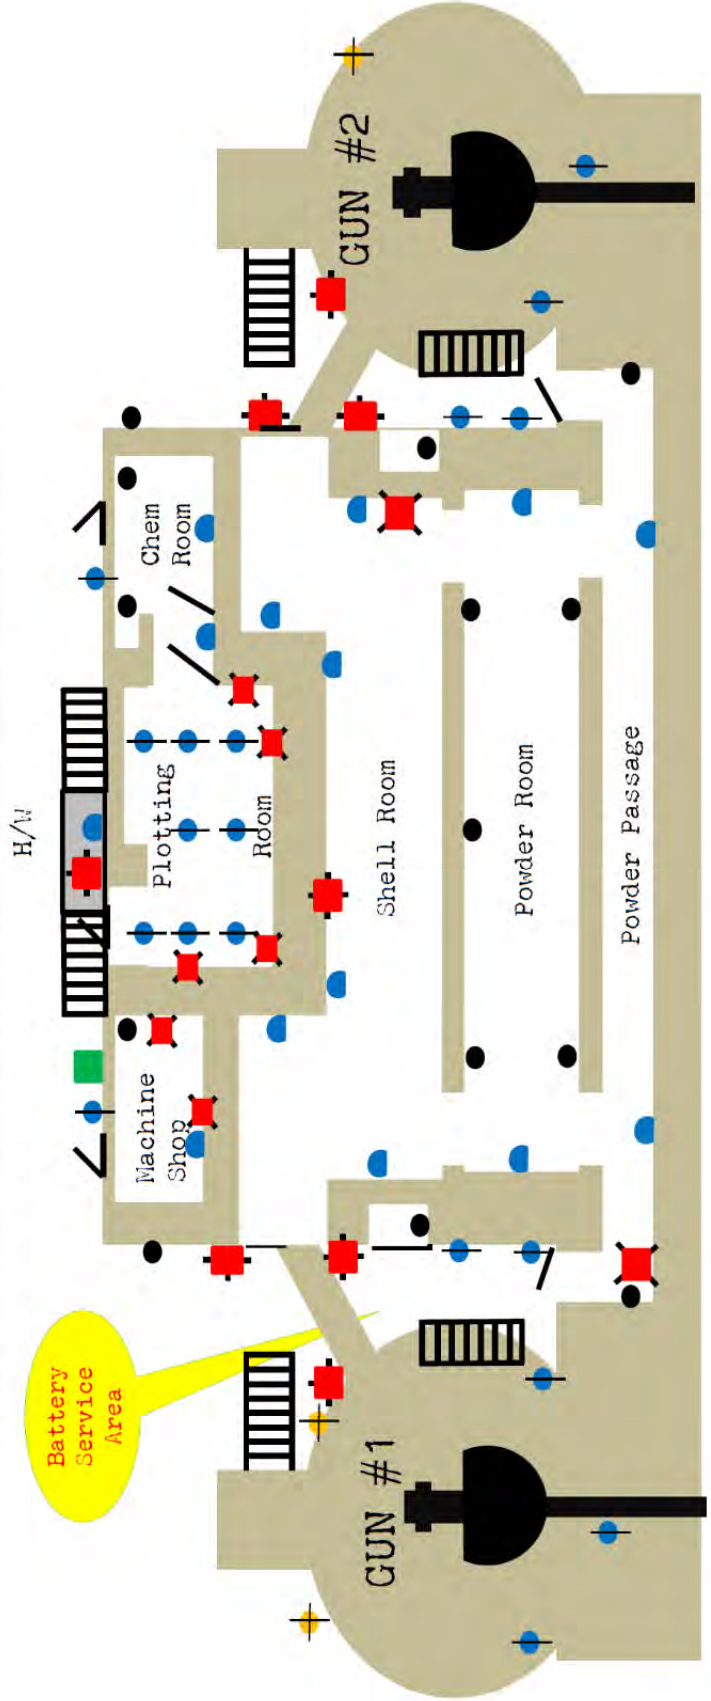
New Battery Peck Electric Service As of May 2018

The drawing on the next page outlines the entire system as currently installed in Battery Gunnison/New Battery Peck. The panel box is not show on this drawing.

- = Light Ceiling
- = Light Wall
- ⊕ = Light Platform
- = Modern Light
- ⊕ = Modern 15 amp receptacle
- = Light/Motion Sensor
- ⊕ = 4 way Junction Box
- ⊕ = 3 way Junction Box
- ⊕ = 2 way Junction Box

All fixtures historic unless otherwise indicated

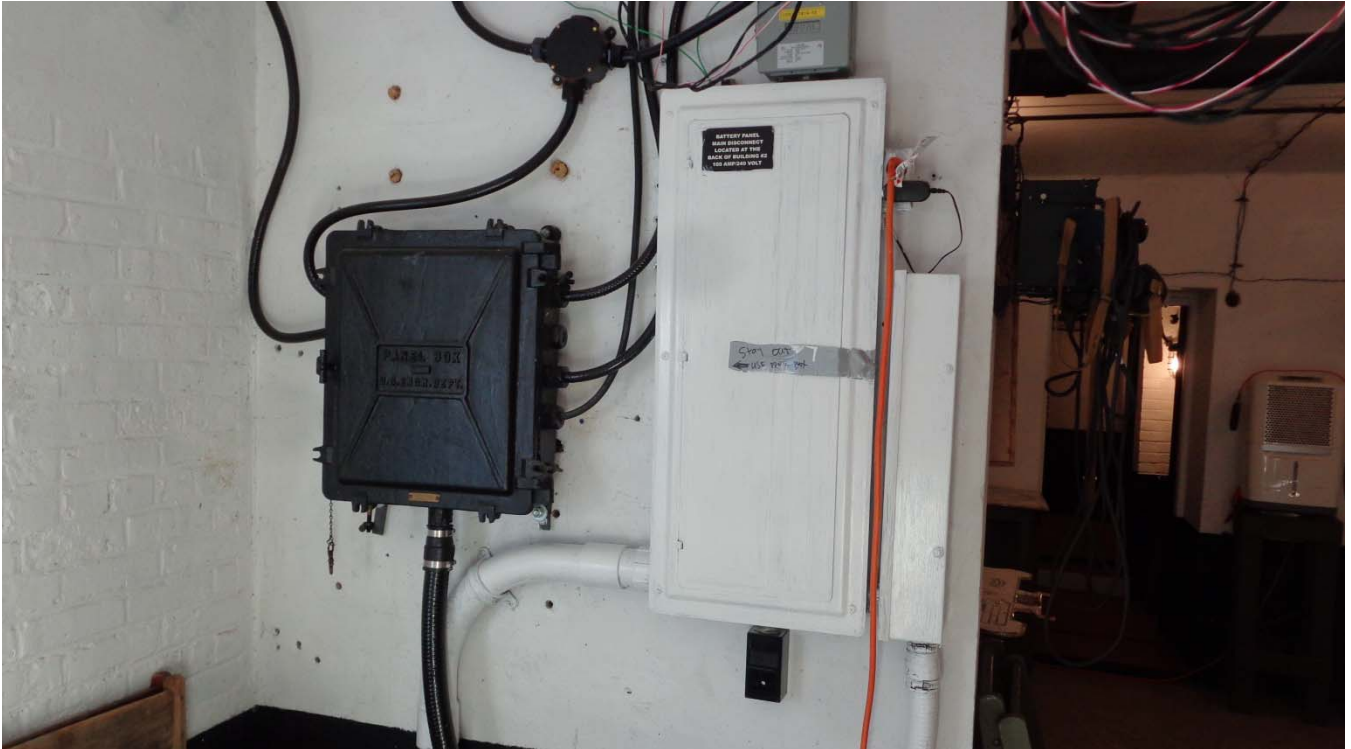
The two photos below from 2018 show the 1915 Corps of Engineers Standard eight circuit panel box and to its right the modern Siemens breaker panel box and the "electric relay switch box" where actual switching is done via a 12 volt DC system. The Siemens panel box, adjacent relay switch box and conduit have been painted white to blend into the background surroundings.

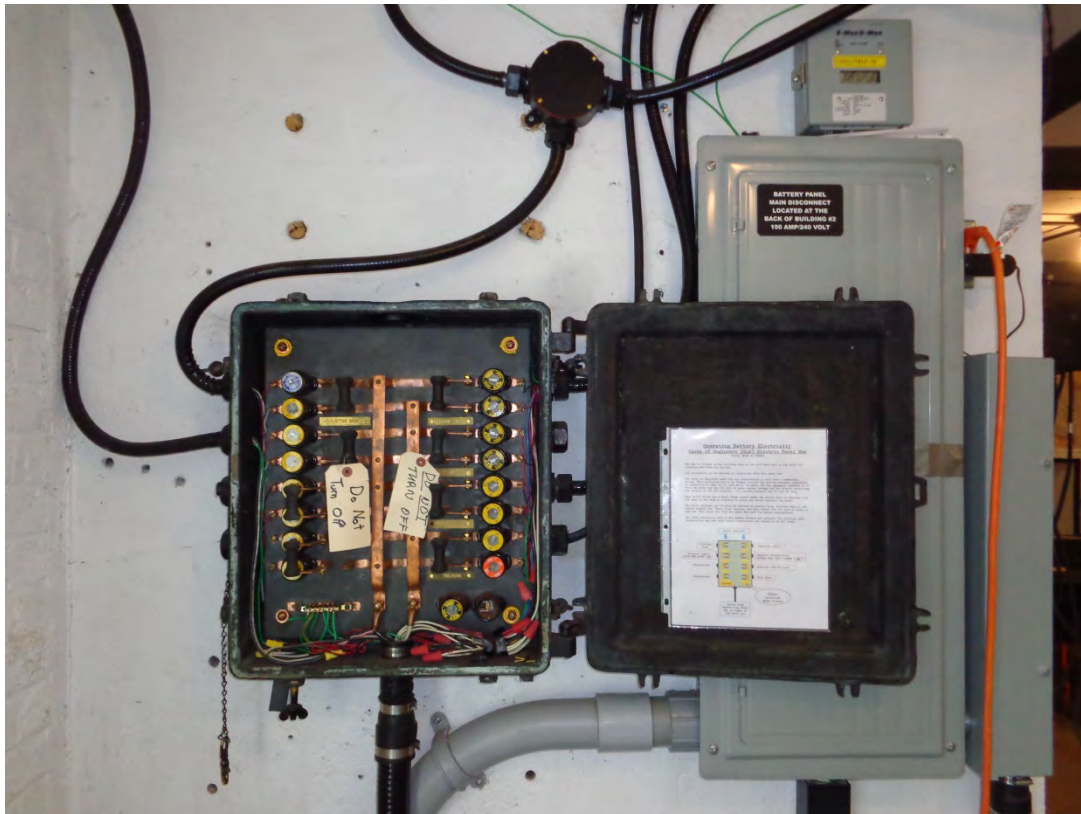
The photo below shows the COE Panel Box open. Notice the 1915 COE box has a paper inside the door explaining the box and the circuits it operates. The two paper tags indicate circuits that must remain "on" to support exterior lights & dehumidifiers.

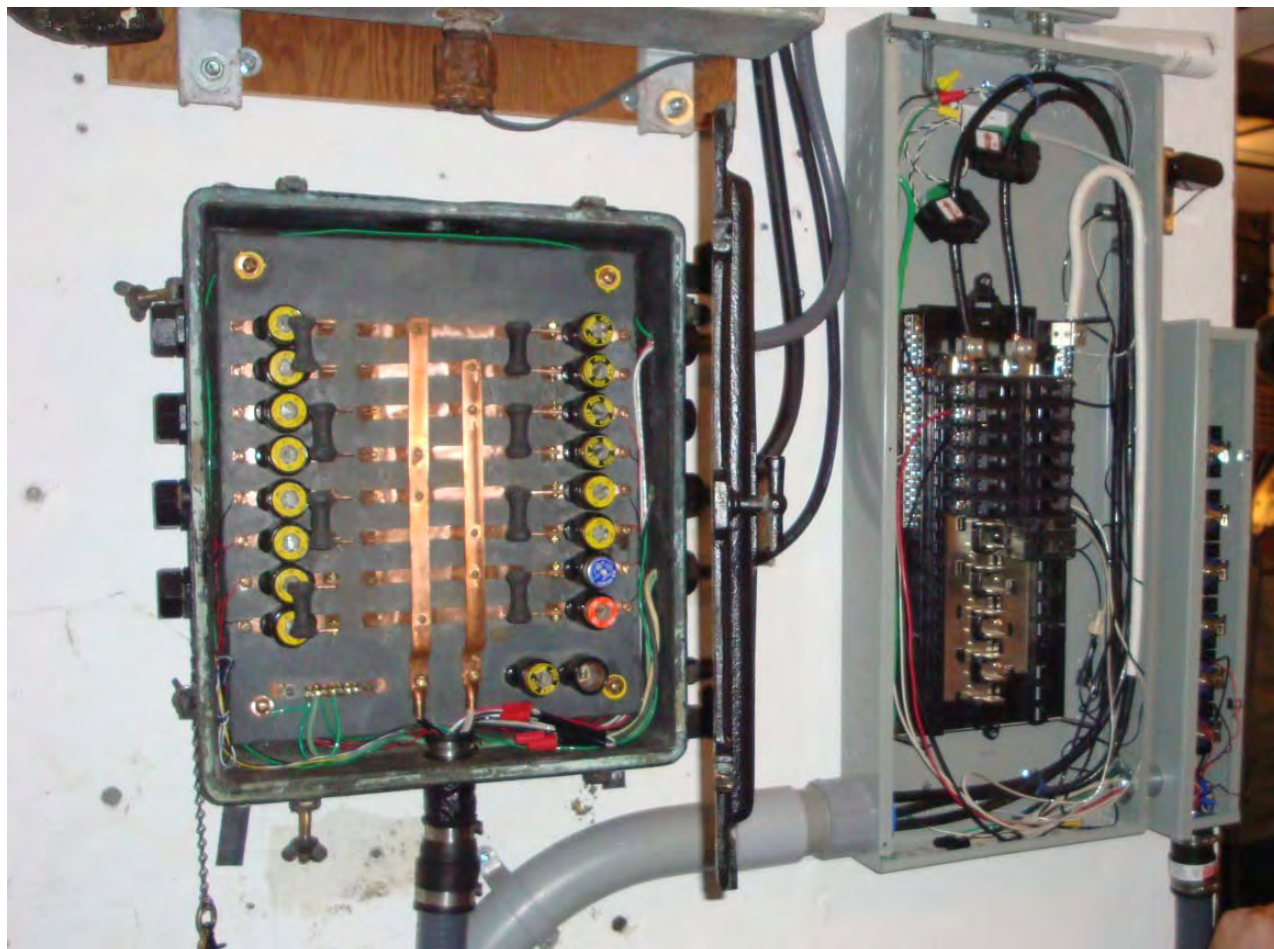
The photo below from October 2011 shows all three boxes open as they are wired and connected. The fuses in the panel box are actually used to complete the 12 volt DC circuits. The green wires in the lower left hand corner of the box are the only other operational wiring in the box. These are the grounding circuits and they effectively ground the box as well. The Siemens panel box and conduit will likely be painted white in the future.

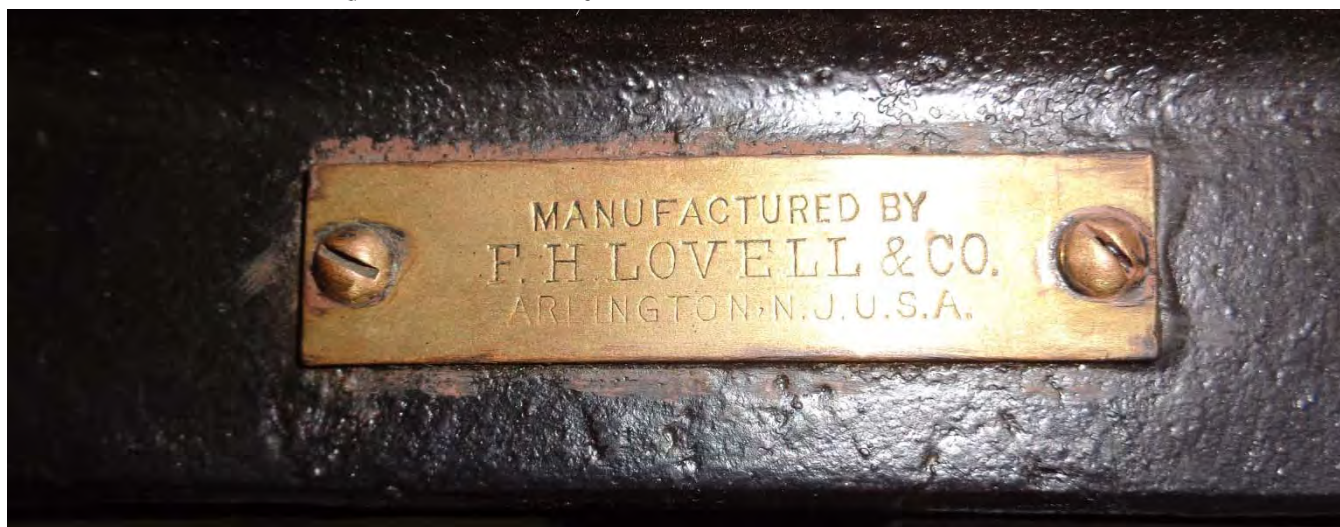
The photo below shows the manufacture's tag for the panel box. Notice that it was manufactured in Arlington, New Jersey.

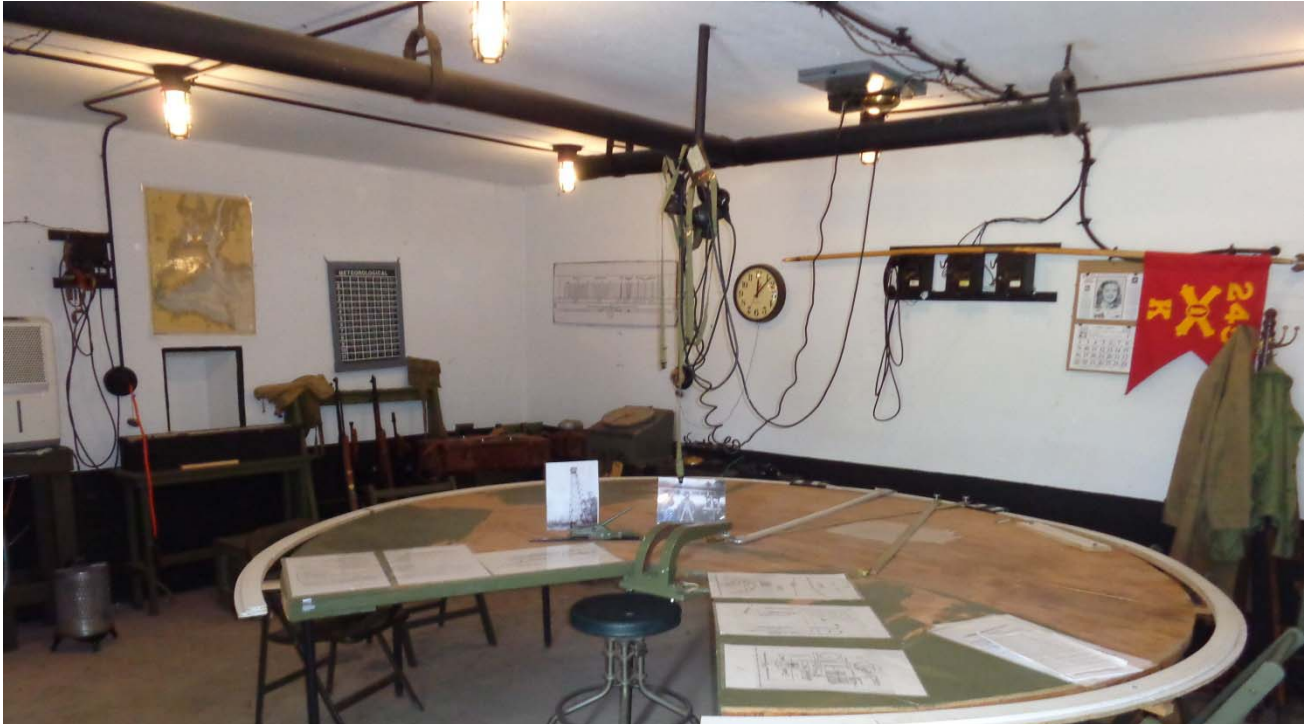
The photo below from May 2018 shows the plotting room and four of its ceiling lights (modern with vintage look) and two of the vintage WWII Crouse and Hinds single plug receptacles on the walls. These modern RAB lights were chosen because they are very similar to WWII period Crouse & Hinds lights which were mounted in the plotting room in 1943, but, are generally unavailable.

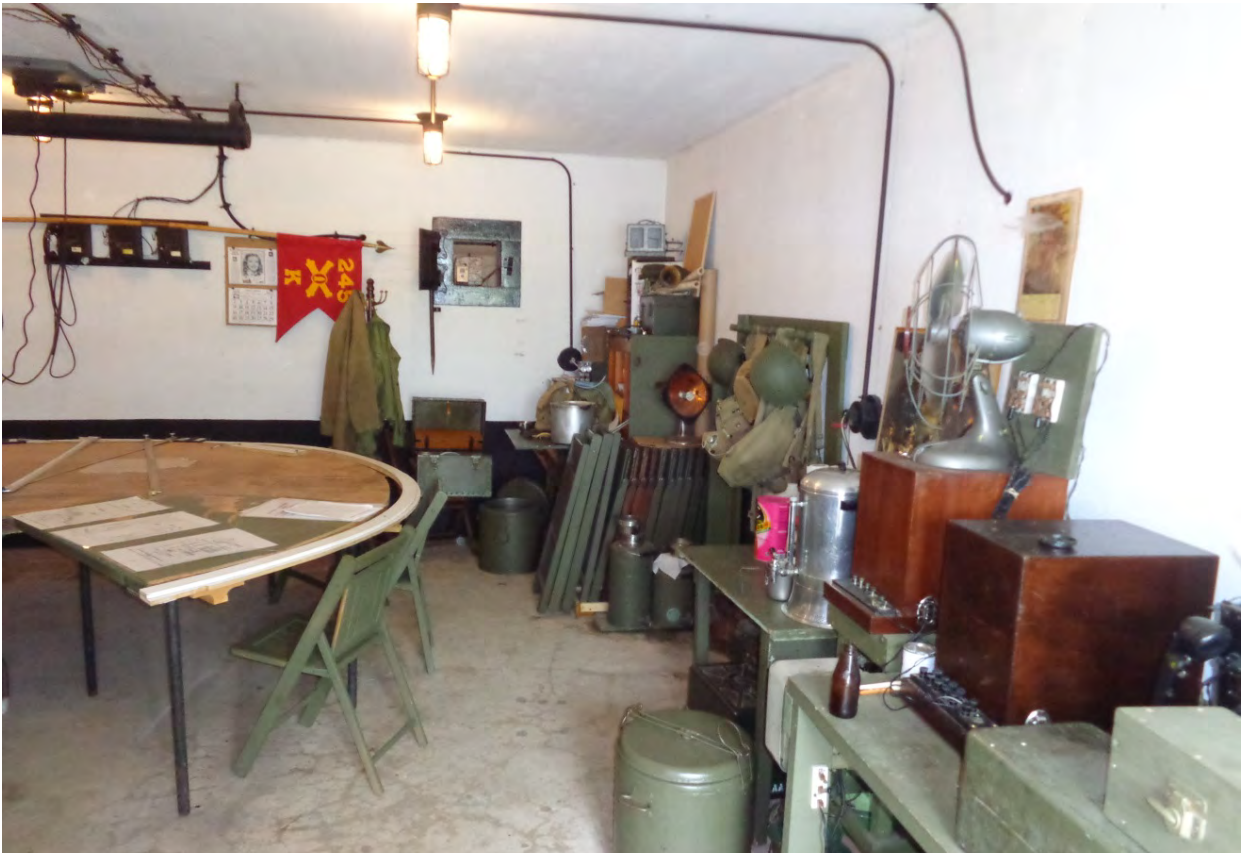
This photo from May 2018 shows three modern (vintage look) ceiling lights.

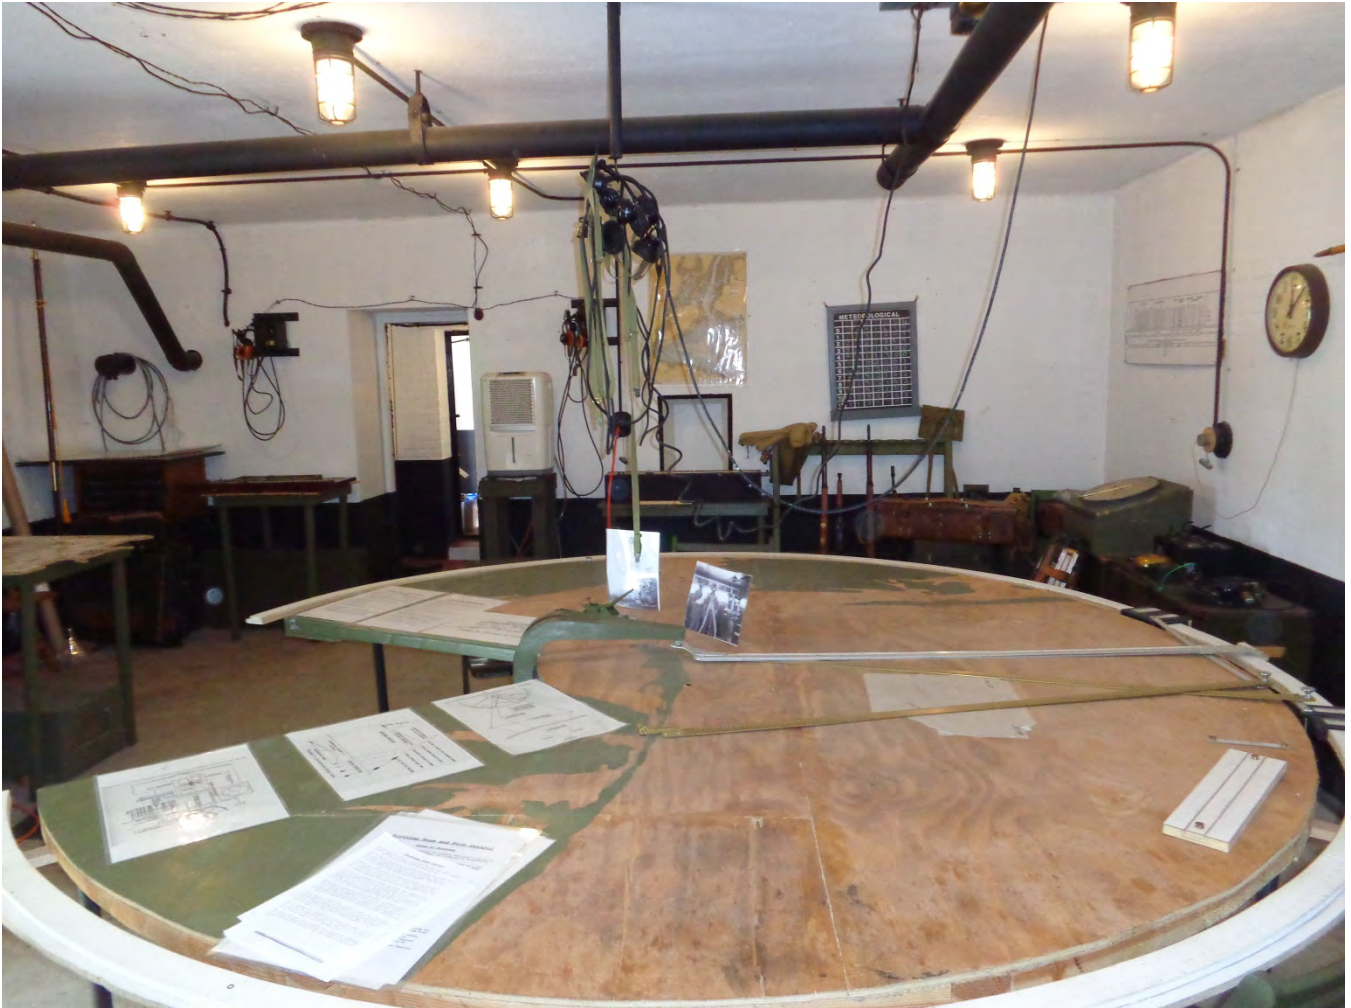
The photo below from May 2018 shows the plotting room from south to north.

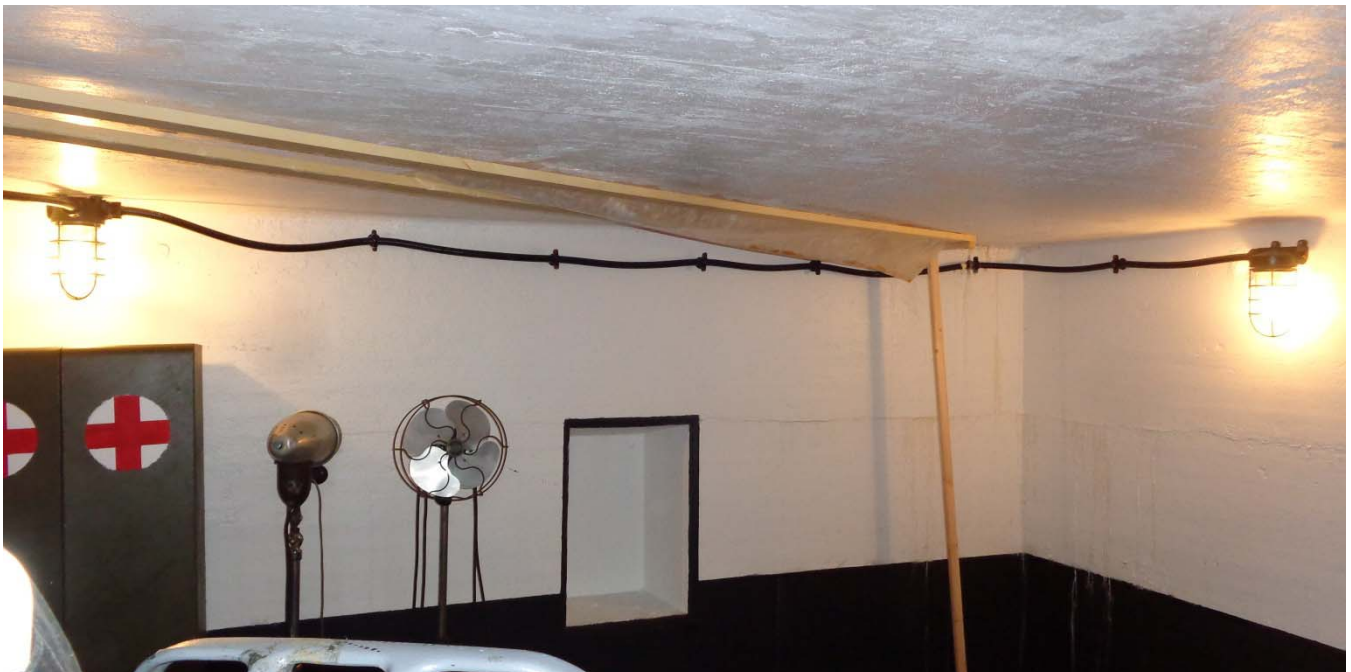
The photo below shows the Chemical Warfare room's ceiling light (left) and wall light (right) along the northern wall.

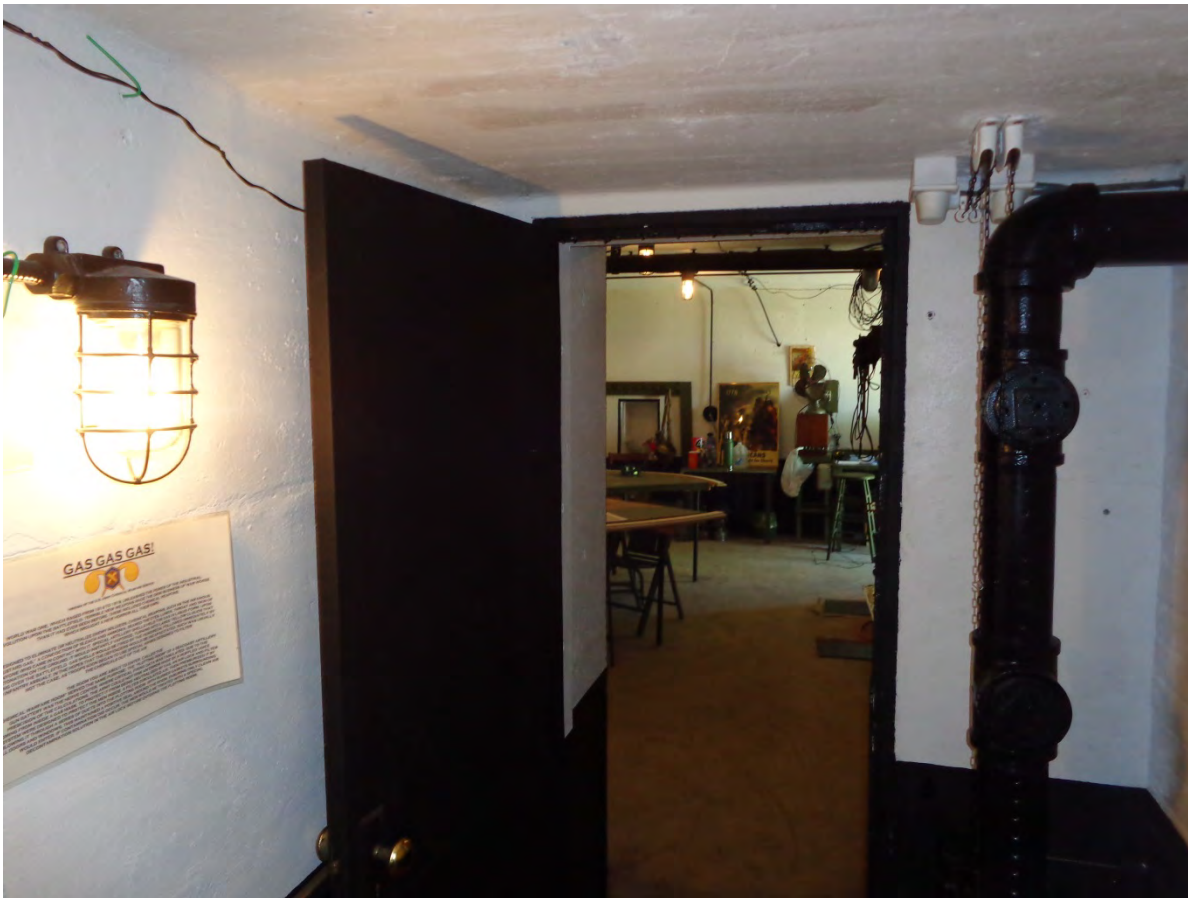
The photo below taken in May 2018 shows the chemical decontamination air lock with its COE vintage wall light on the left.

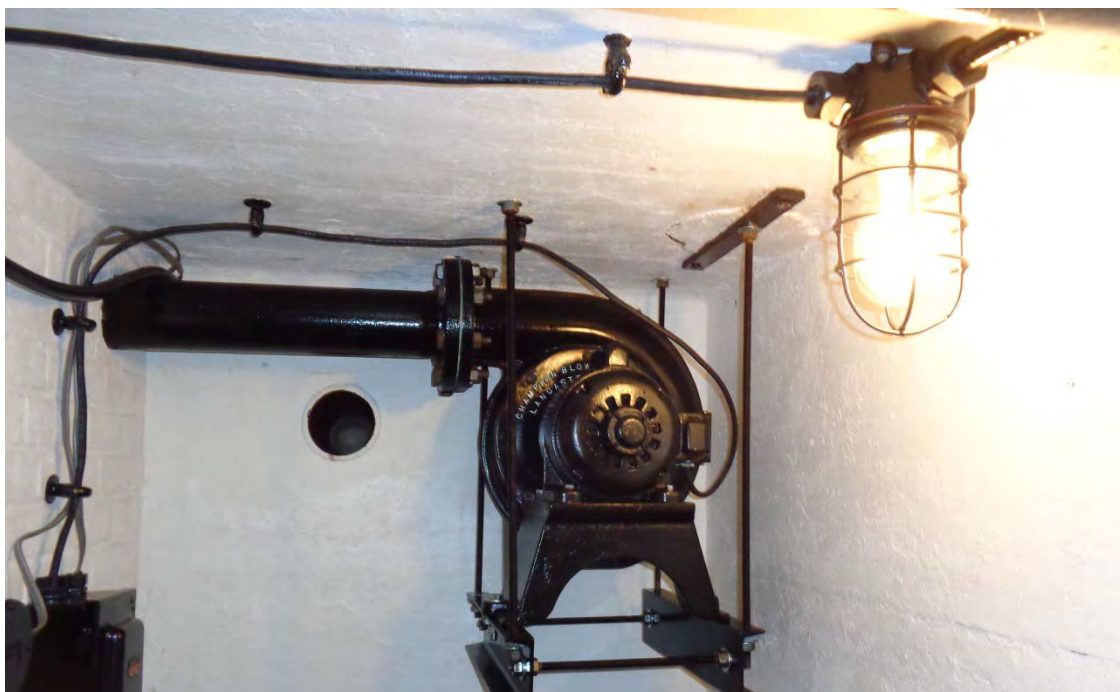
The photo below from May 2018 shows the vintage COE ceiling light inside the mechanical section of the Chemical Warfare room. The electrical system for the blower motors is addressed in a separate document.

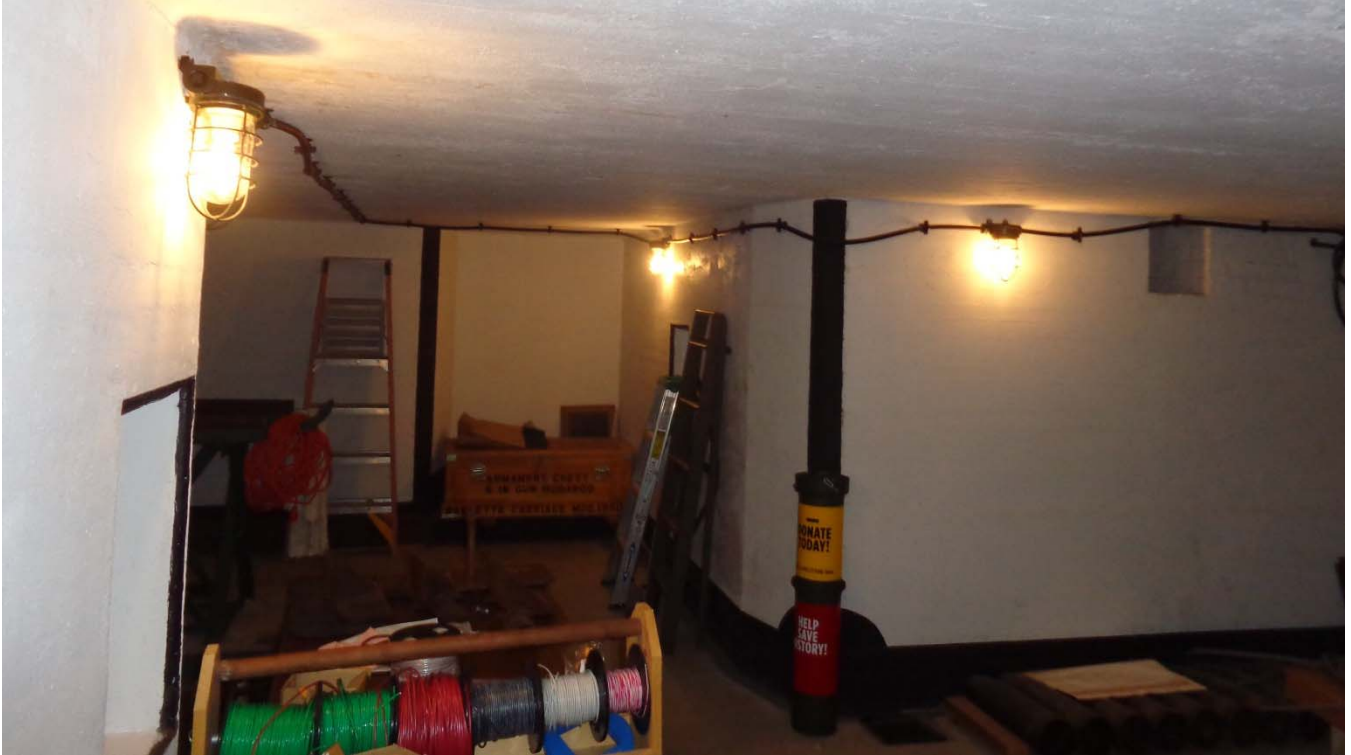
The photo below from May 2018 shows the Gun #1 main entrance to the shell magazine with three COE wall lights.

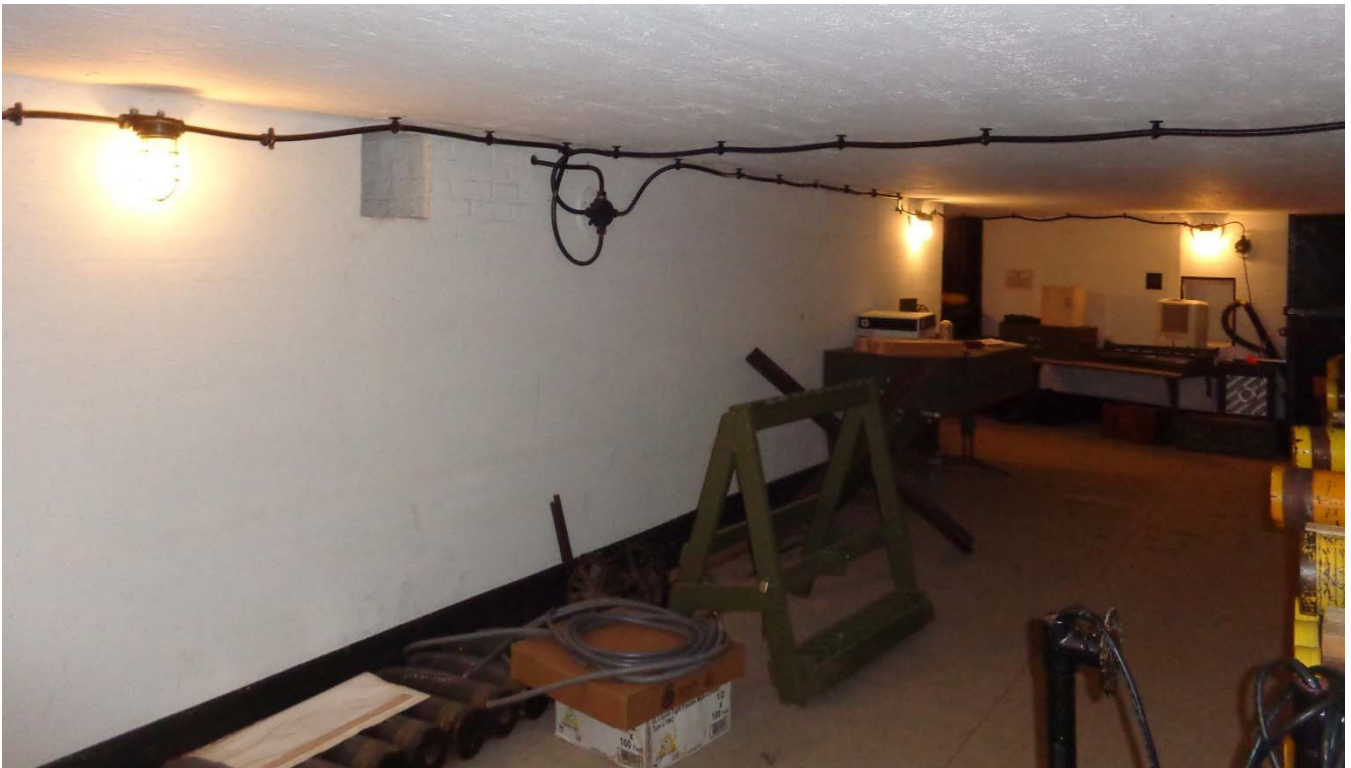
This photo from May 2018 shows the shell magazine looking towards the Gun #2 side with three COE wall lights and one COE four line junction box. The shell room dehumidifier is under the wall light on the right. The dedicated receptacle for the two magazine dehumidifiers is to the right of the wall light.

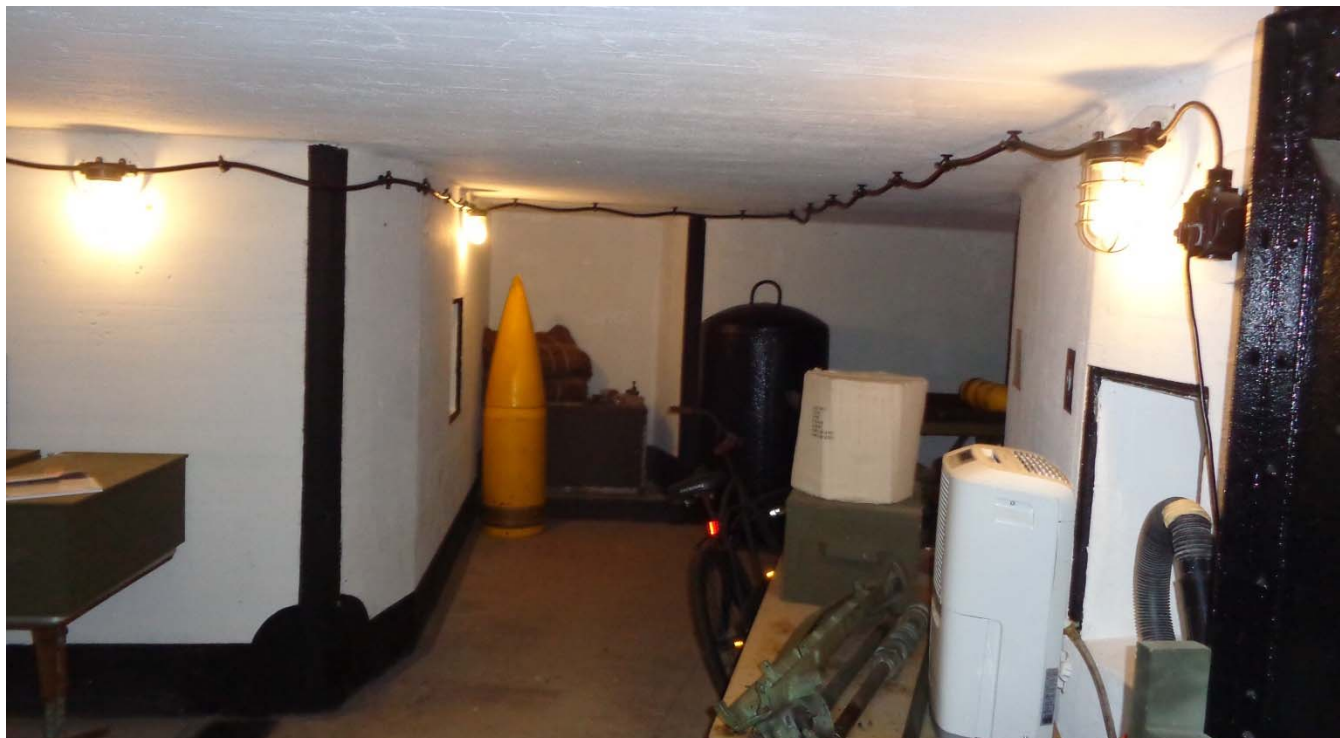
This view from May 2018 is from the entrance to the powder magazine looking towards the Gun #2 entrance. It shows three wall lights, and the dedicated dehumidifier receptacle on the right.

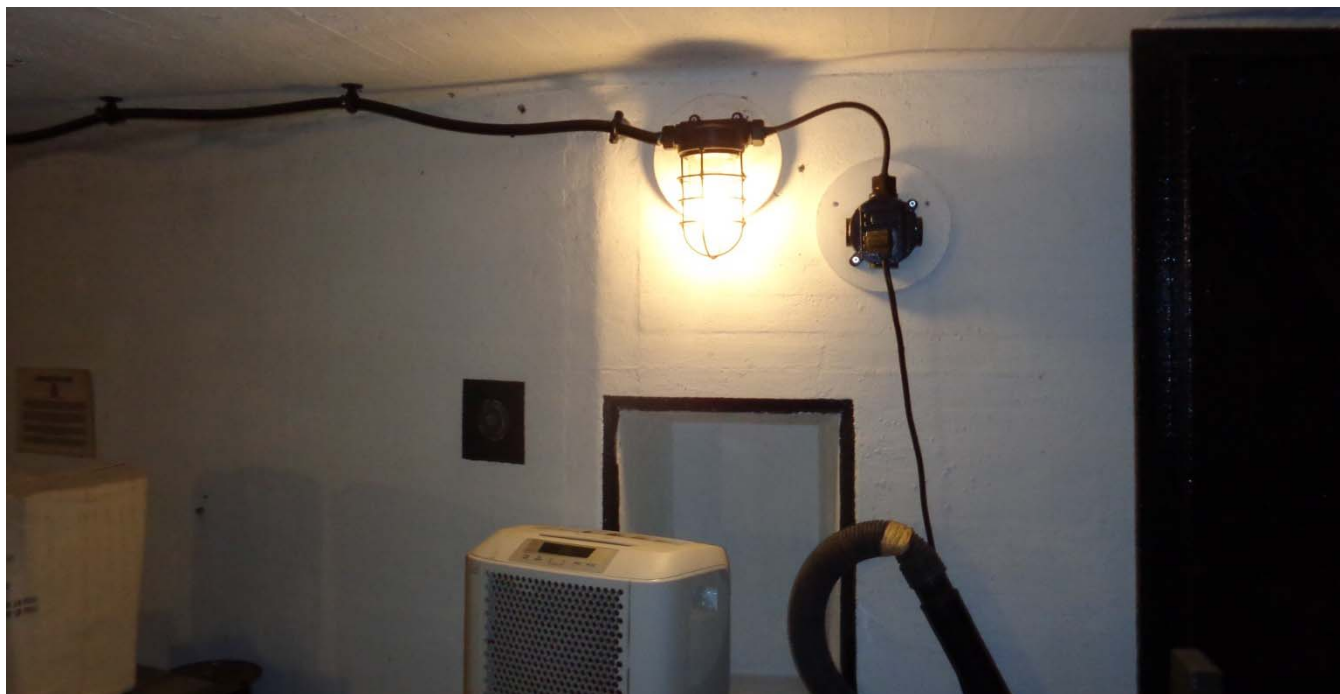
This photo from May 2018 shows the shell room dehumidifier, wall light and dedicated circuit receptacle for the dehumidifiers.

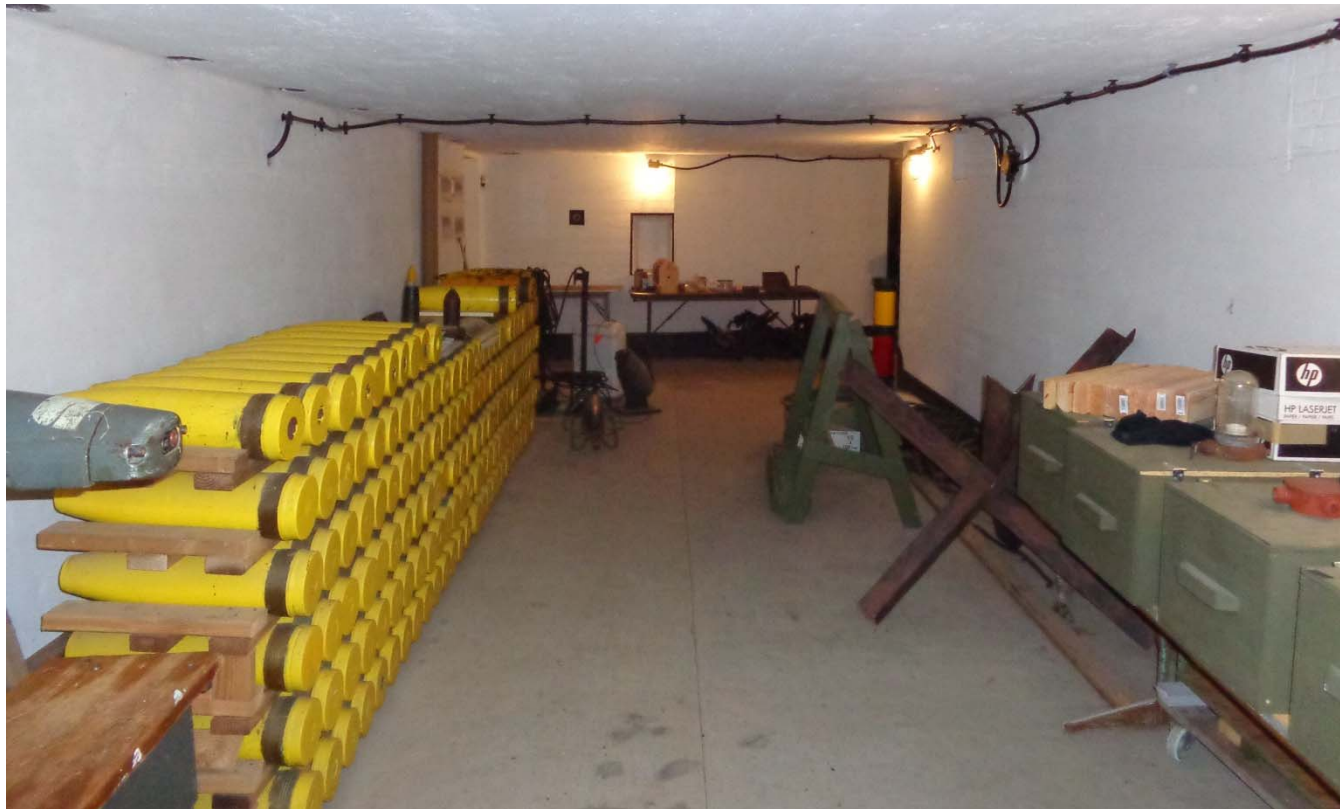
This view from May 2018 shows the shell room looking towards Gun #1 showing two COE wall lights.

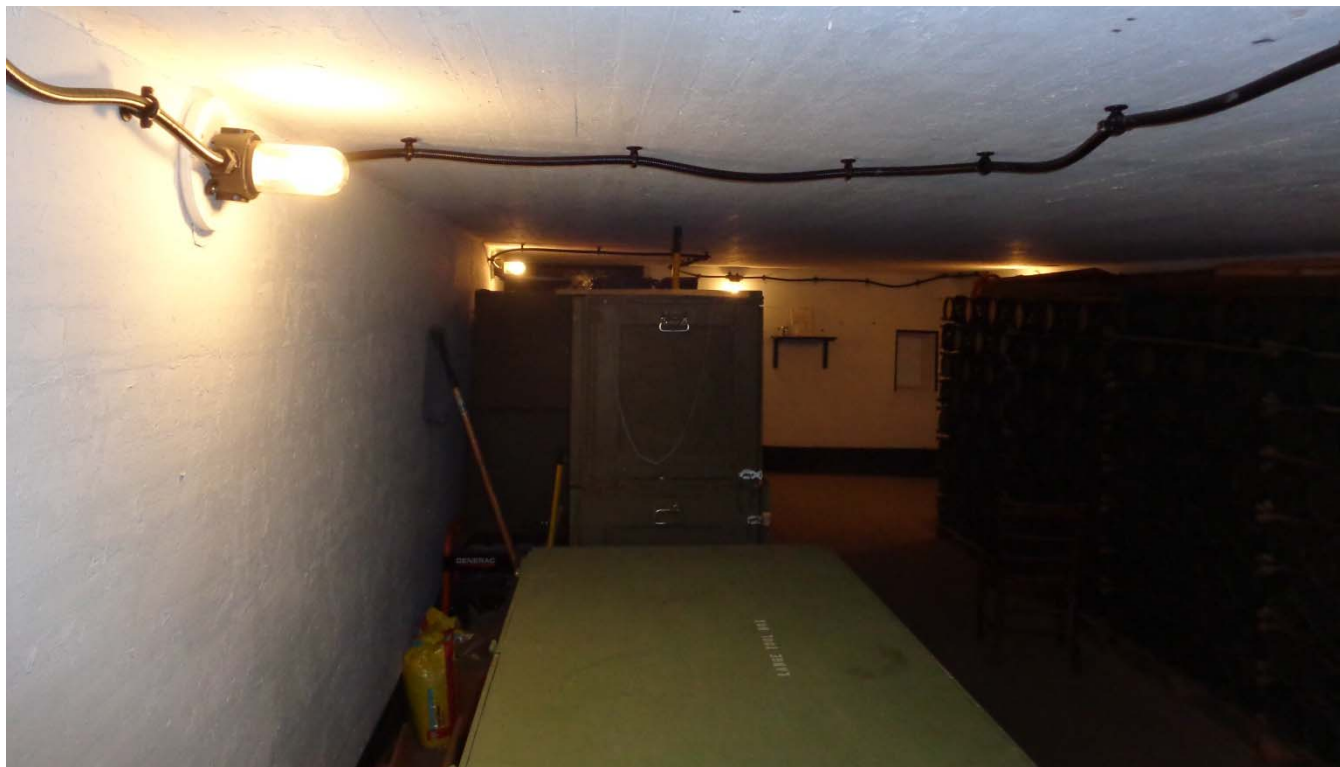
This photo from May 2018 shows the three COE lights (two ceiling lights mounted on the wall and one wall light to the right).

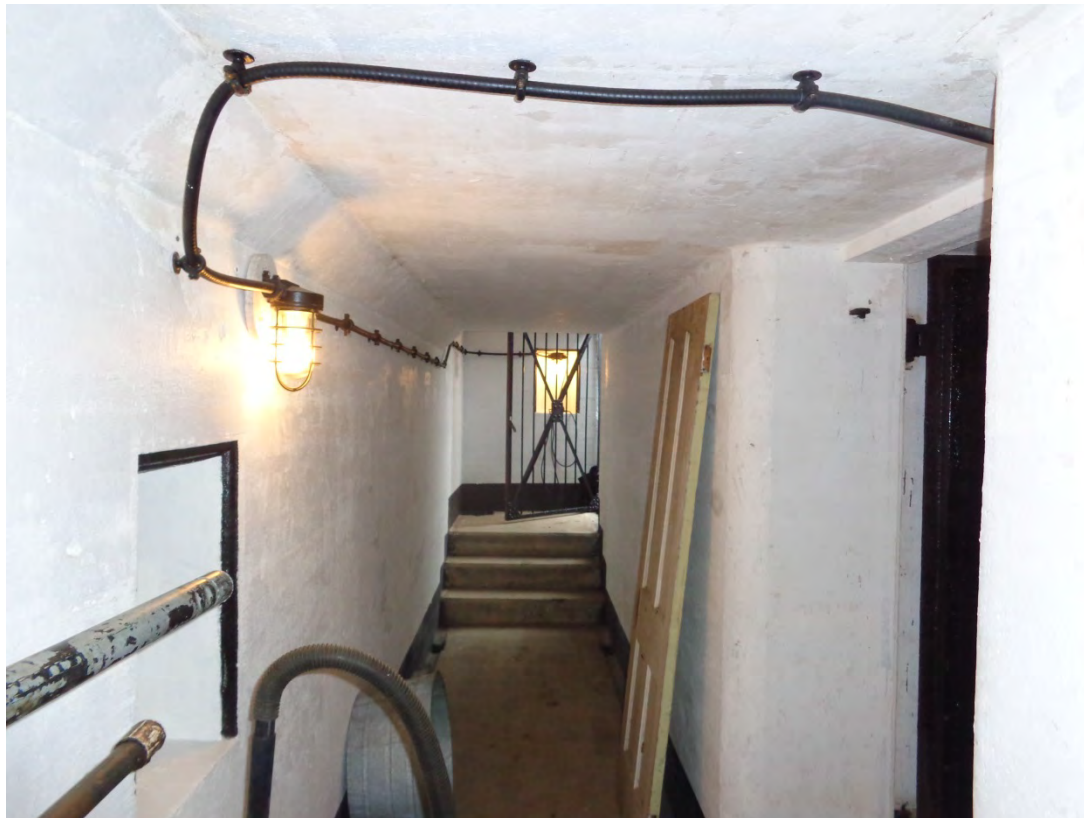
This view from May 2018 looking out the powder passage shows one COE wall light and one COE ceiling light in niche. Both lights are historically correct.

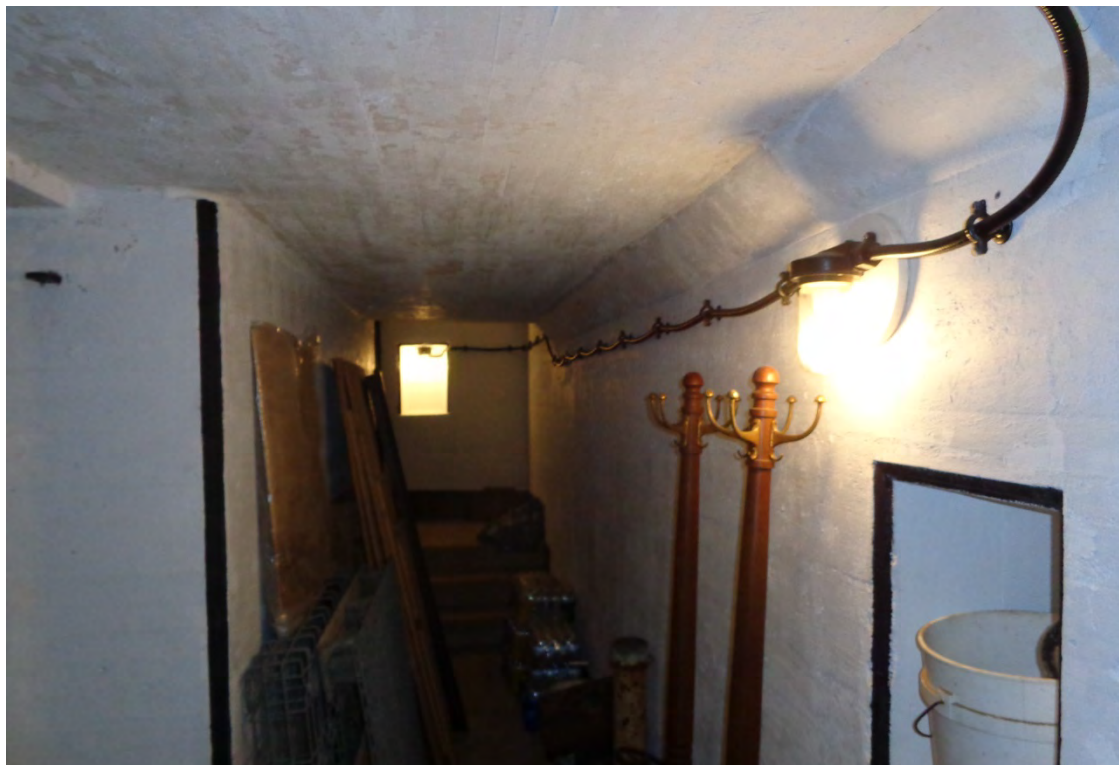
This view is looking down the Gun #2 powder passage showing one COE wall light and one COE ceiling light in niche.

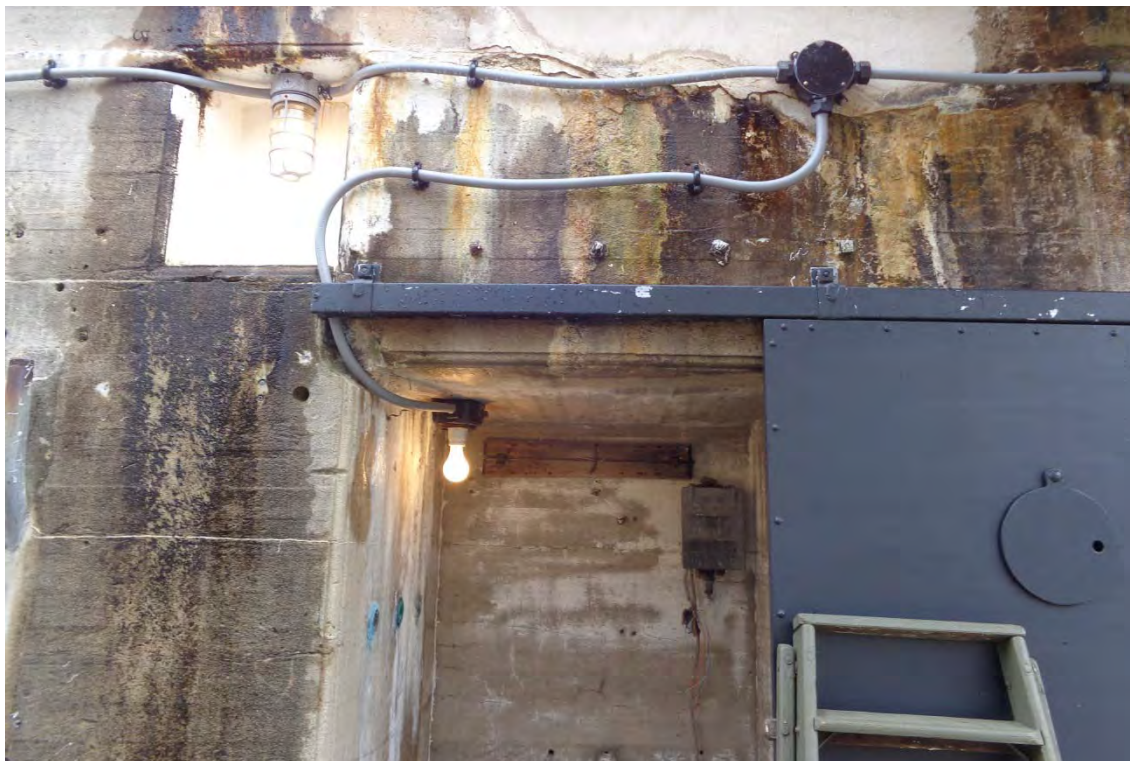
The photo below from April 2018 shows the Gun #2 telephone booth light installed and niche light both illuminated. The telephone booth light and the junction box are historic COE Standard fixtures.

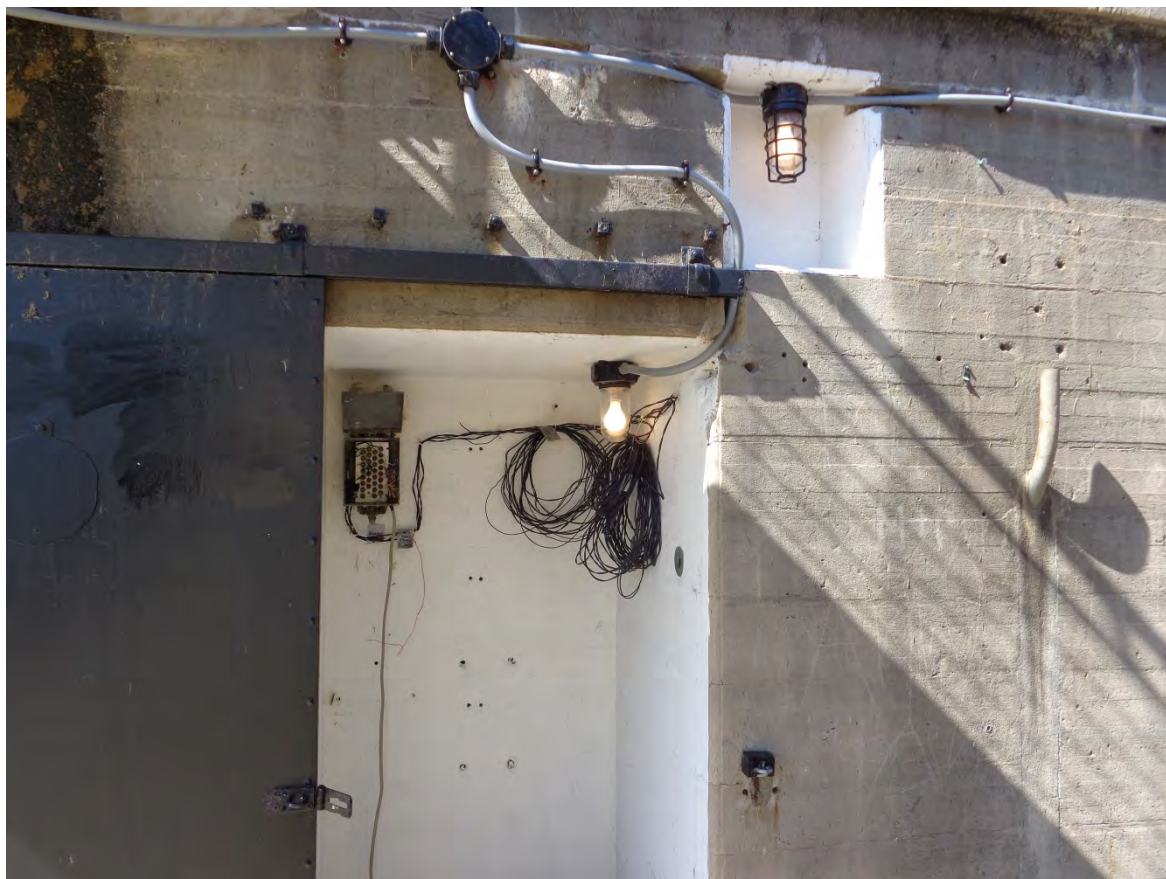
The photo below from May 2018 shows the Gun #1 telephone booth light and wiring for telephones and Time Interval Bell.

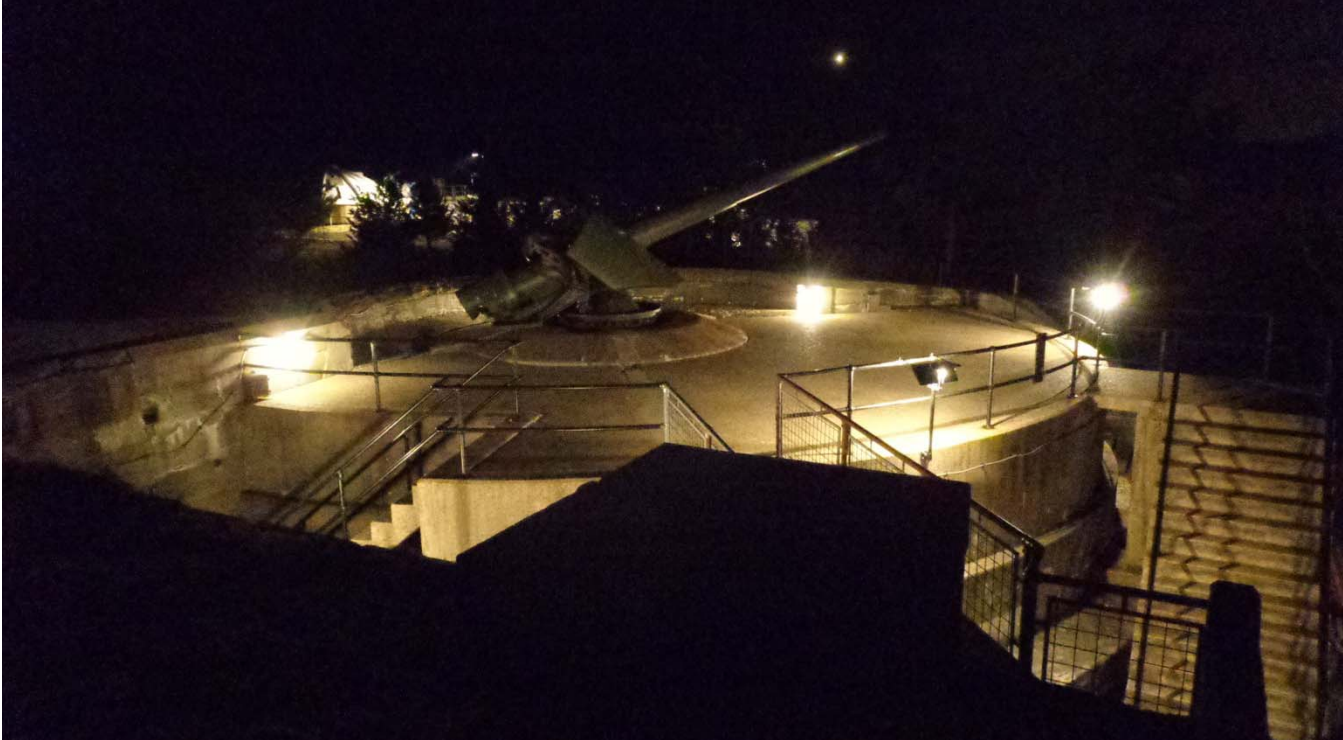
The photo below shows Gun #1 with its full light installation (three wall lights and two stanchion lights) operating in May 2018. All three front lights and the two stanchion lights are in place.
