Restoring Electric System at Battery Gunnison/New Battery Peck *Ft. Hancock, New Jersey*

The reintroduction of electrical service to Battery Gunnison/New Battery Peck began in 2003 when the National Park Service introduced a 20 amp circuit with approximately nine modern interior lighting fixtures and two standard 15 amp outdoor standard receptacles. This very basic service was the starting point. Fifteen years later the system is essentially completed both interior and exterior lighting using predominantly restored and the correct historic fixtures and fittings.

This paper begins with the current status of the Electric Installation at Battery Gunnison/New Battery Peck as of May 2018. As of that date, the installation is over ninety five percent complete. The next part will give a brief chronology of the improvements beginning with NPS electrification in 2003 up to May 2018.

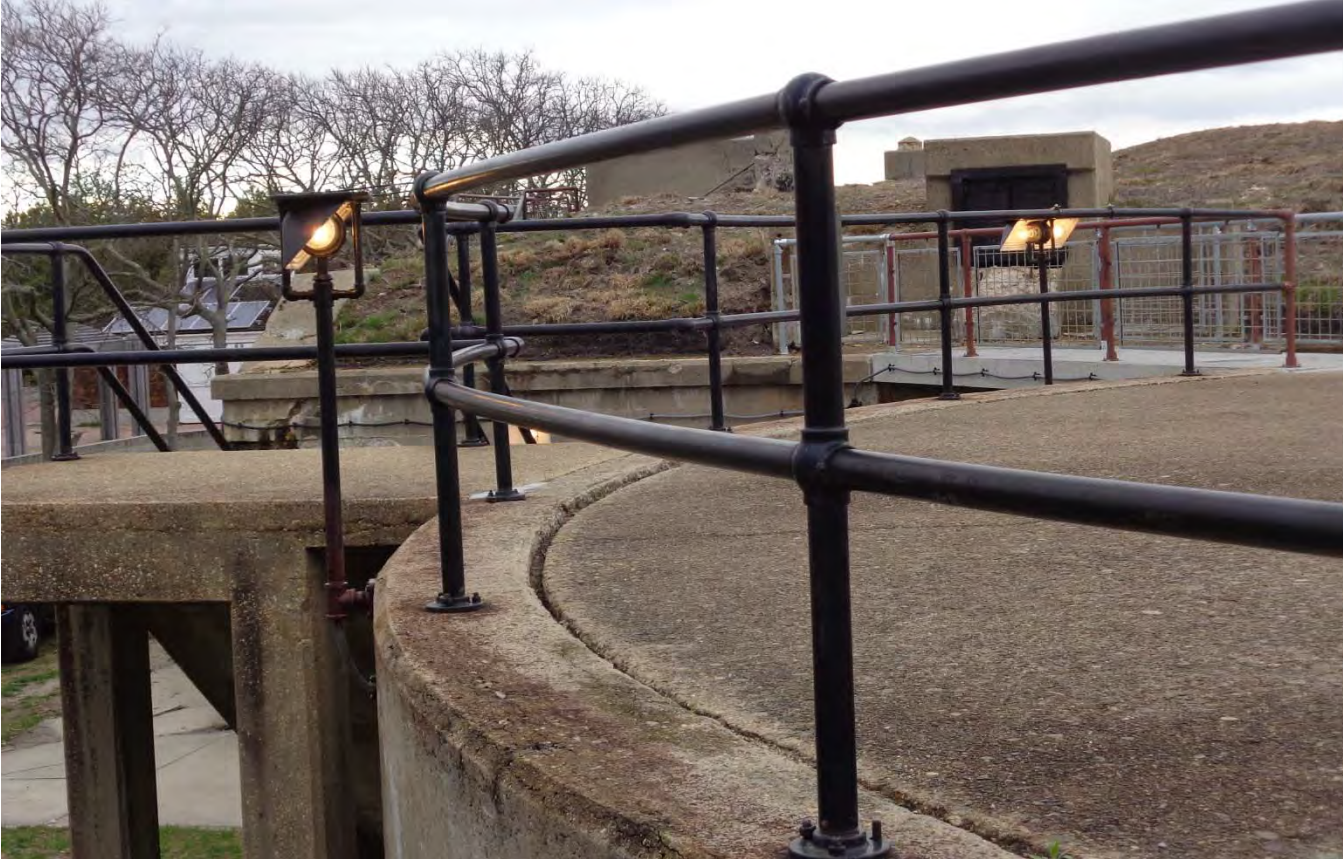
The photo below shows them in operation. These two lights are full restorations with original light fixtures cleaned and re-wired.

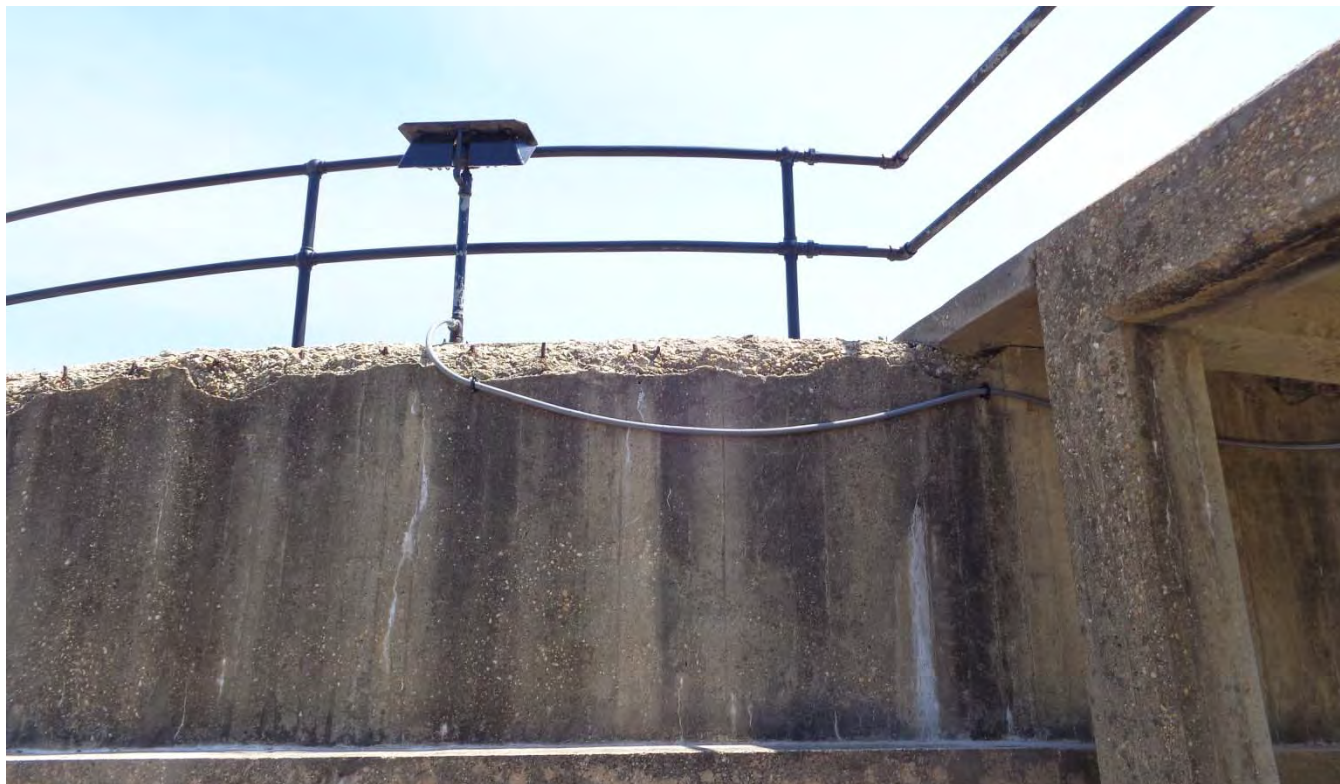
The photo below shows the platform light for Gun #2 in May 2018. This particular light uses a historic COE light stanchion from a New England fortification and modern light fixtures. There remain to be mounted about ten cable hangers.

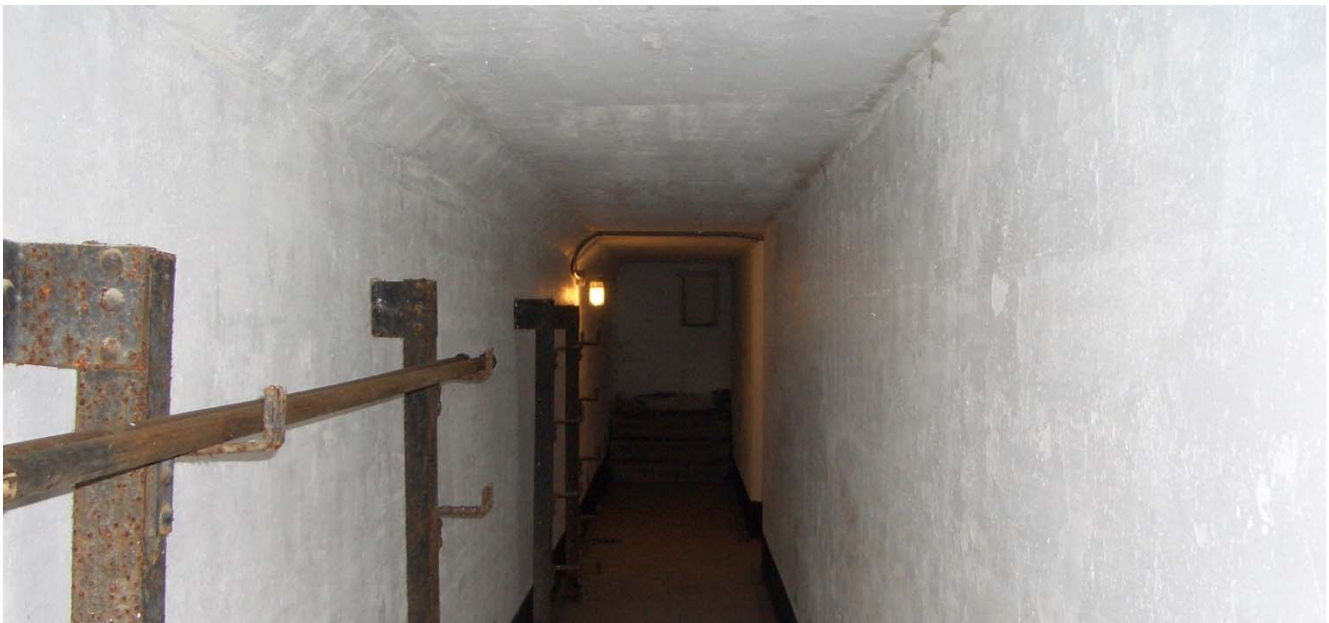
This was a first step. Eight bulbs were barely adequate for lighting. Additionally, the battery electrical service shared the 20 amps with a soda vending. Power tools were problematic and the soda machine often was turned off to ensure a reliable circuit. The photo below shows one of two lights in the powder passage in May 2005.

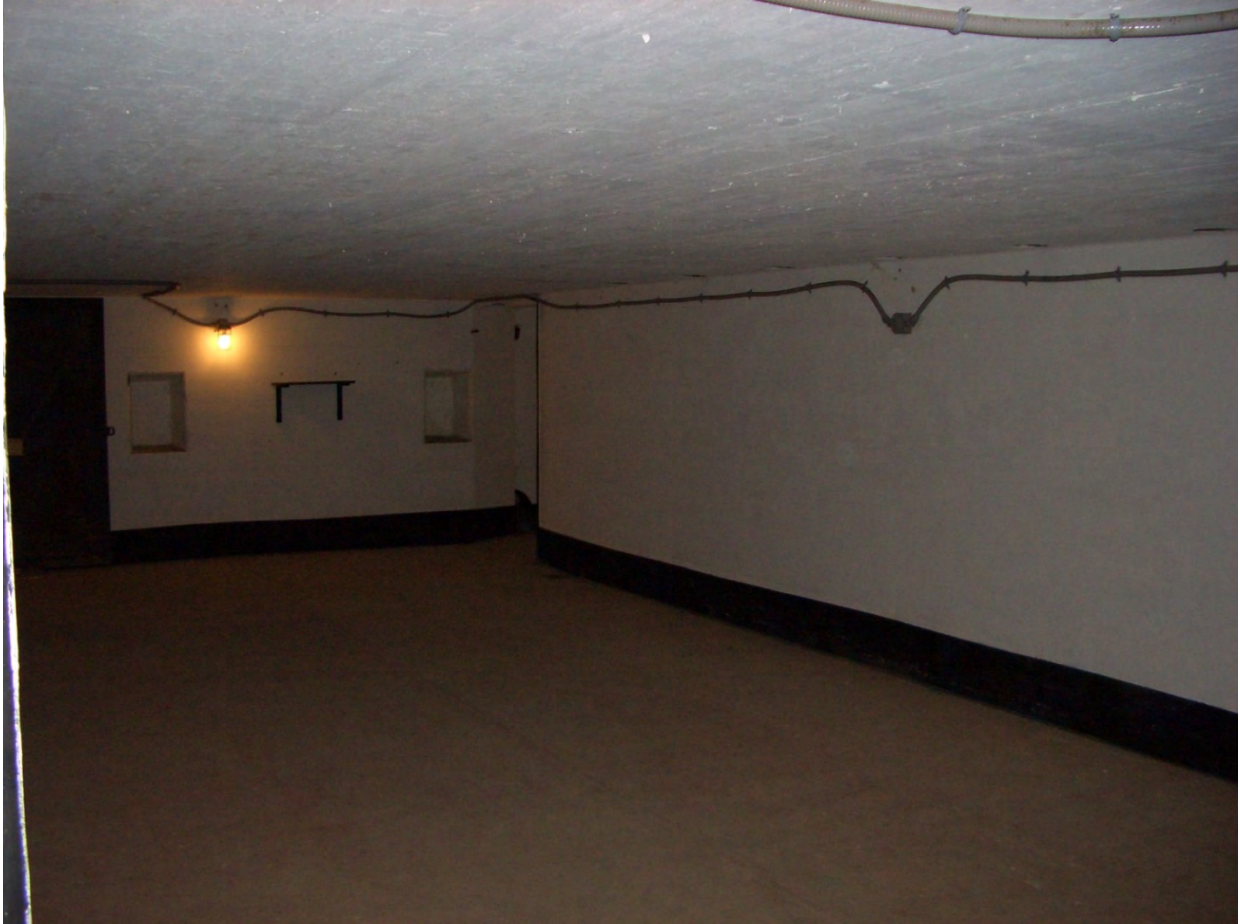
The photo below of the powder magazine looking south was taken in May 2005. Notice the openness of the magazine. Two lights worked when the room was empty, however, displays and storage (approx. 290 powder cans and storage boxes) brought the shortfalls of two bulbs into sharp focus.

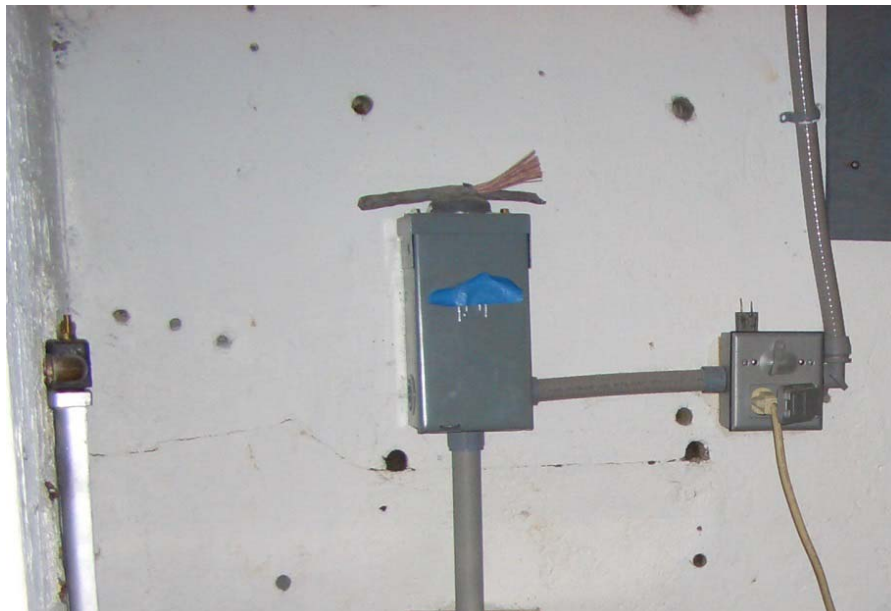
The photo below from 2004 shows the electric breaker box (two circuits) for the receptacle and lighting. The light switch was above the receptacle. This receptacle was the only receptacle inside the Battery from 2004 until 2011 when the 100 amp service was brought into the battery by the NPS.

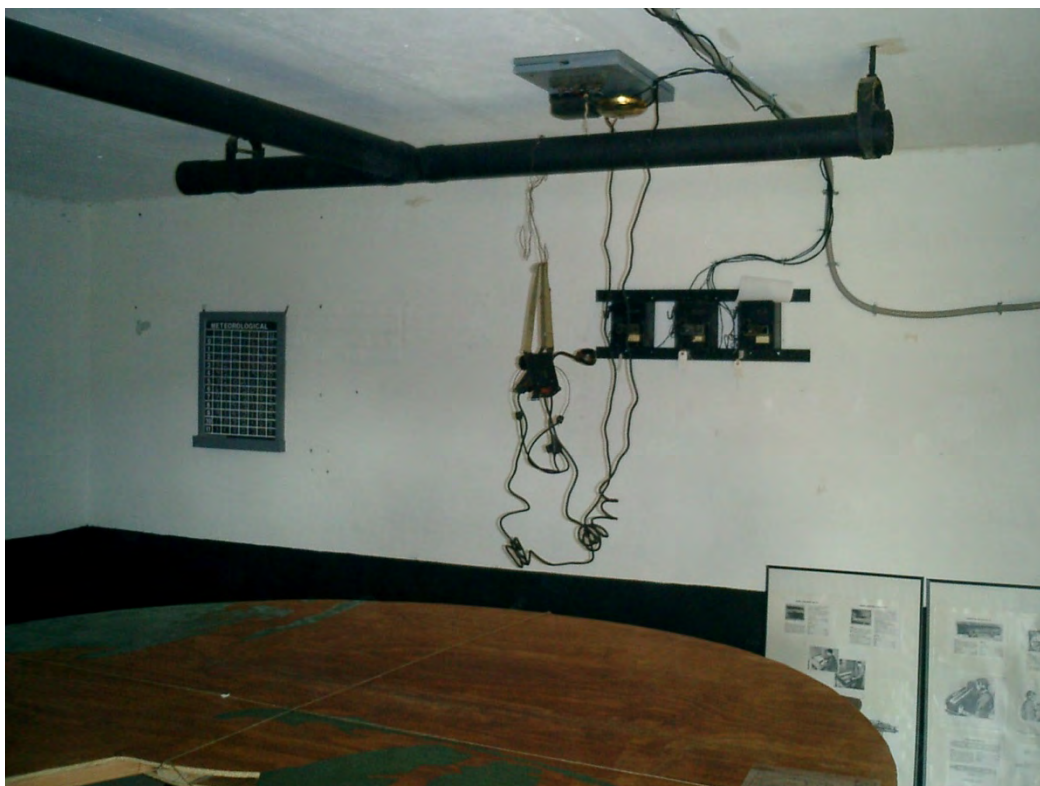
The photo below from April 2004 shows the absence of lighting in the plotting room. AGFA installed the telephone system and the replica (PVC) cast iron pipe overpressure system just before this photo was taken.

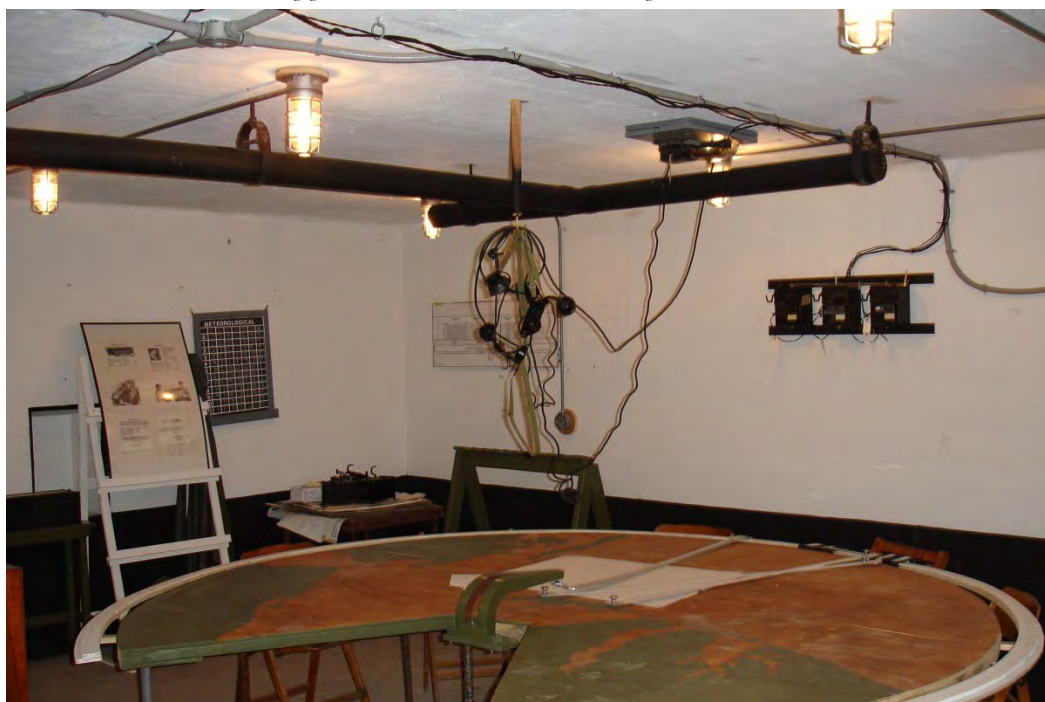
The first major electrical effort undertaken by AGFA was the installation of the plotting room lighting. The photo below from June 2007 shows the system as installed in 2006. The basic system had standard grounded household plug that used the single receptacle in the plotting room for power. This view shows five of the eight lights and one of the four single line receptacles installed. The fixtures are modern but are similar in appearance to the WWII period Crouse and Hinds fixtures.

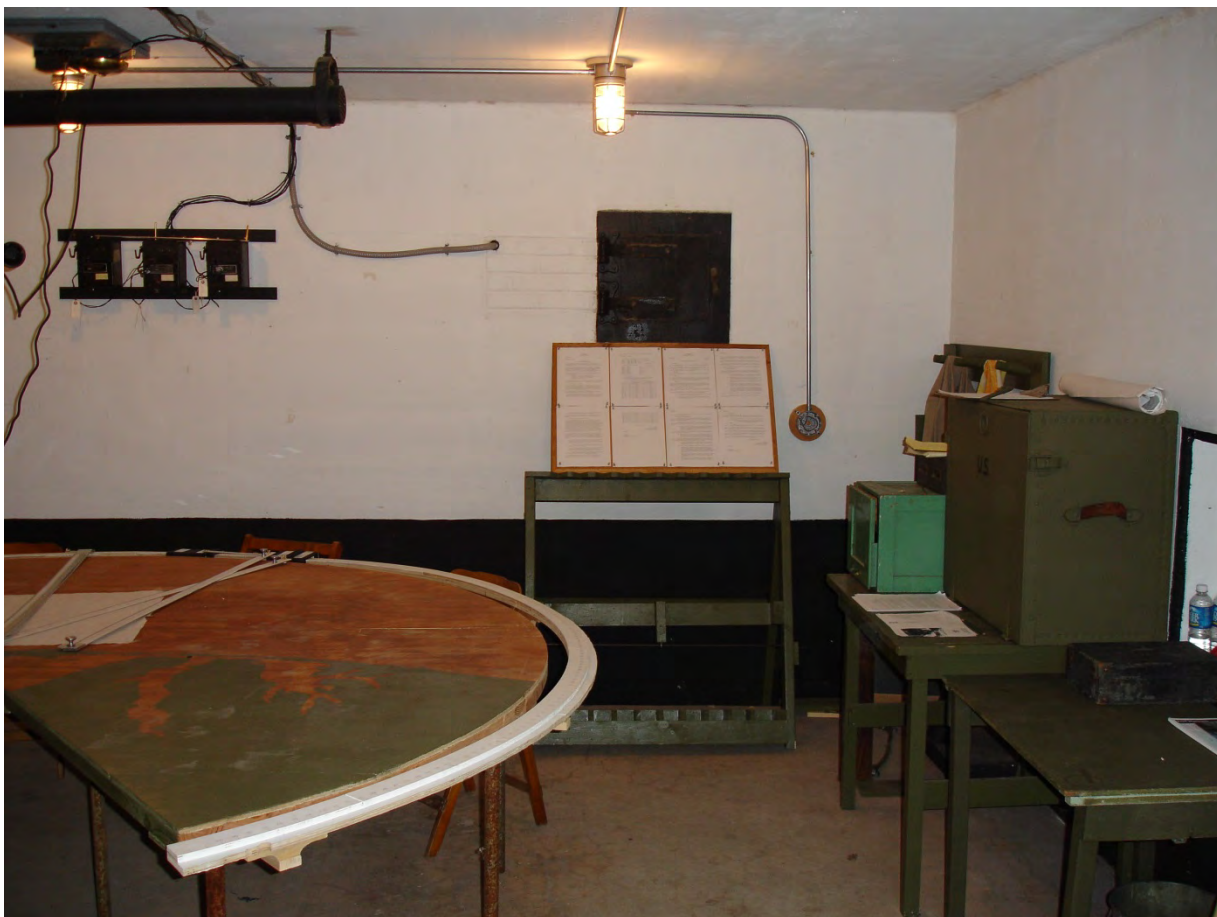
The photo below shows two lights and one of the four single line receptacles.

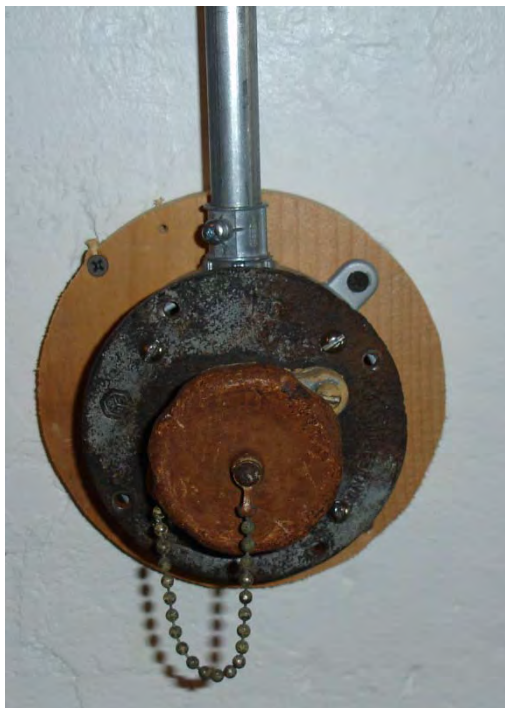
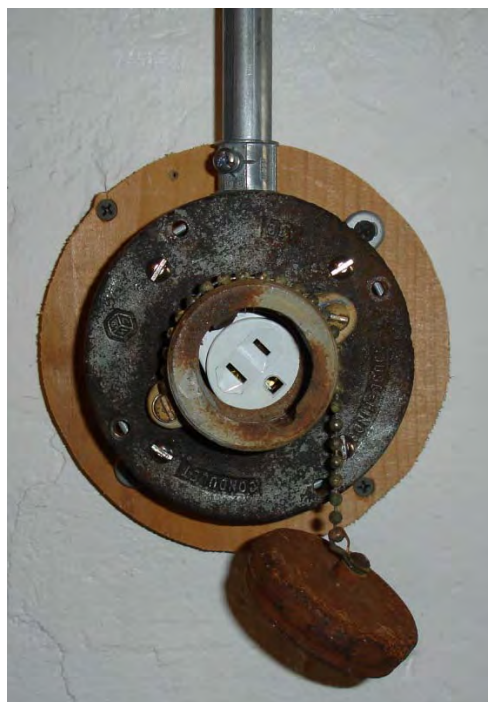
The single line receptacles are shown below. These are actually historic covers - the boxes are modern but accept the historic covers nicely. These covers are WWII vintage and were obtained from a WWII fortification in New England.

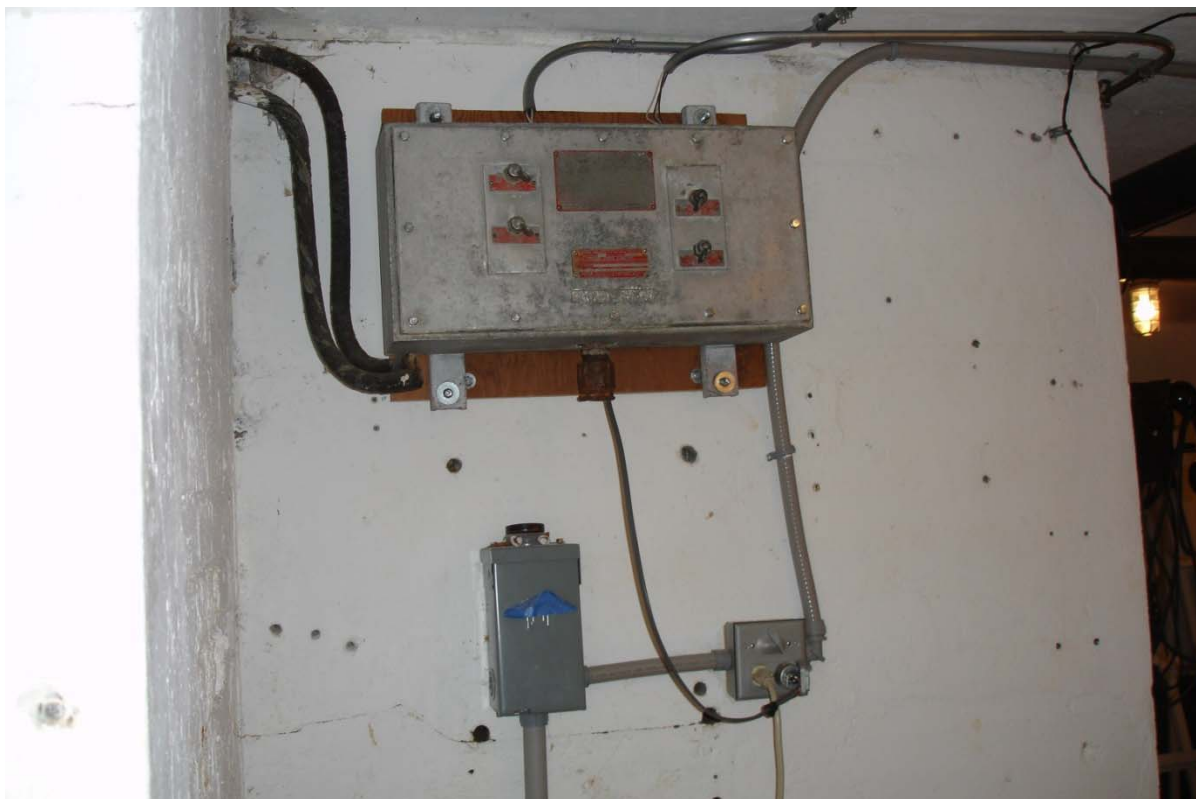
The next significant project was installing the WWII period Crouse and Hinds four switch explosion proof box in 2008. This photo is from March 2011. This box was found outside of Battery Kingman in the grass. AGFA restored it to usable condition by opening it up, replacing the switches with modern switches and a new seal. This box still required a household grounded plug to obtain power from the single receptacle shown below. This box was replaced in October 2011 by the 1915 Corps of Engineers Panel box. This box is in storage inside the magazine of Battery Gunnison/New Battery Peck awaiting a suitable reinstallation and reuse as appropriate at Fort Hancock.

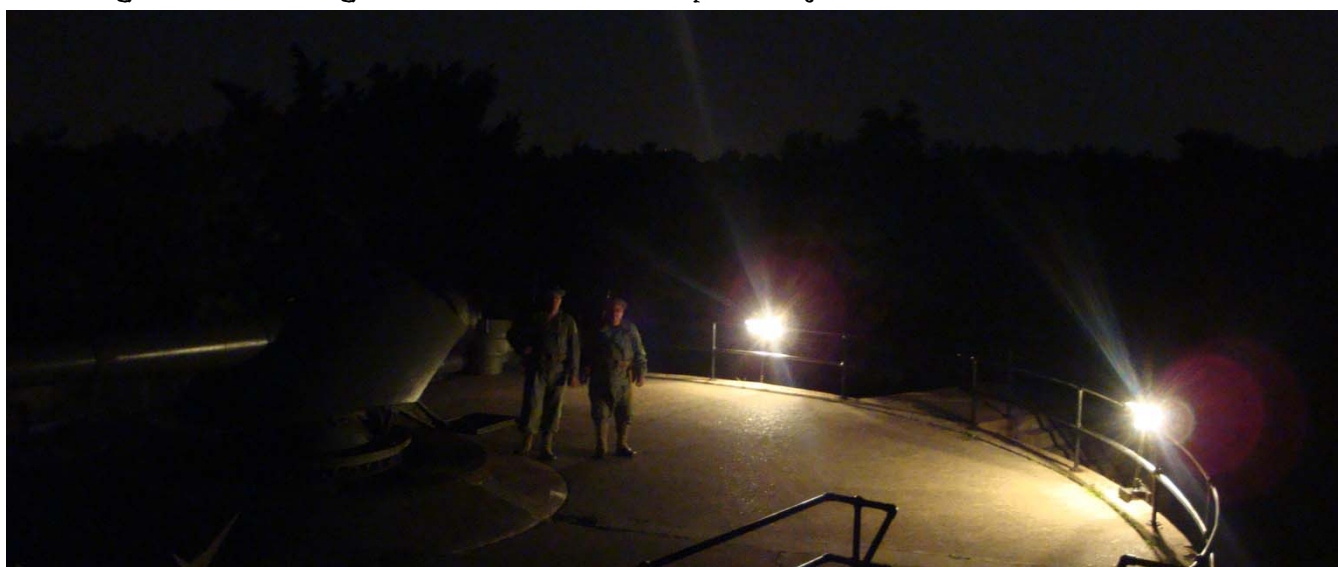
The next electrical work undertaken was restoring two platform lights in early 2010. These two lights were obtained outside of Fort Hancock. One was fully restored and had a wooden base mounted on it to use as a work light. The second used modern light fixtures mounted to the historic stanchion. The two lights are shown below. Both lights were designed to be mounted temporarily and stored between events.

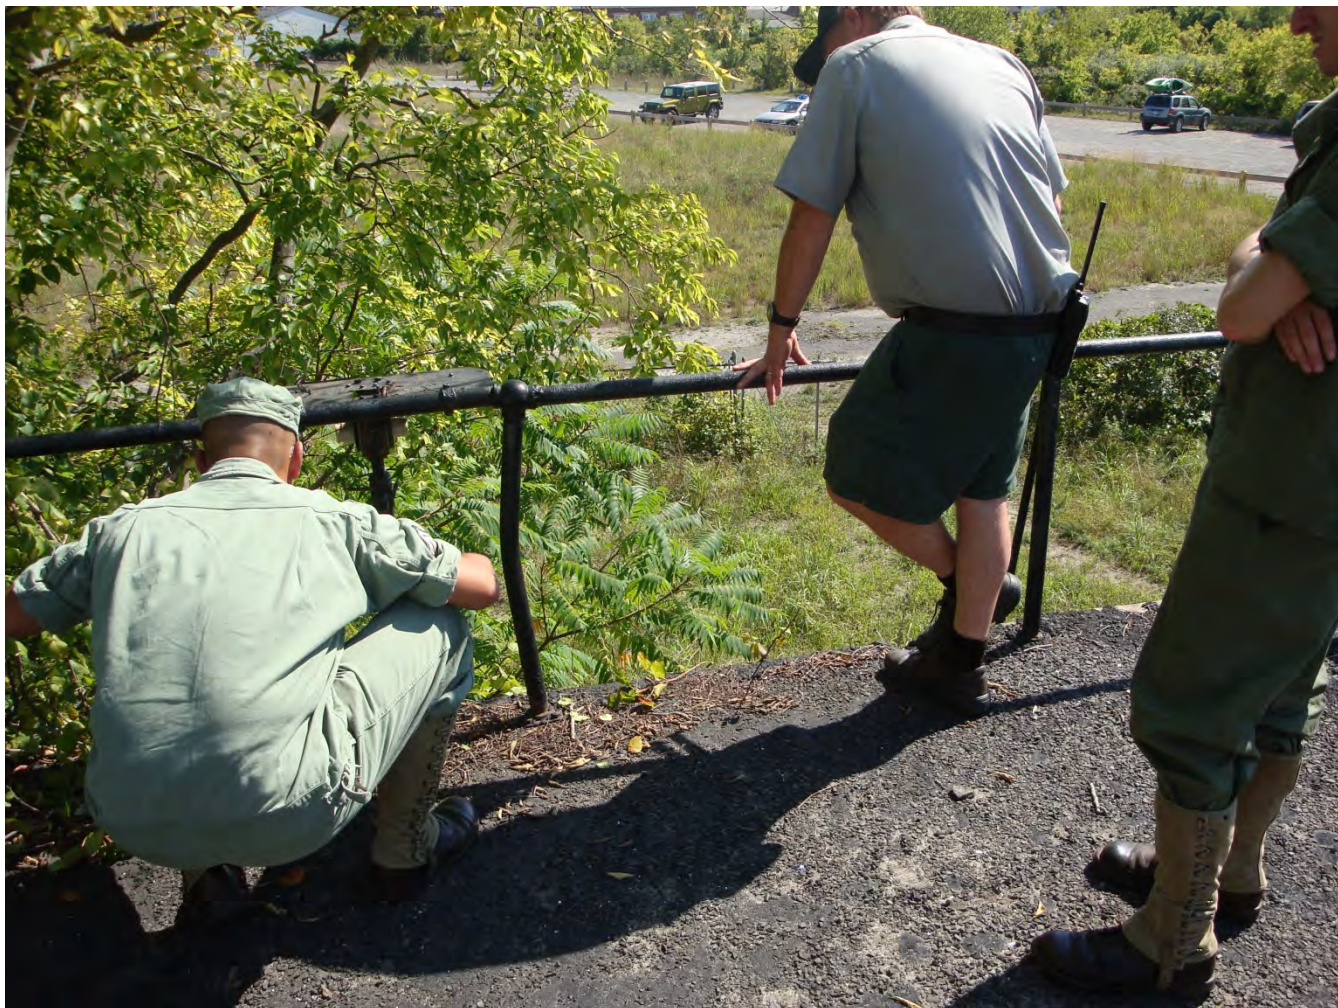
The next two platform lights were restored in conjunction with Dan Meharg, NPS. Two lights were obtained from 9-gun battery and summarily restored to operating condition. These two lights were obtained in early 2011 and restored by the summer of 2011. These were also designed to be mounted during events and otherwise stored.

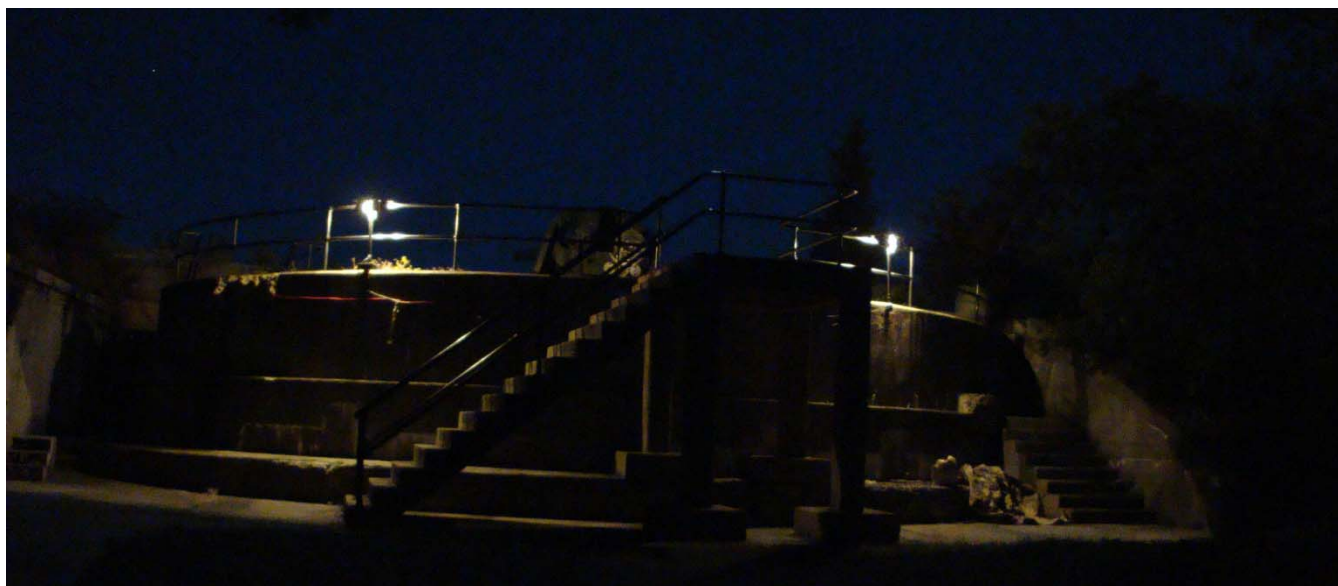
Below is another view of these restored platform lights in 2010.

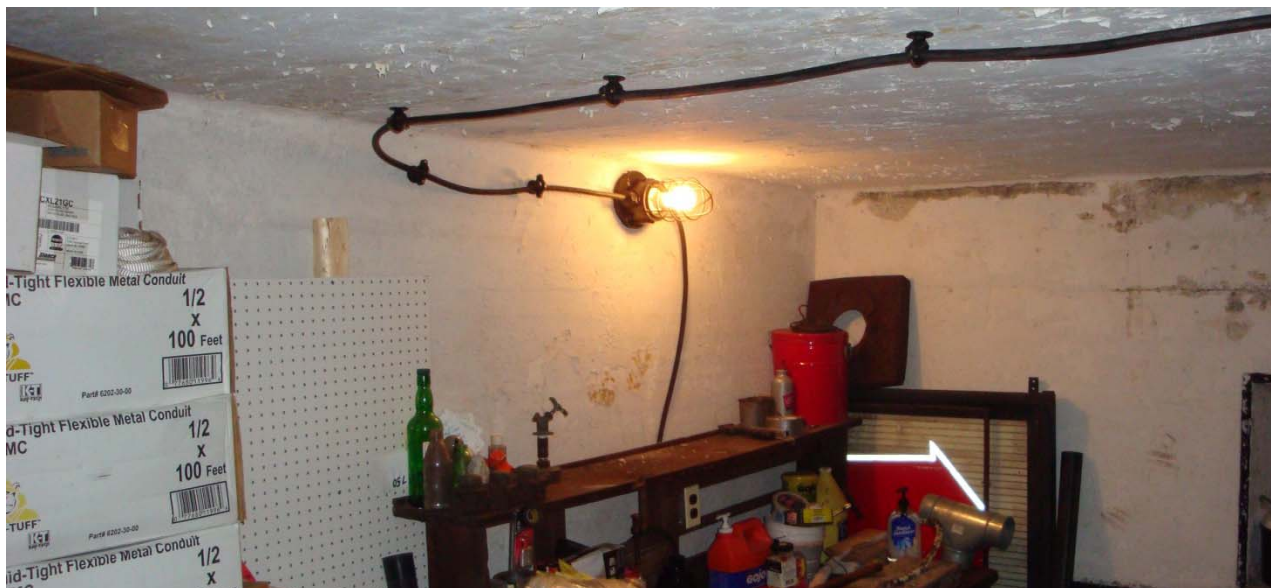
The first major work that occurred as a result of this acquisition was installation of lighting in the tool room (now a machine shop) in March 2011. There was no lighting in that room and this created significant operational difficulties. Two lights were installed. The one below has since been replaced by a wall light.

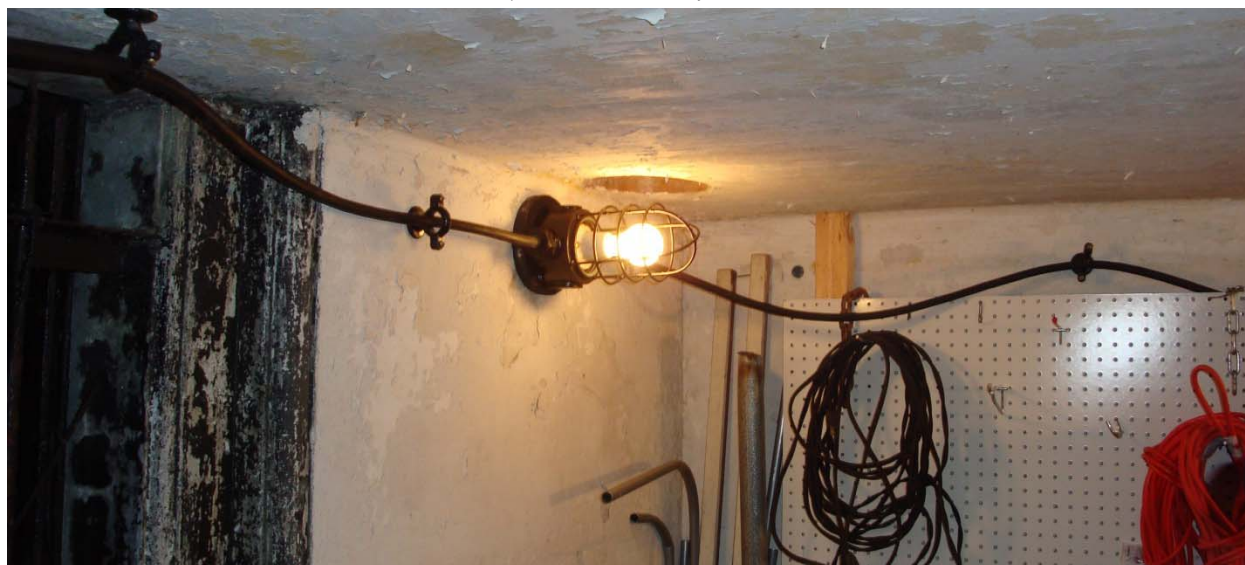
The COE standard ceiling light (shown below) remains in place as of May 2018.

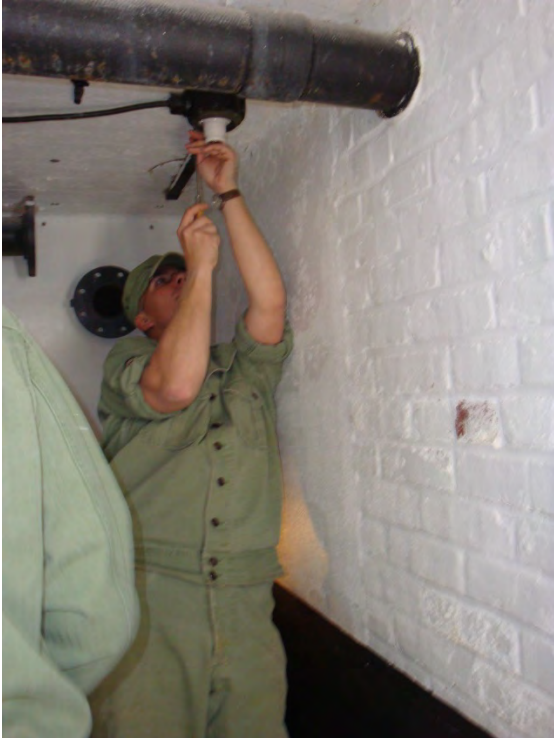
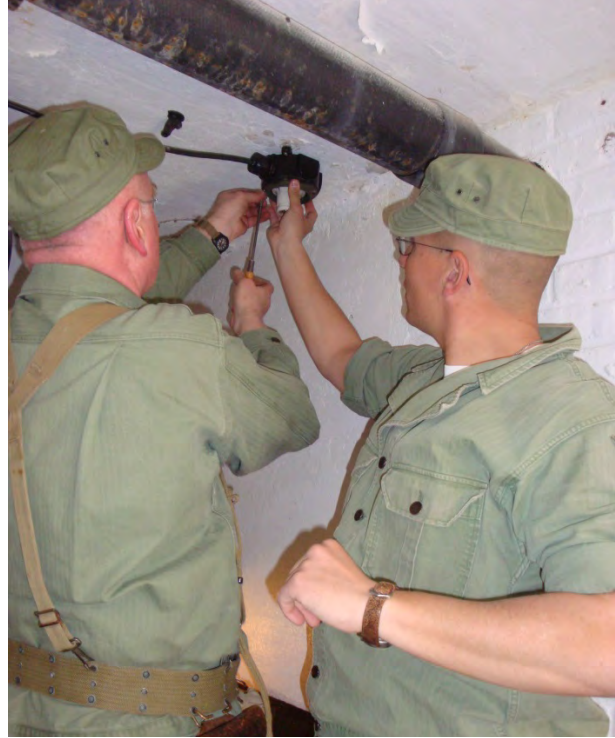
In April 2011, we began installing lighting into the Chemical Warfare room. Below the installation of a ceiling light in the mechanical niche.

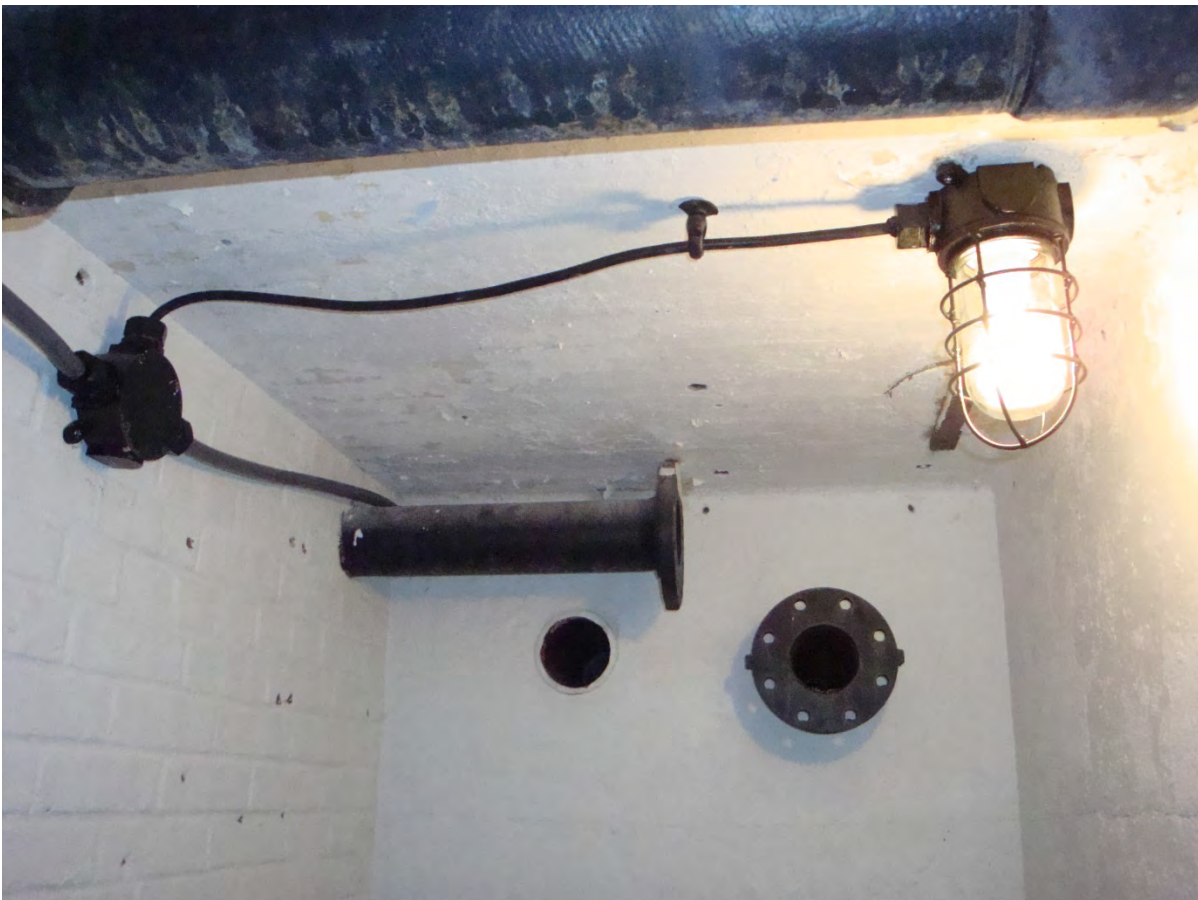
The light as installed is shown below and it remains in place as of May 2018. Notice the three line COE Standard junction box. It would be replaced a year later with a four way COE standard box.

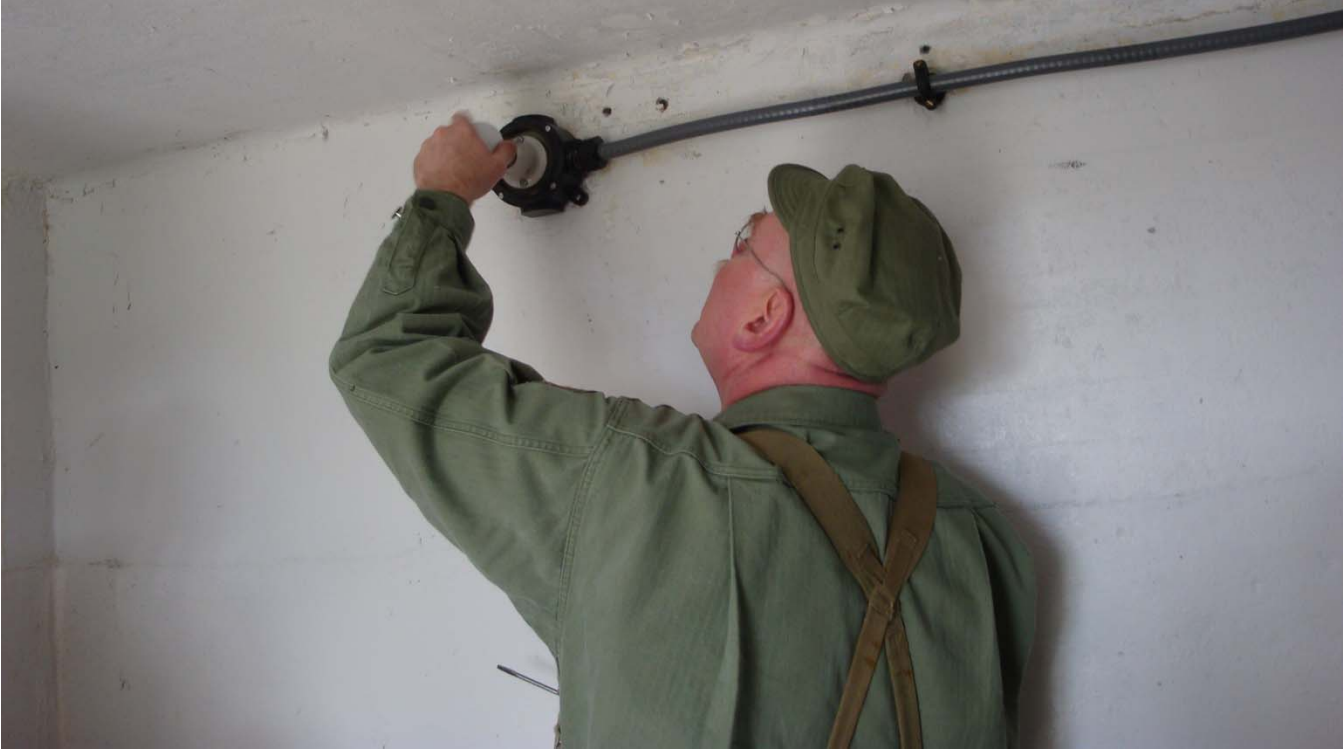
The photo below shows an AGFA member installing the COE ceiling light on the eastern wall of the Chemical Warfare room in May 2011.

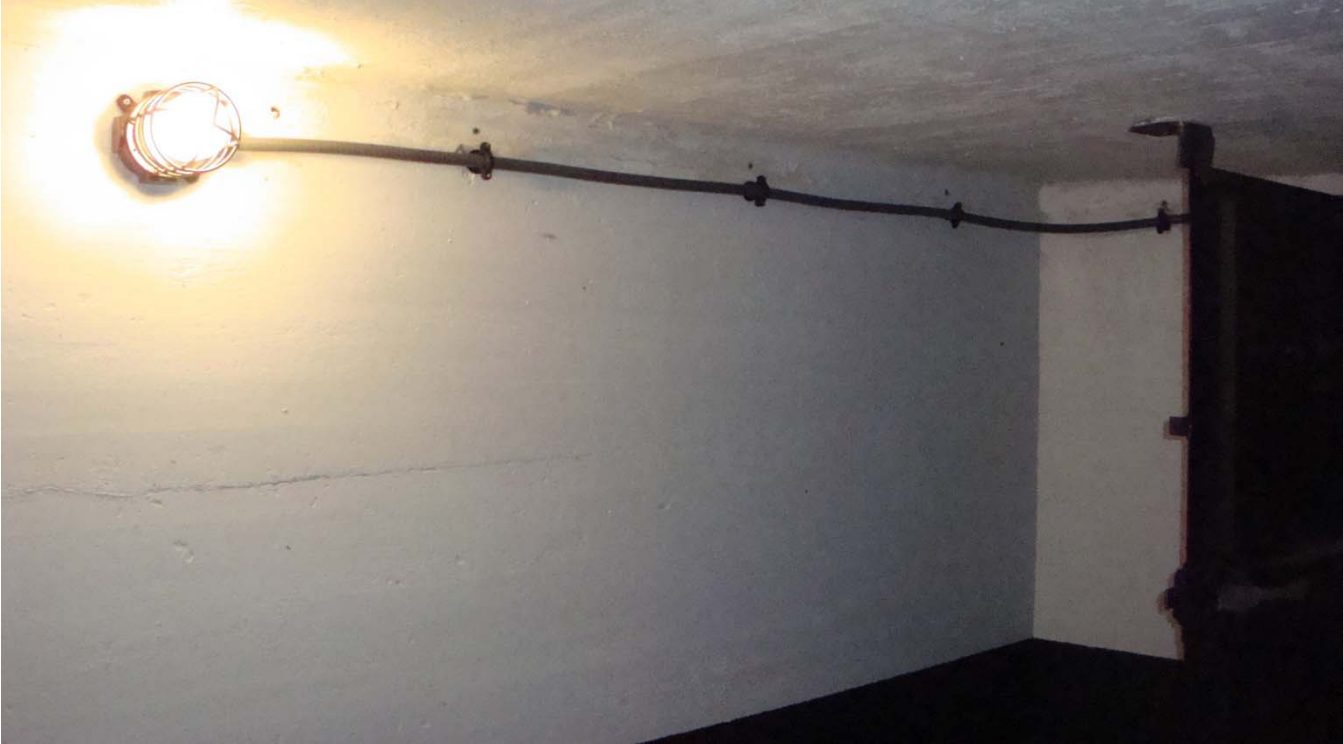
The COE ceiling light as installed in 2011. This light has since been replaced by a COE wall light and the wiring enters the fixture on the opposite side as of May 2018. Two vintage COE lights and one WWII wall light were installed in the chemical warfare mechanical spaces.

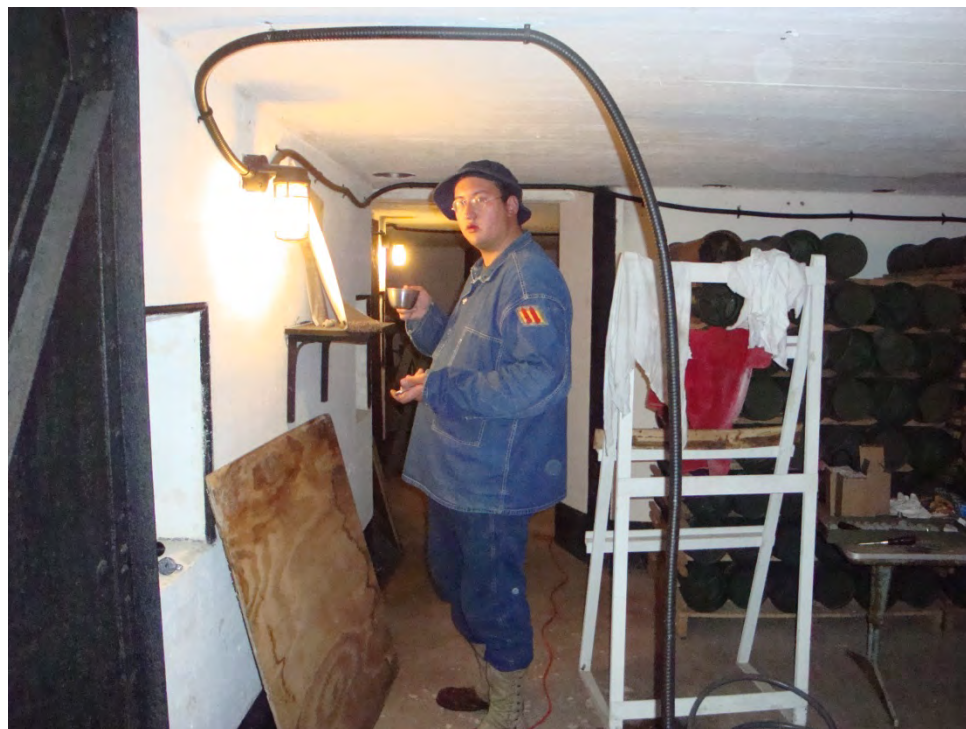
In the photo below an AGFA member begins the process of laying out the required equipment to install our first lighting in the magazine - the two lights on the Gun #1 side of the powder passage and one light inside the magazine proper. The light that is facing the member is one of the original NPS installed lights.

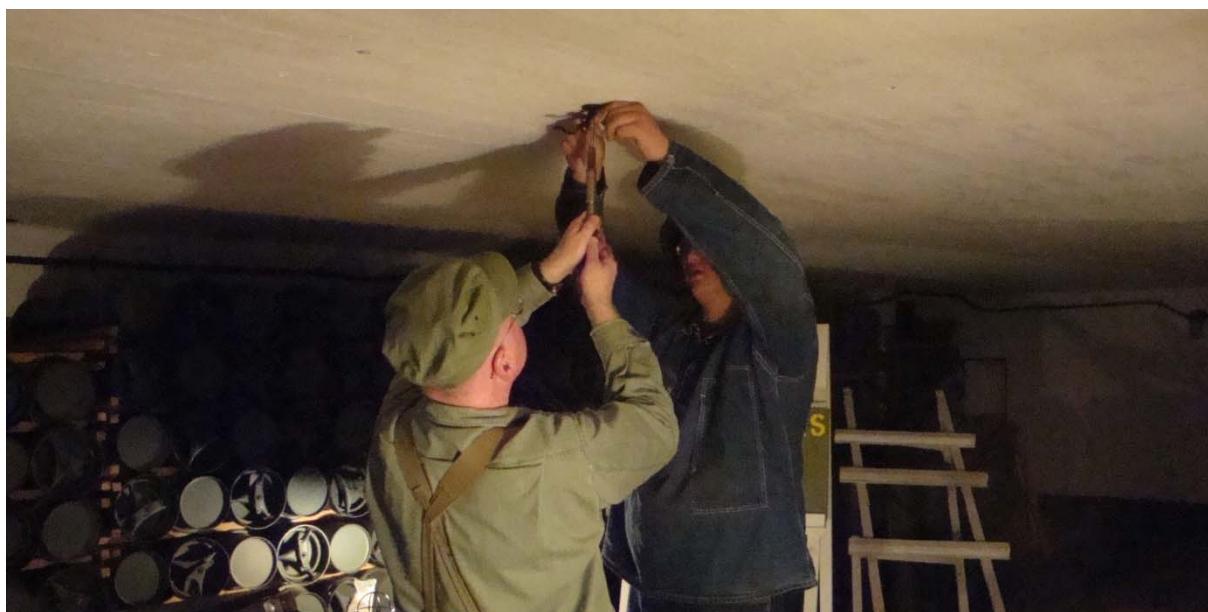
In the photo below two AGFA members begin installing cable hangers for the conduit.

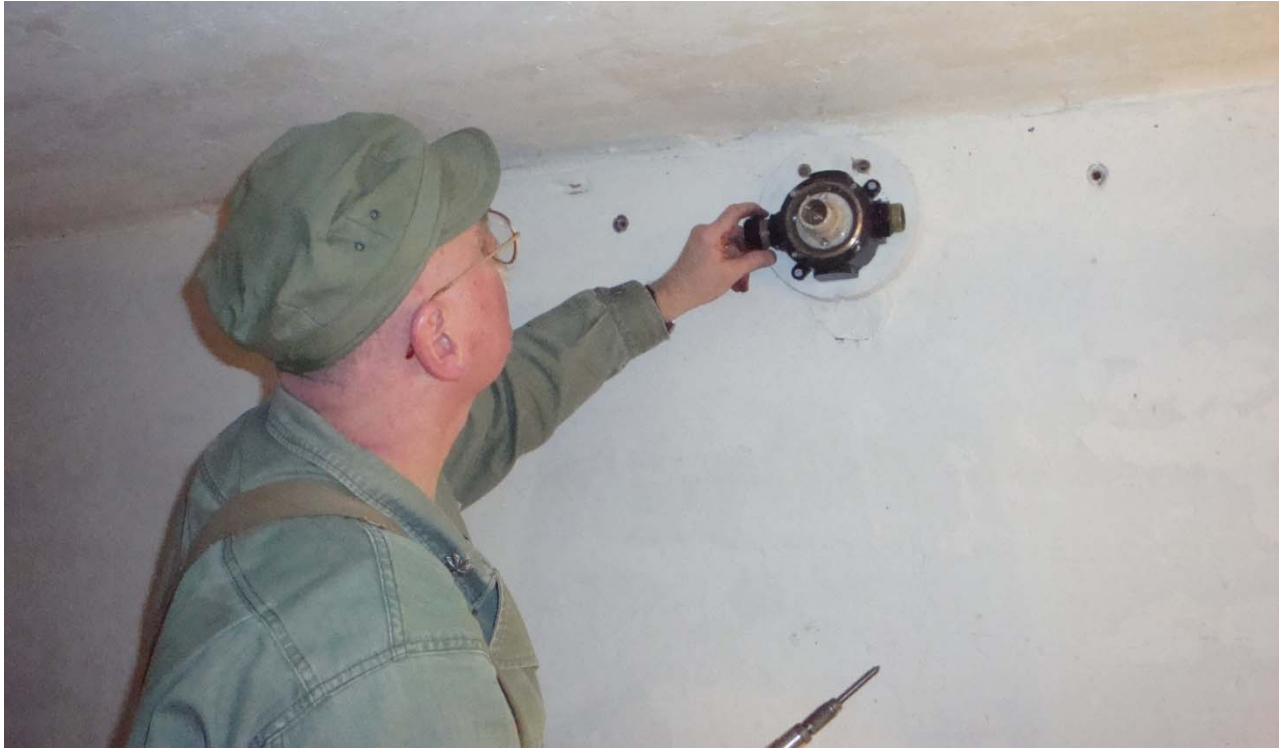
In the photo below an AGFA member installs a COE ceiling light on the wall in the powder passage. The member is removing the large brass connecting nut to prepare for installation of the modern conduit. Since a wall light was originally mounted in this space, a large wooden disc was mounted using the wall light screw holes in the concrete. Then ceiling light was then affixed to the wooden disc. The disc is painted white to match the wall.

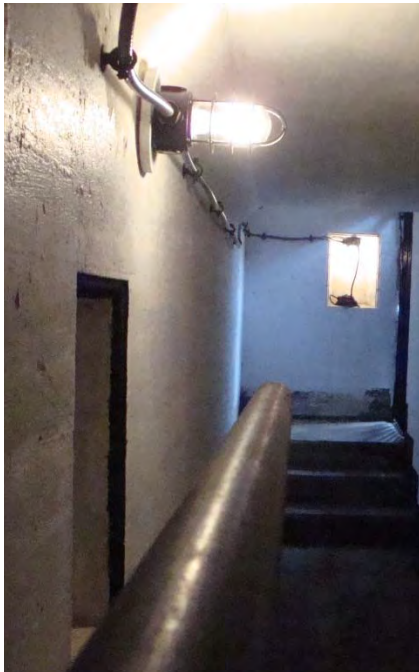
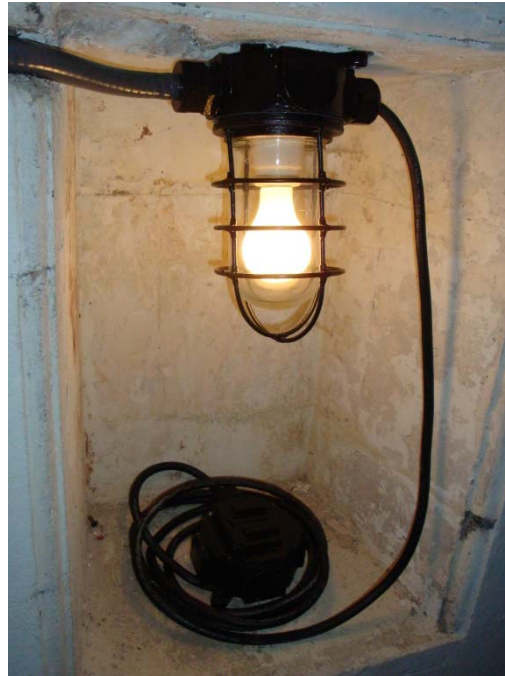
The photo below shows the two newly installed lights in the powder passage. The far light has a two plug receptacle installed using a historic COE junction box. This ceiling light has since been replaced by a COE wall light. The picture on the right shows the ceiling light in the niche and the flexible corded receptacle attached to it.

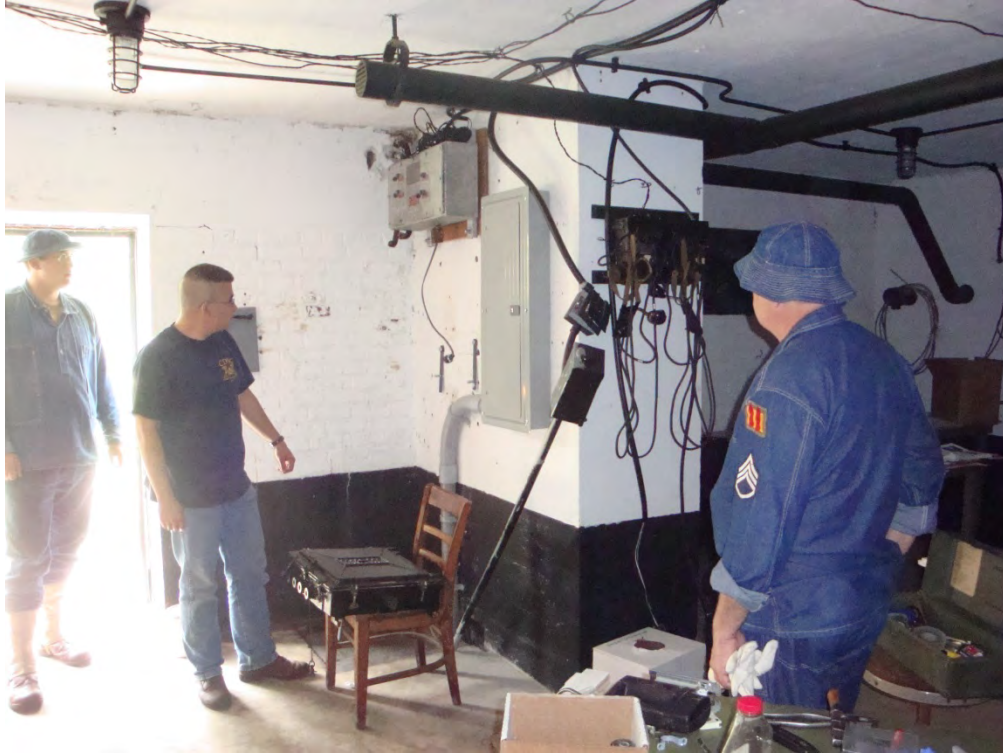
The photograph below from May 2011 shows the new 100 amp Siemens panel box installed and the deactivated 20 amp service being removed.
