Restoring Electric System at Battery Gunnison/New Battery Peck *Ft. Hancock, New Jersey*

The reintroduction of electrical service to Battery Gunnison/New Battery Peck began in 2003 when the National Park Service introduced a 20 amp circuit with approximately nine modern interior lighting fixtures and two standard 15 amp outdoor standard receptacles. This very basic service was the starting point. Fifteen years later the system is essentially completed both interior and exterior lighting using predominantly restored and the correct historic fixtures and fittings.

This paper begins with the current status of the Electric Installation at Battery Gunnison/New Battery Peck as of May 2018. As of that date, the installation is over ninety five percent complete. The next part will give a brief chronology of the improvements beginning with NPS electrification in 2003 up to May 2018.

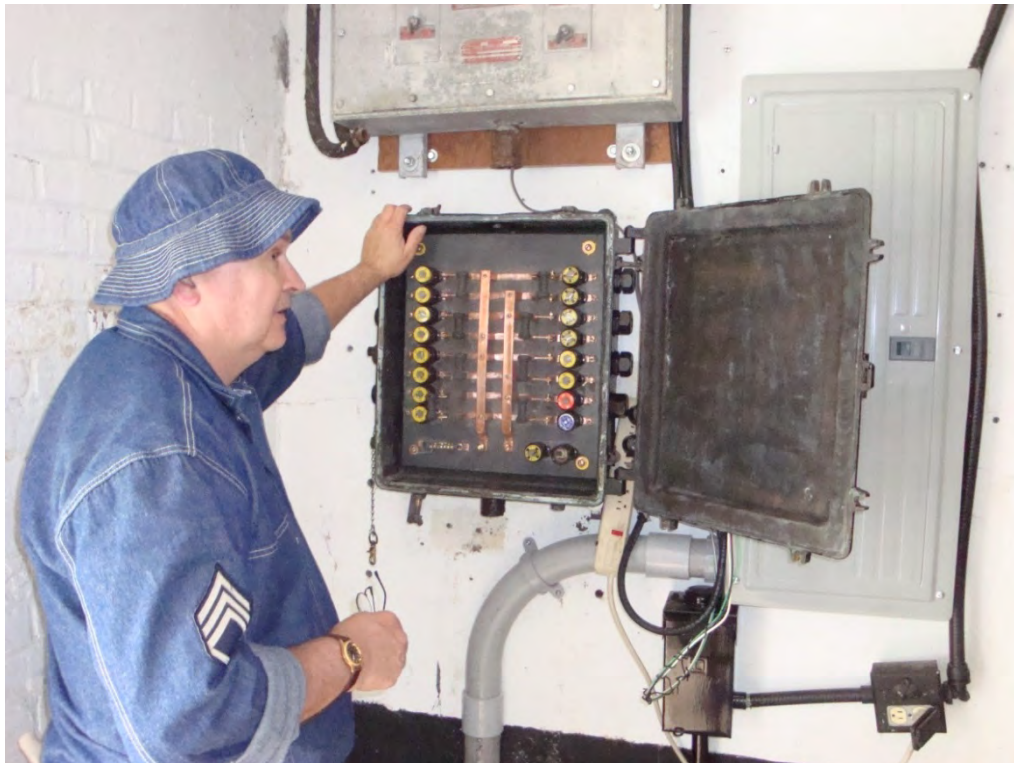
The photo below is later in the day showing the 1915 Corps of Engineers Standard panel box mounted. This box is made of bronze with a slate board and weighs over 150 pounds. The NPS 20 amp service is just below the panel box and will soon be removed. However, this box is totally open and not even close to safety code. Another four months of discussion and work with Pete McCarthy and other NPS experts was spent determining the safest way to integrate this box into the system.

The solution developed involved using relay switches in a separate service box that was placed next to the main Siemens service panel. The 110 volt AC "hot" line would be connected to one of the relay switches. Both the hot and neutral lines pass "through" the 1915 COE panel box. The connections shown below in the panel box are actually a 12 volt DC system that actuates the relay switches when the knife switch is closed. The ground circuit is on the lower left side of the slate board. All grounding connects to this bar and then to the ground in the main Siemens box.

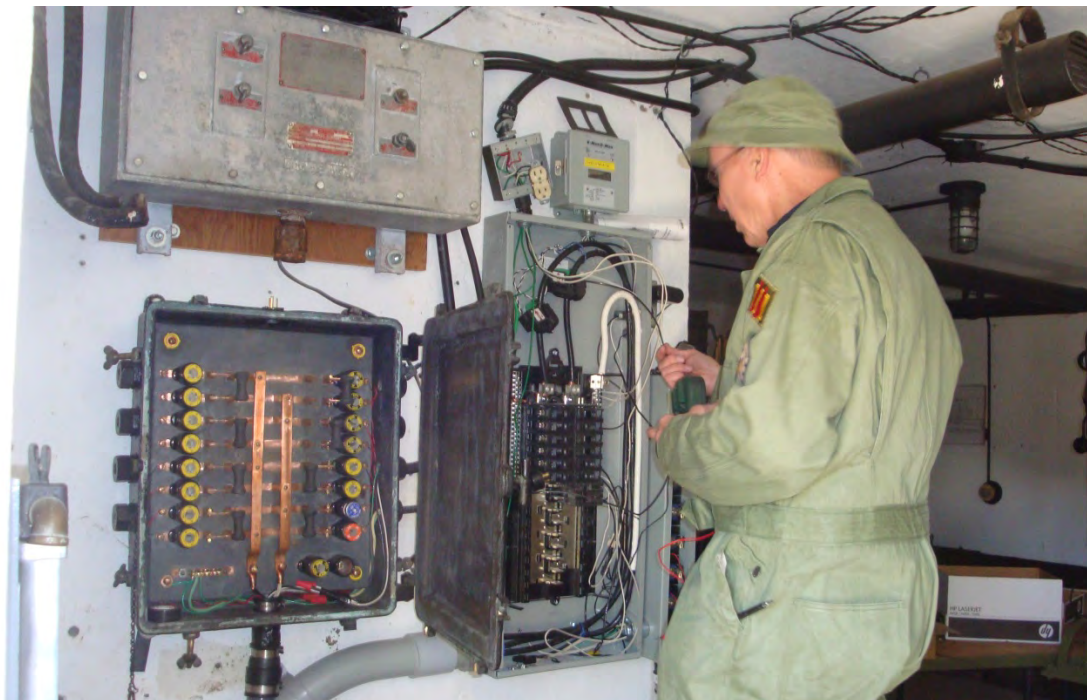
The photo below shows an AGFA member testing circuits in the box as each is connected. The main power was disconnected and all circuits tested prior to re-energizing the system.

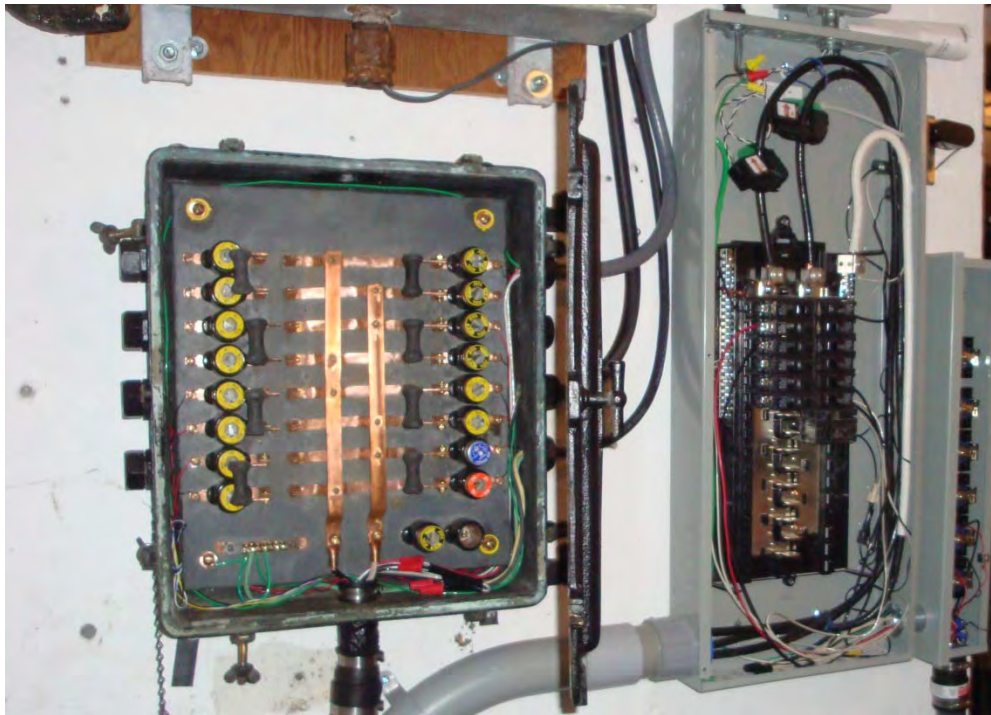
The photo below shows the panel box wired as of May 2011. At that time there were four active circuits: (1) machine shop/tool room; (2) Chemical Warfare room; (3) Magazine including dehumidifier.

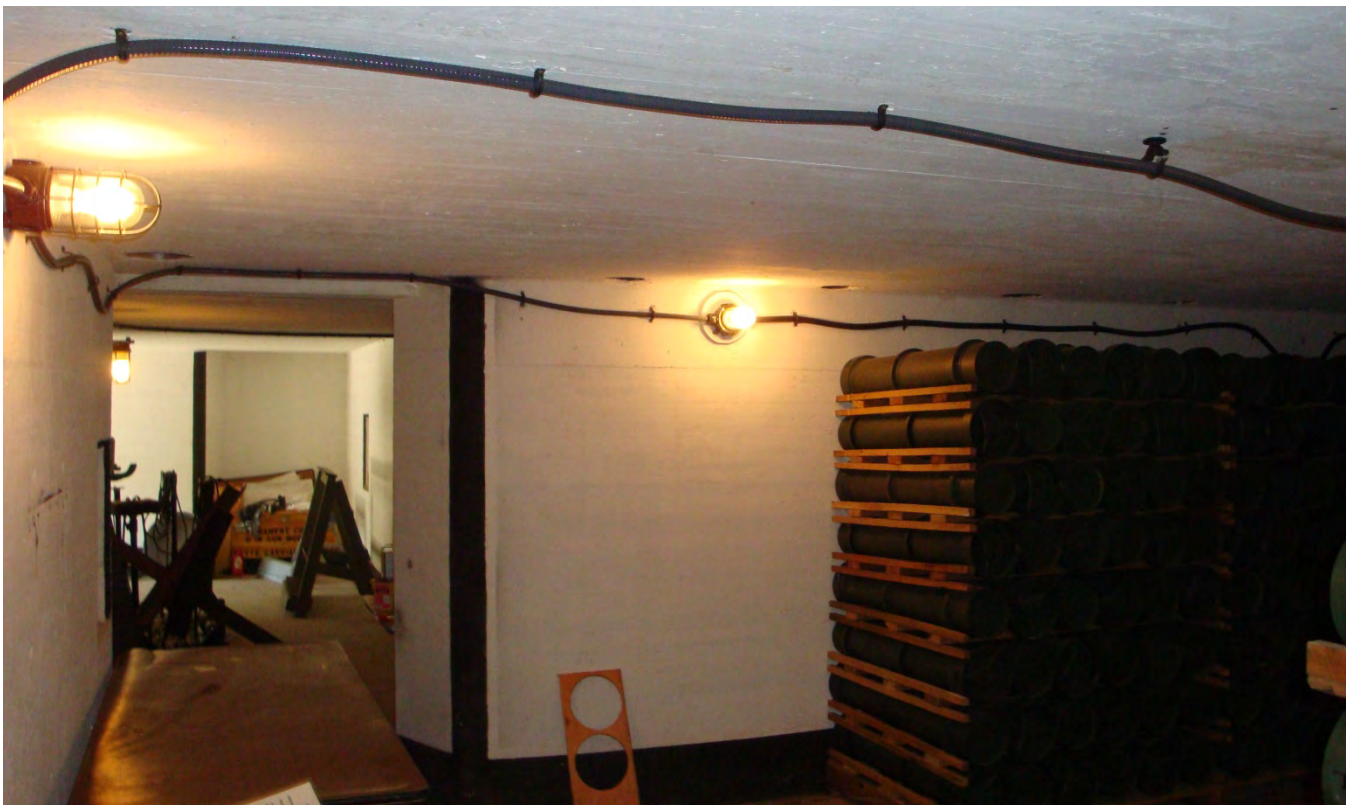
In July 2011 we installed two more lights on the Gun #1 side of the magazine. About this time we began to run out of cable hangers. In coordination with NPS we secured additional cable hangers from structures classified as "ruins" in the General Management Plan of Gateway National Recreation area (specifically Old Battery Peck).

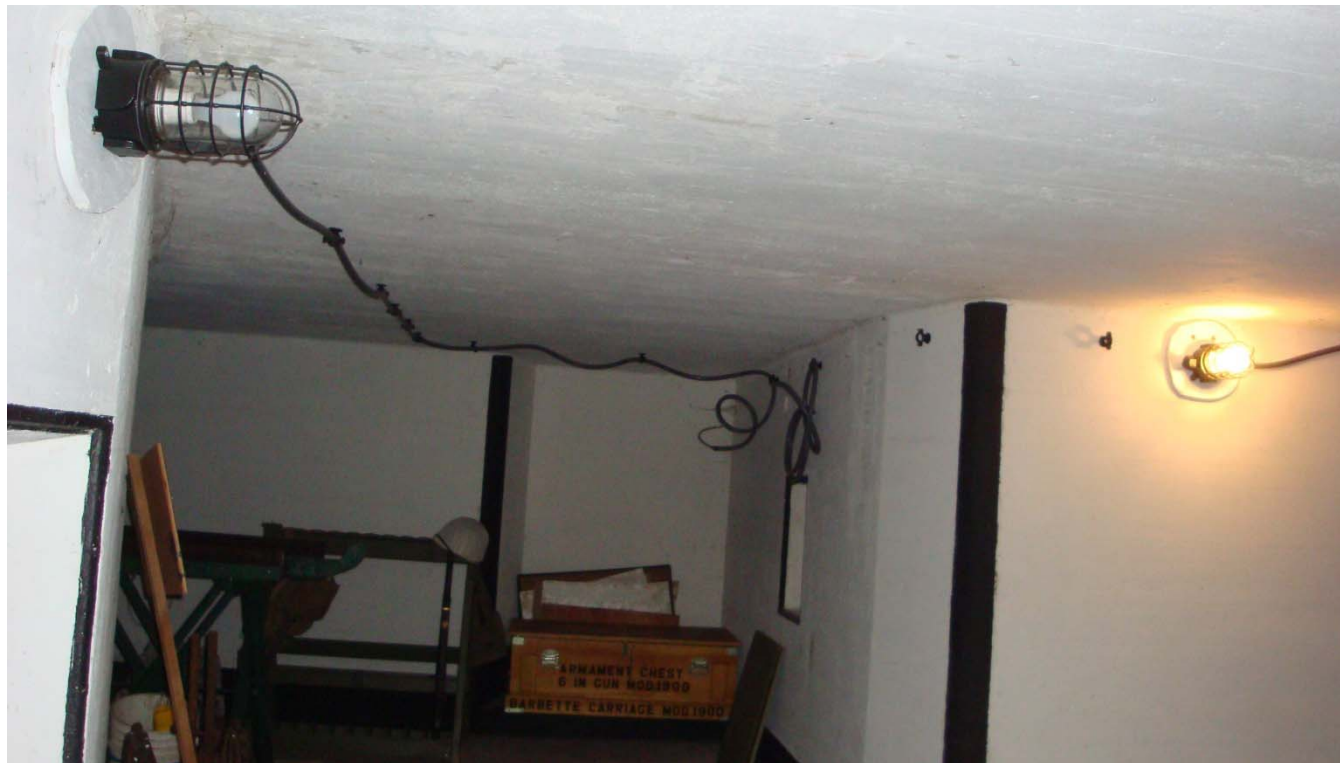
In December 2011 AGFA began installing lights in the Gun #1 entrance and hoist area of the magazine. At the end of the work session two lights were mounted and one was working. Throughout this work we incrementally replaced the exiting NPS magazine lighting installation as more materials were restored from the original acquisition.

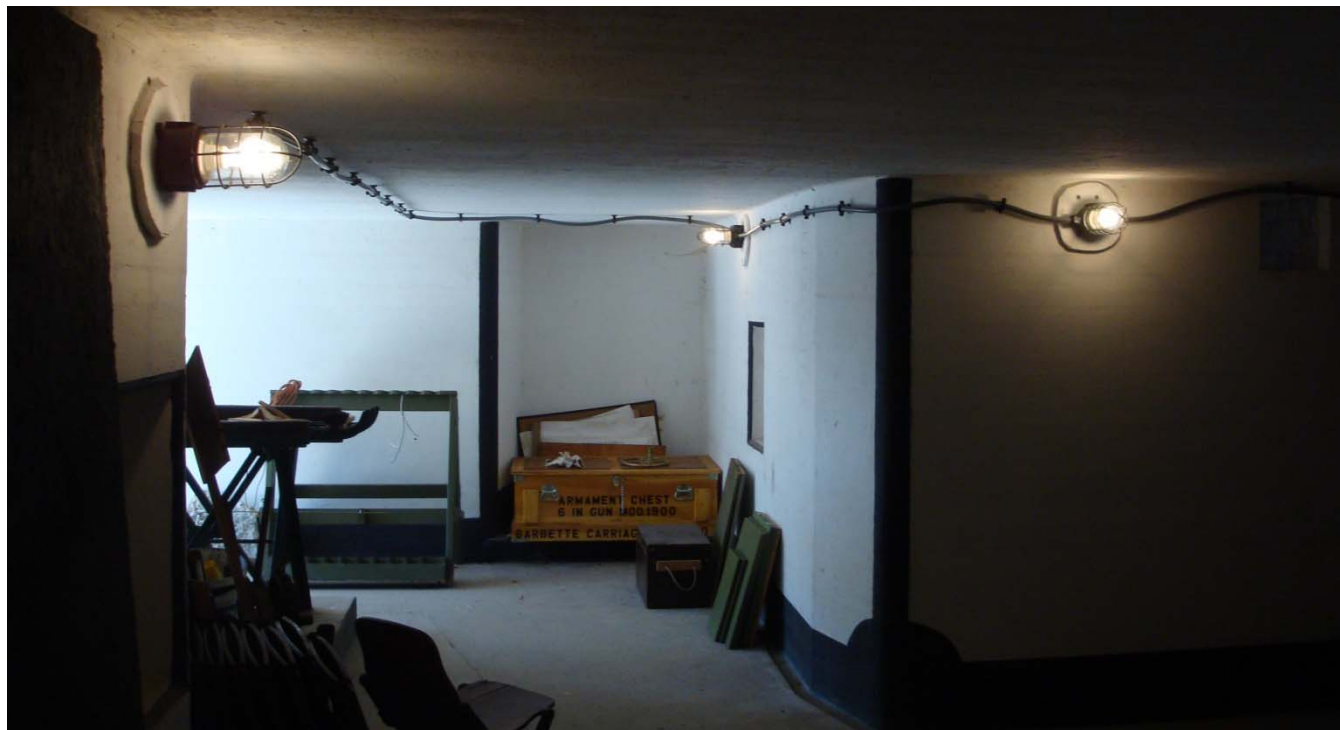
By March of 2012 all three light were installed. These are COE ceiling lights. As of 2018 these lights were replaced by COE wall lights. The COE ceiling light in the center was replaced in May 2012 by a COE wall light.

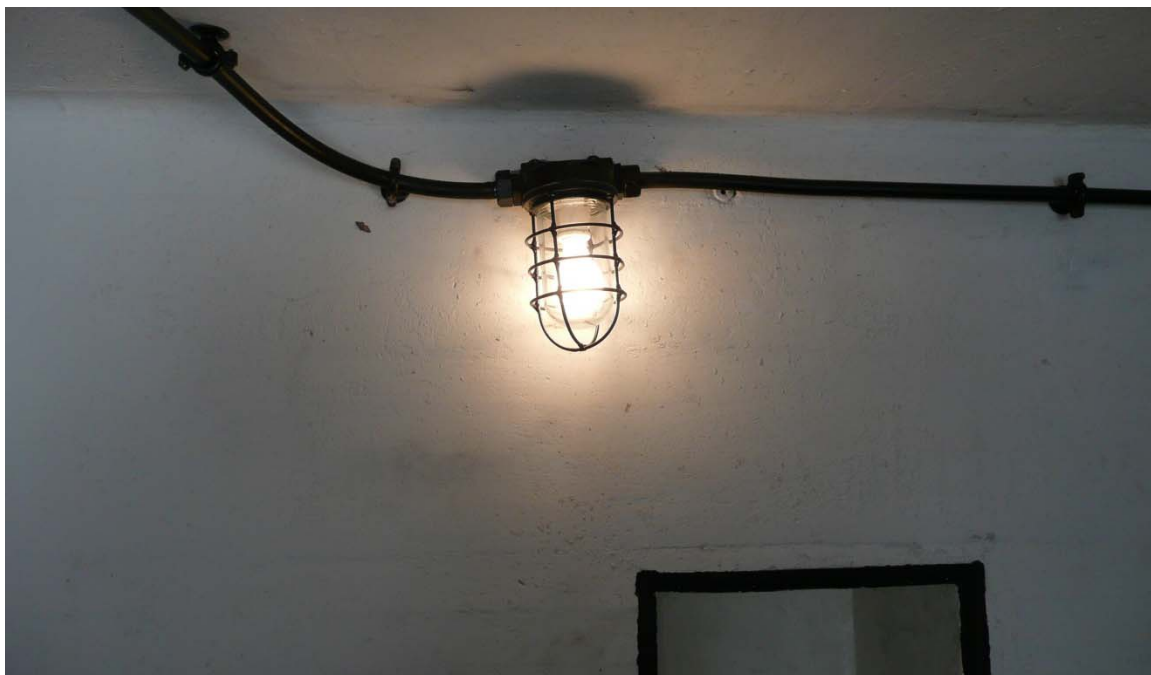
In May 2012 we installed two of four COE wall lights in the magazine. We had four wall lights on hand from our original acquisition and had been using them as lights for the front of a gun emplacement for events in a temporary manner. We decided to install these lights permanently inside the magazine as they are the correct lights for use inside the magazine. The magazine calls for fourteen wall lights. As of May 2018 there are ten COE wall lights mounted. The one below is installed in the entrance to the magazine next to Gun #1 hoist area.

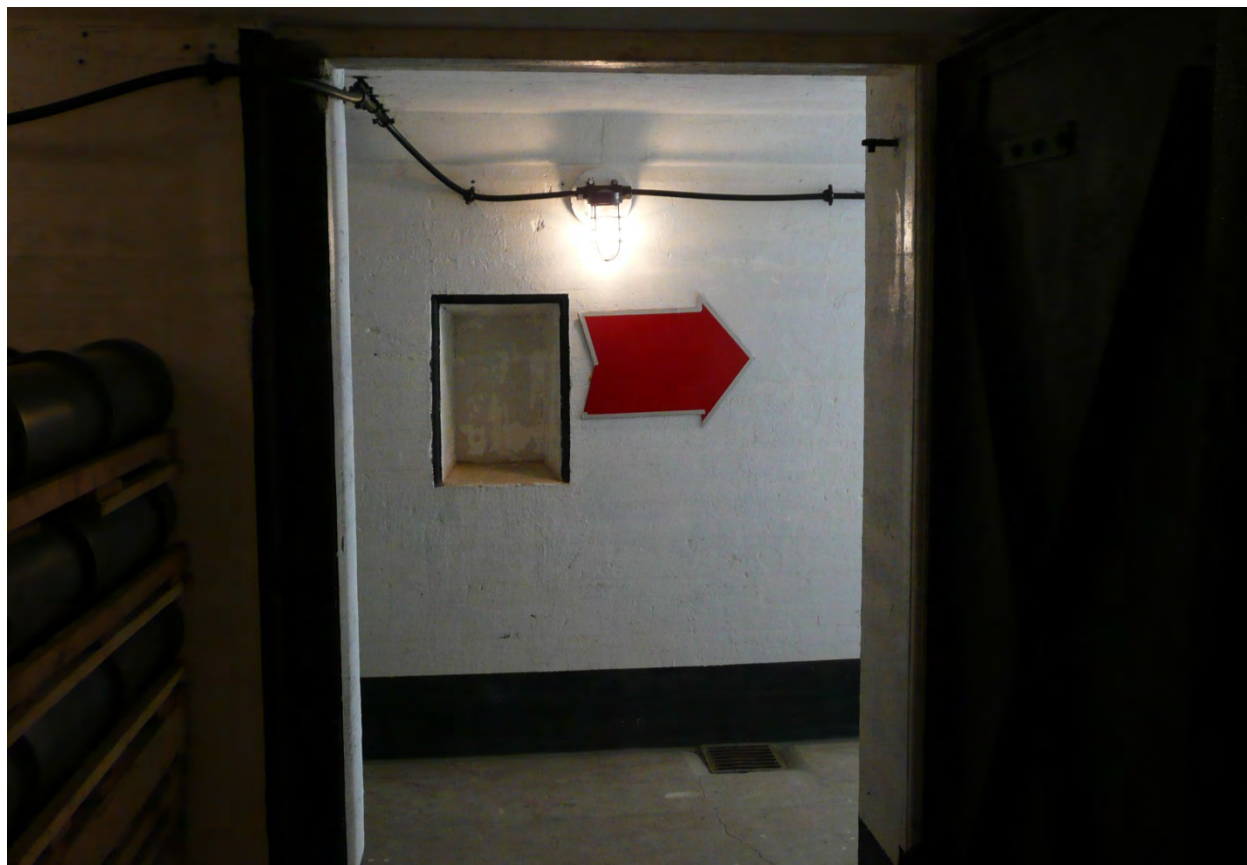
The other was in the Gun #1 powder passage. Both lights remain in place as of May 2018.

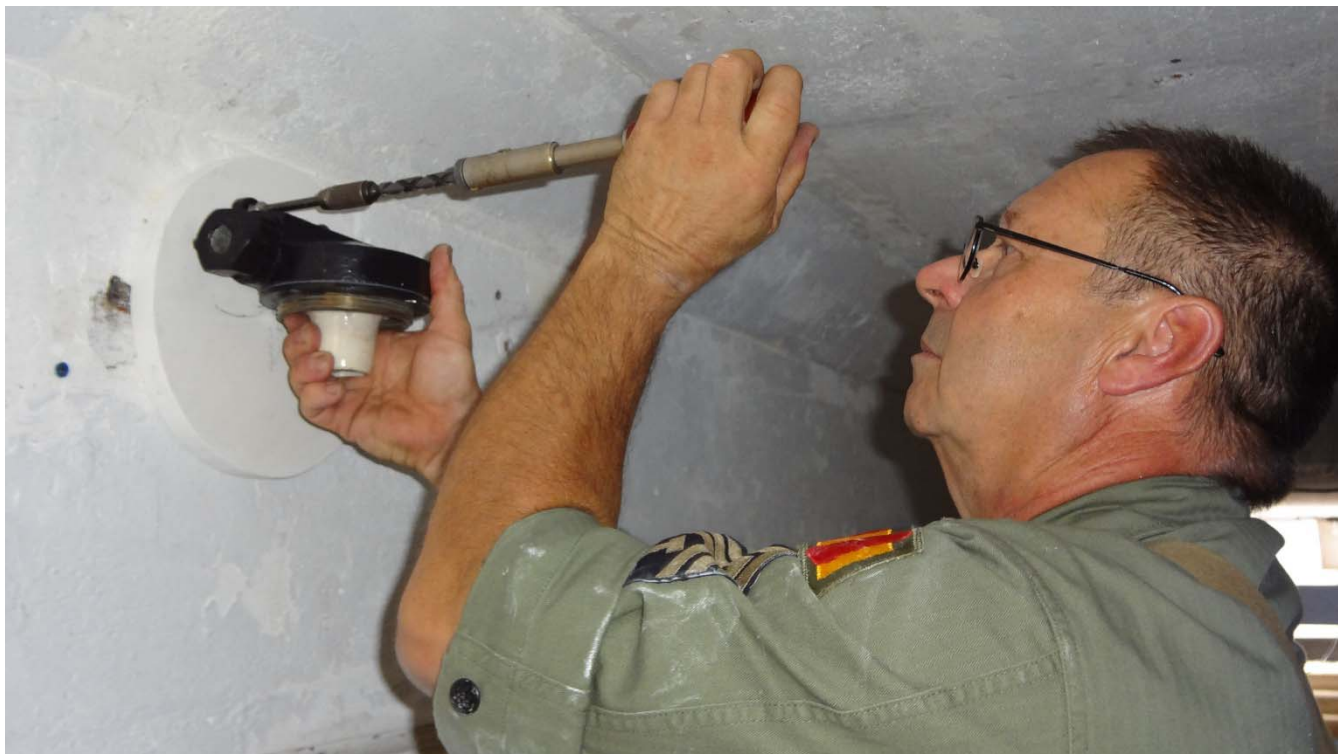
In July of 2012, AGFA replaced the remaining NPS lighting in the magazine with historic COE ceiling lights. In the photo below an AGFA member installs a COE Standard wall light in the Gun #2 powder passage using a ratcheting "Yankee Screwdriver".

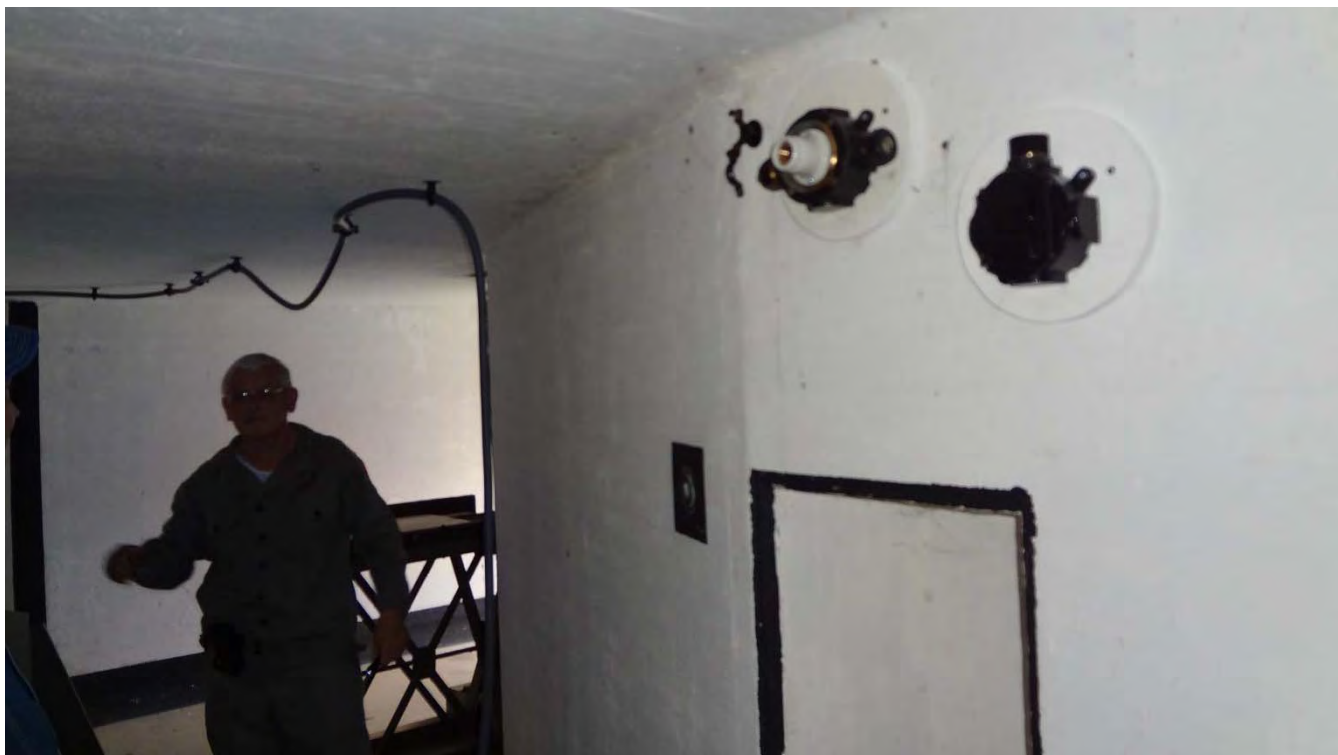
In the photo below an AGFA member works on installing a light and receptacle in the Gun #2 side of the shell room.

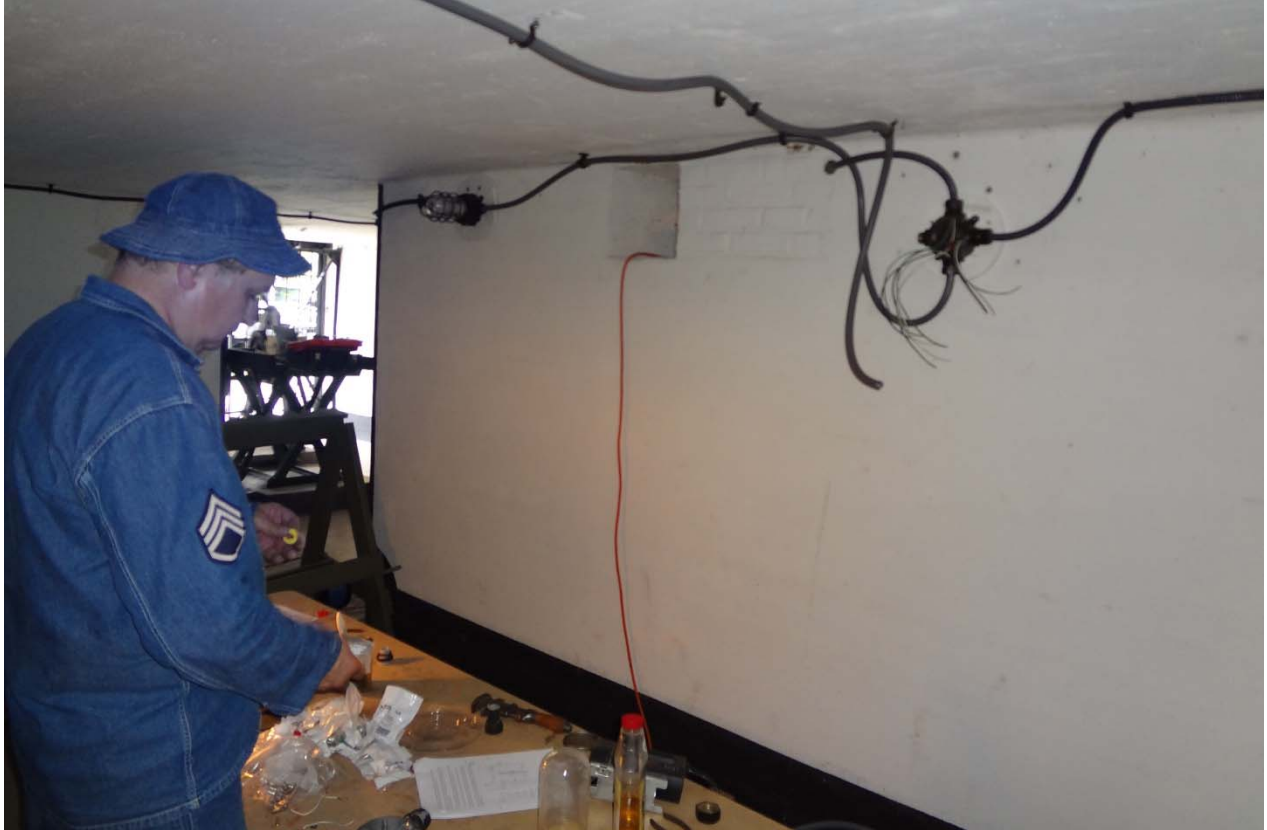
Below an AGFA member installs a vintage COE four way junction box to connect all the lines inside the magazine to the main line from the plotting room.

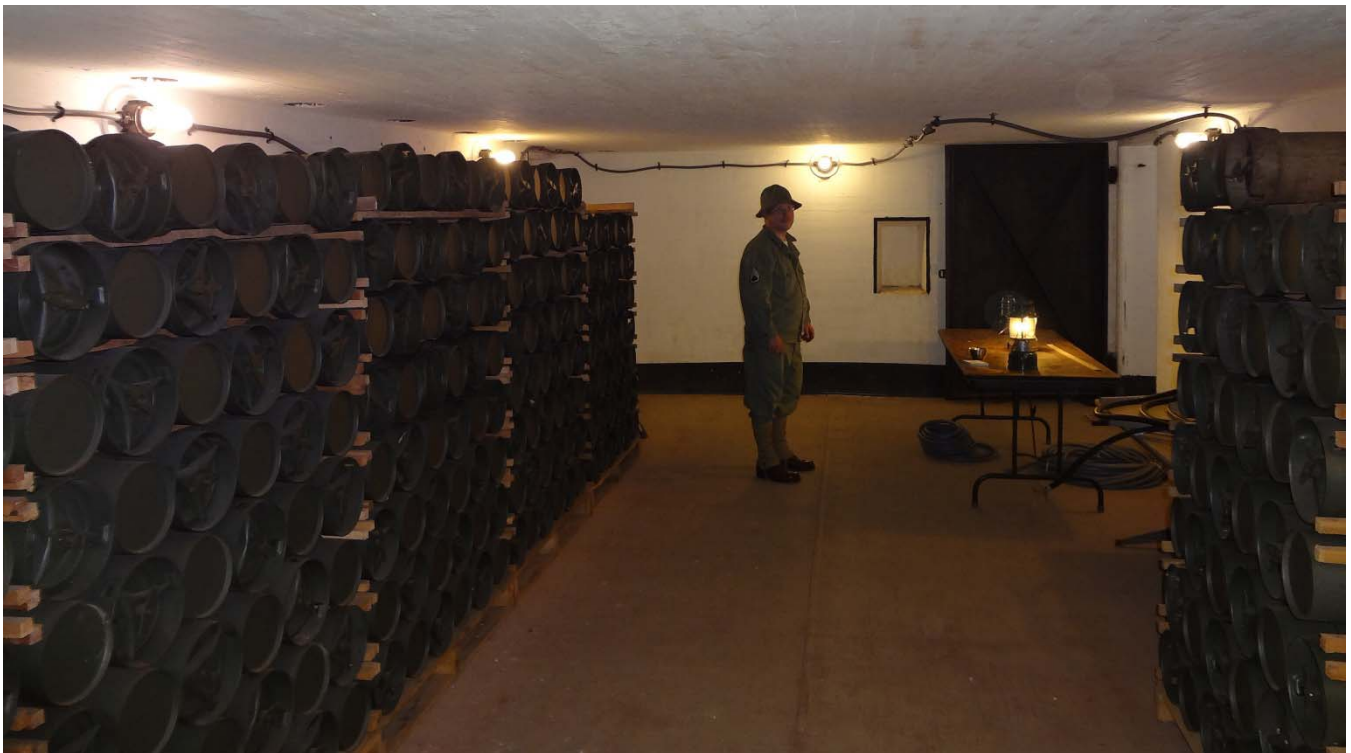
The photo below shows four newly installed lights on the Gun #2 side of the powder magazine. The light in the center has since been replaced by a wall light.

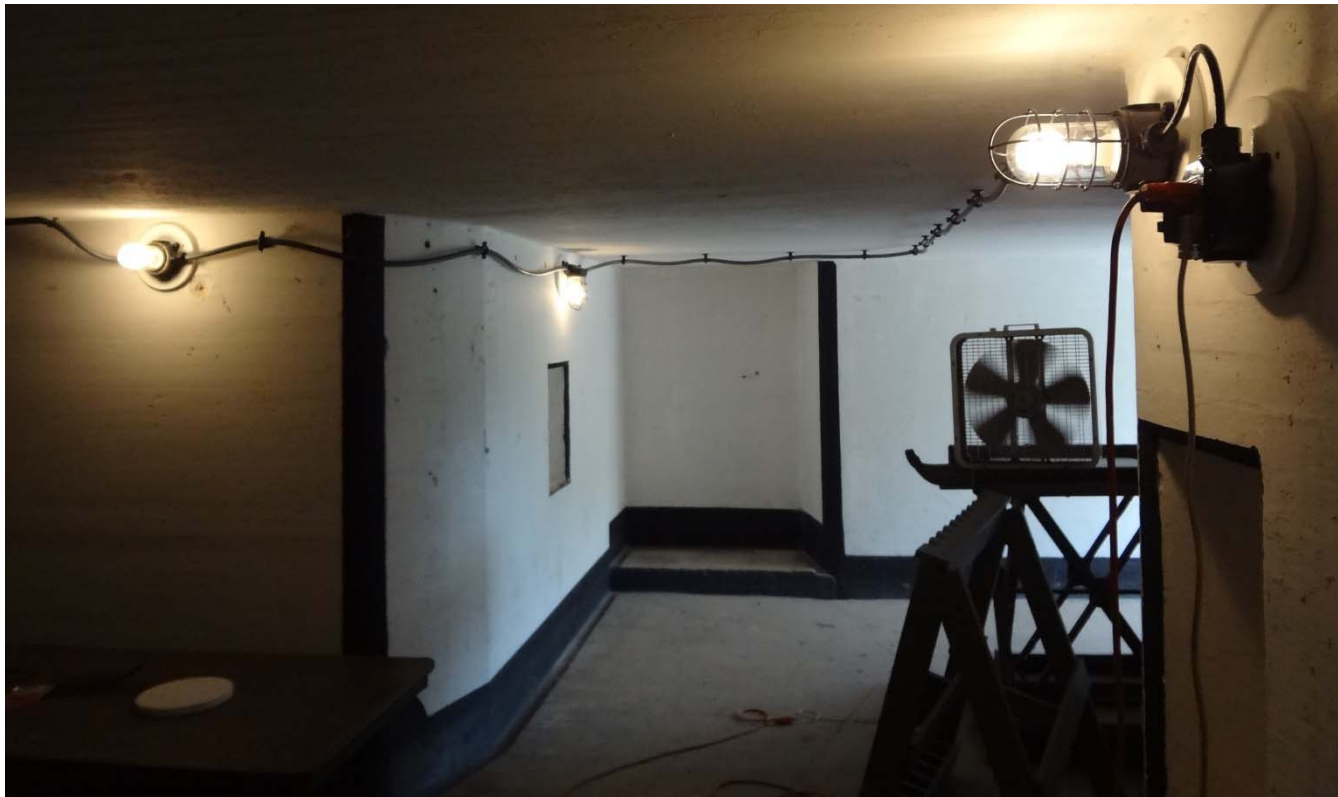
Below shows the installation of two COE Ceiling lights and one COE Wall light on the Gun #2 side of the shell magazine.

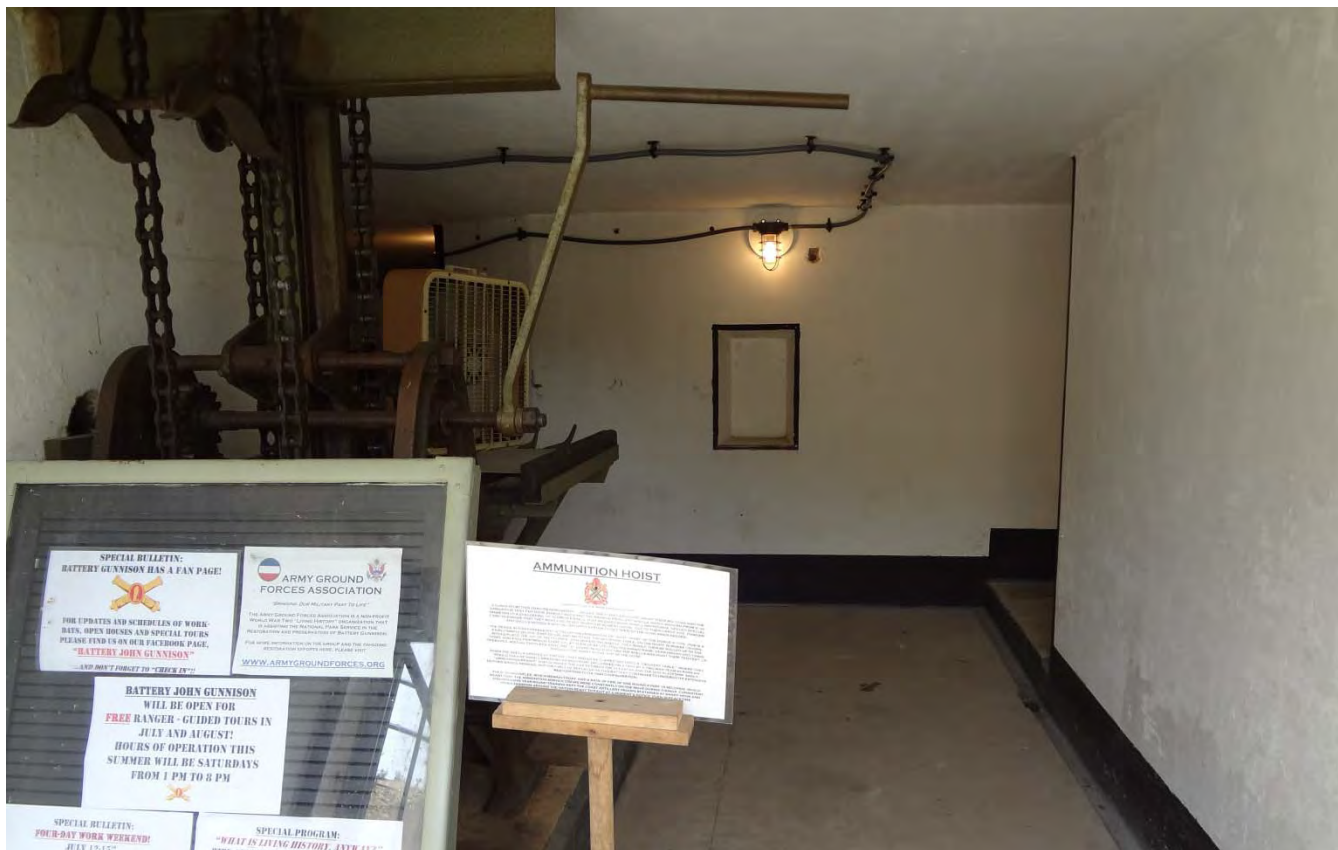
The photo below shows the COE Wall light from the entrance to the Gun #2 side of the magazine. AGFA installed four wall lights inside the magazine in July 2012. This substantially completed the interior of the magazine.

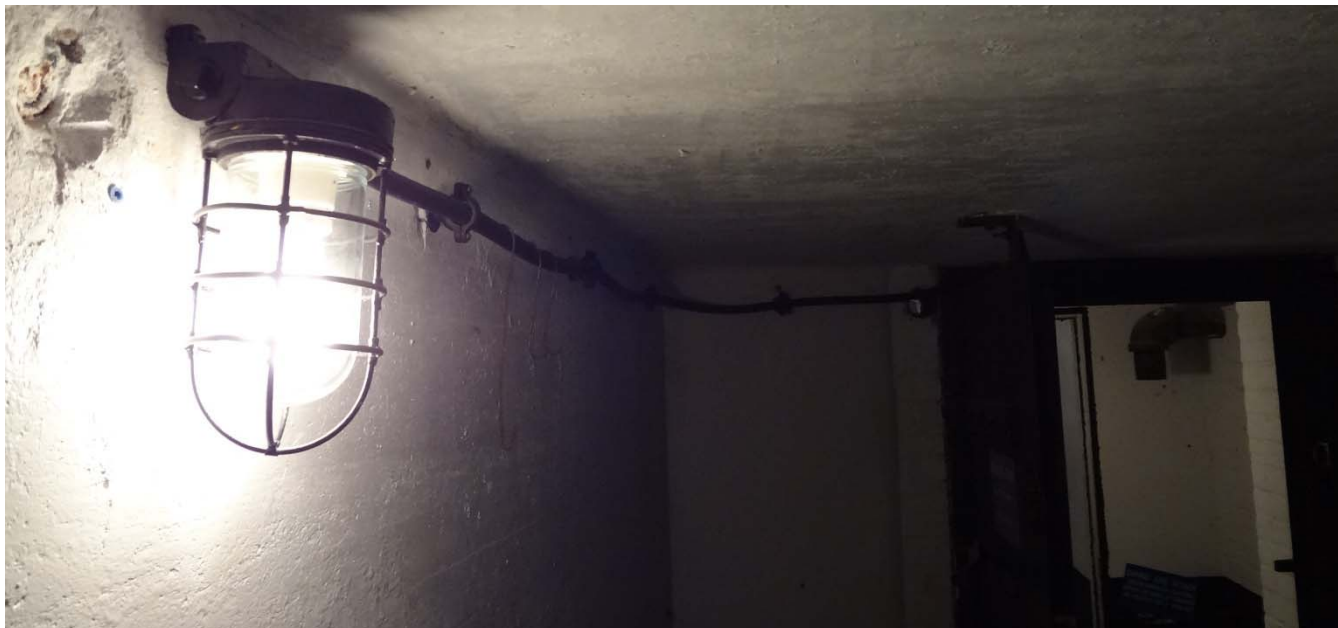
In 2012, working with Pete McCarthy, we recovered two COE Standard wall lights from Battery Kingman. These lights were installed in the Chemical warfare room and decontamination air lock. This wall light replaced a ceiling light installed in April 2011. Notice the “missing” decontamination stand pipe inside the decontamination chamber (right side of photograph). It would be 2017 before that would be fully restored.

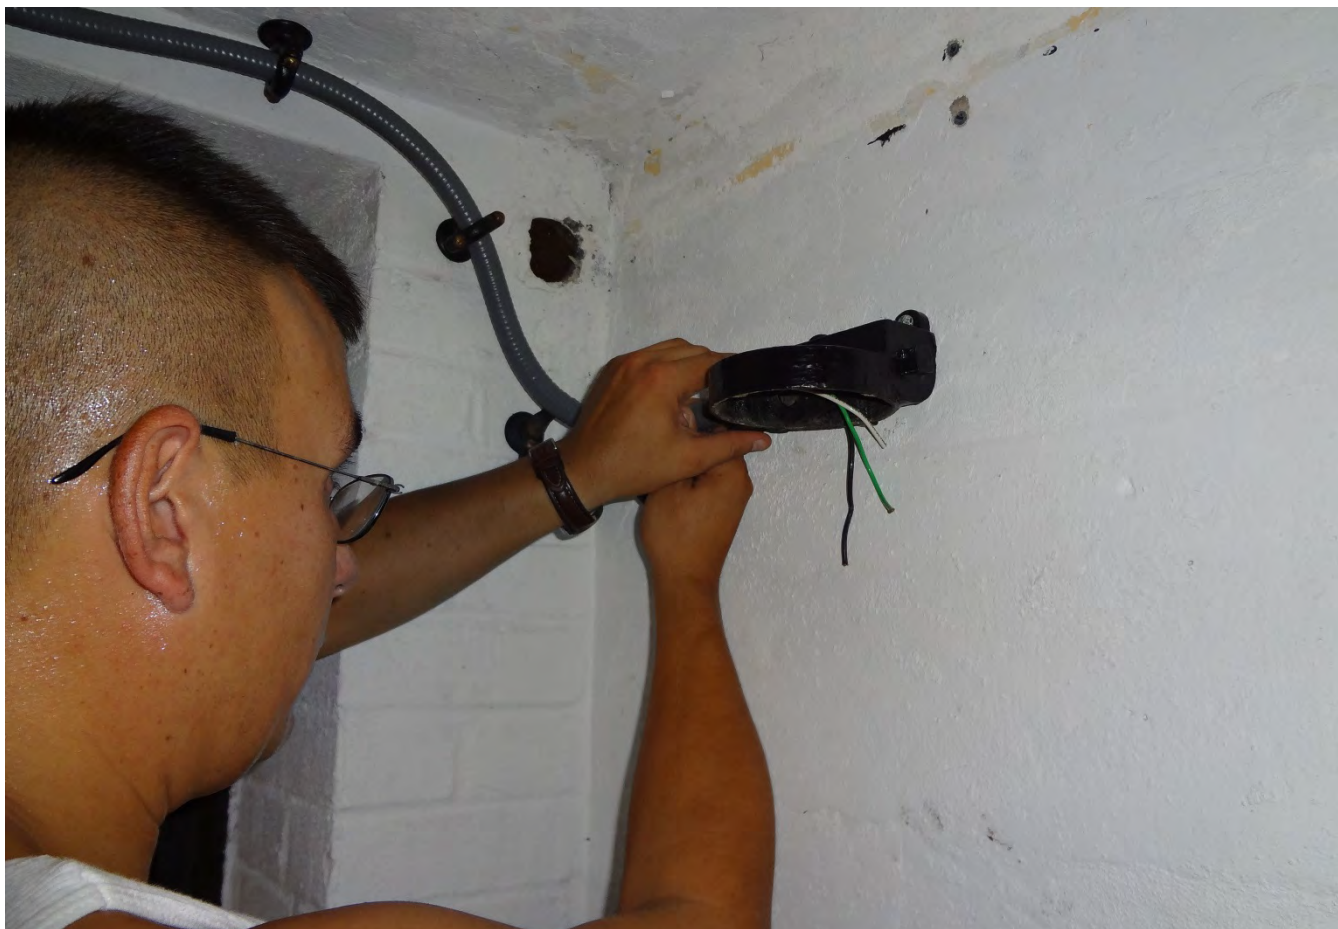
Below the COE Standard Wall light is being installed in the Chemical Decontamination chamber.

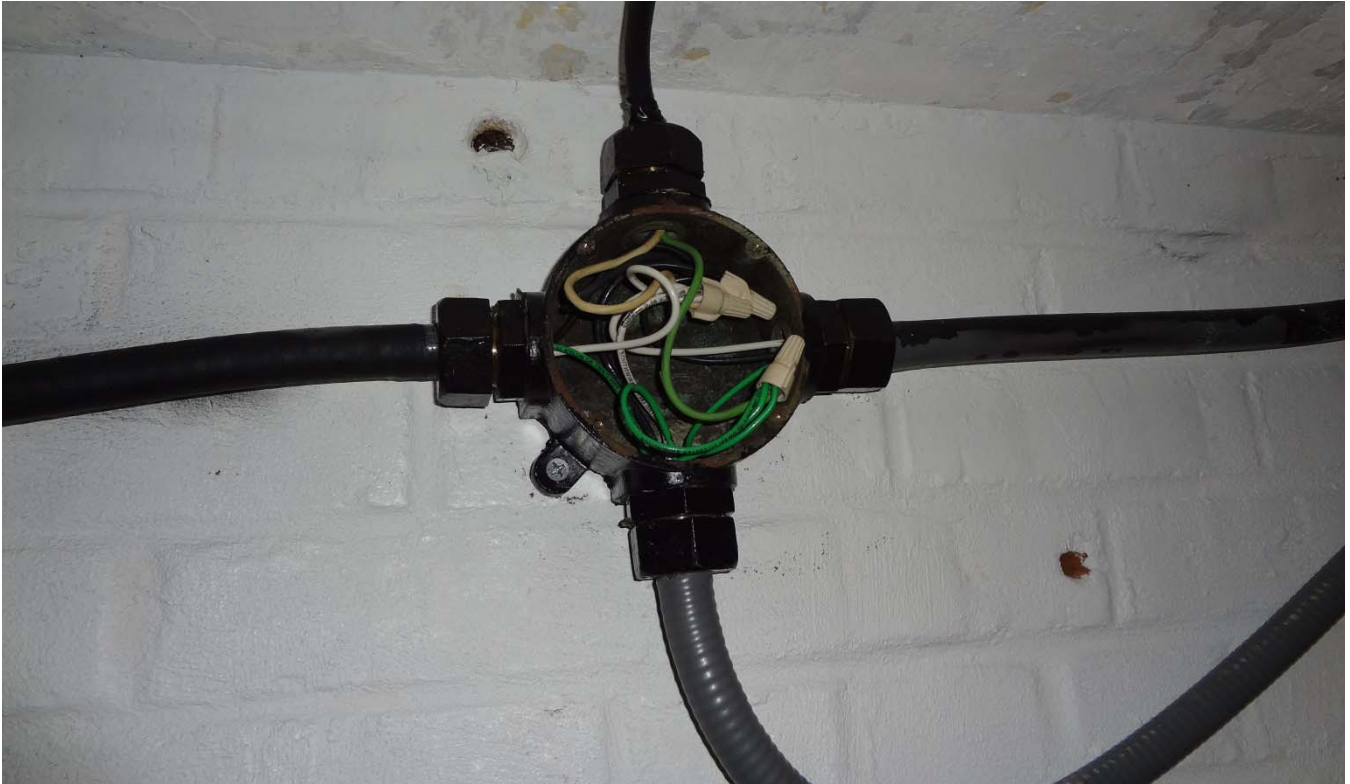
The decontamination light required another line that the existing three line COE junction box would not support. A four line COE standard junction box replaced the three line box which was then available for use in another Fort Hancock location.

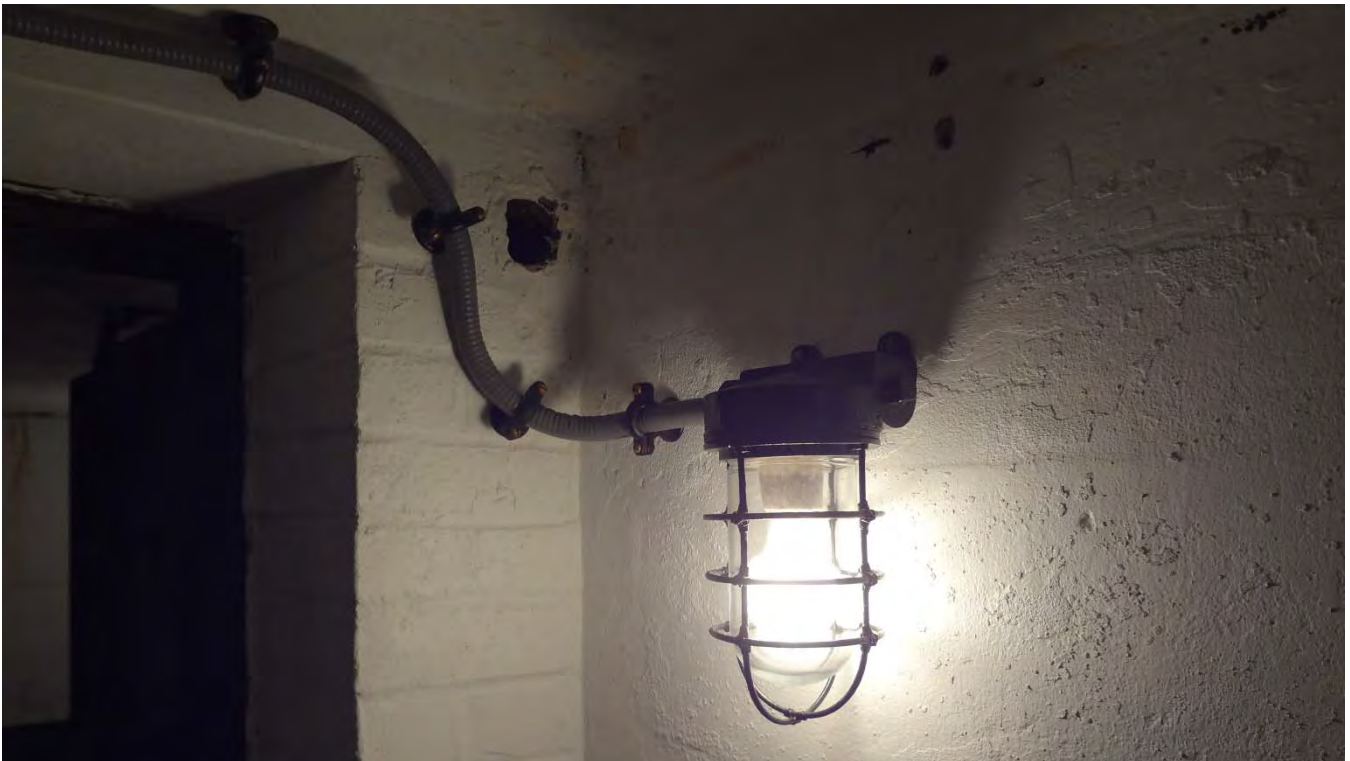
Below is a restored COE standard wall light from Battery Kingman. This provides a total of six COE standard wall lights inside Battery Gunnison/New Peck out of a required eighteen COE standard wall lights.

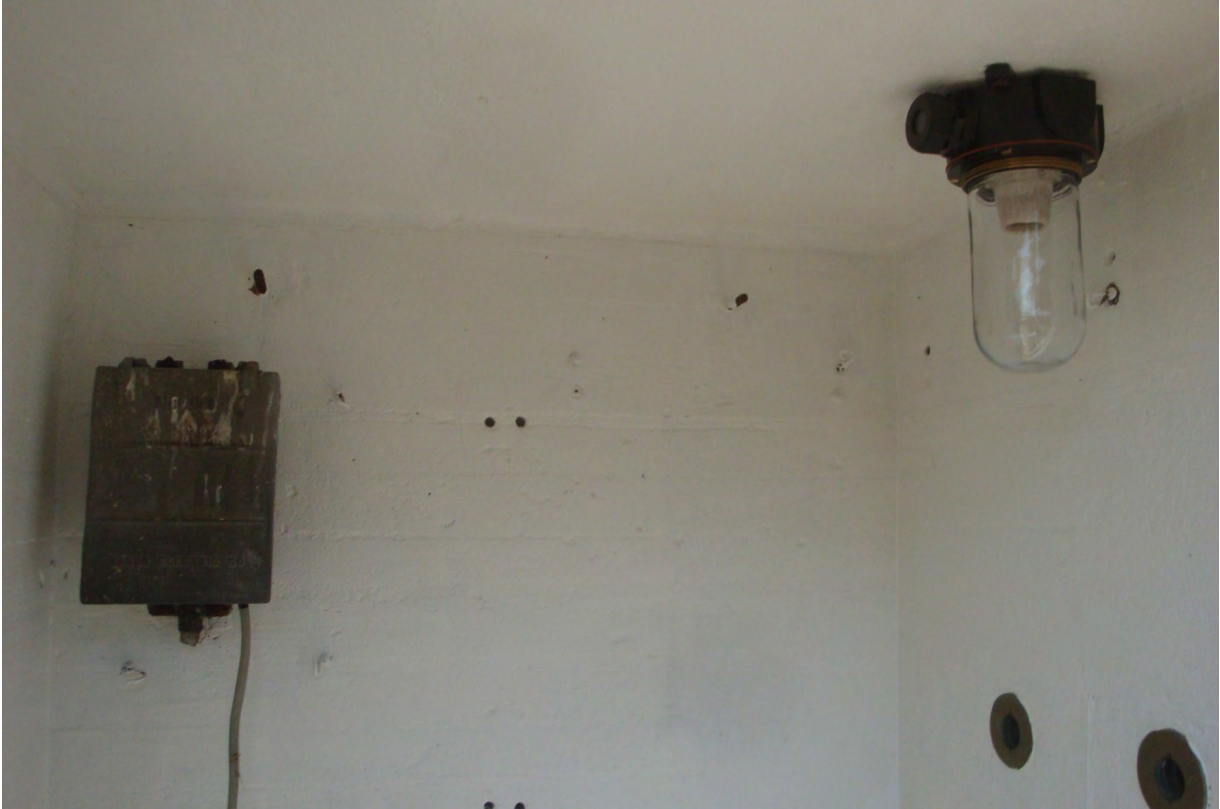
In August 2014, AGFA installed a COE Standard Ceiling light in each telephone booth. The light below is in the Gun #1 booth where it remains as of May 2018.

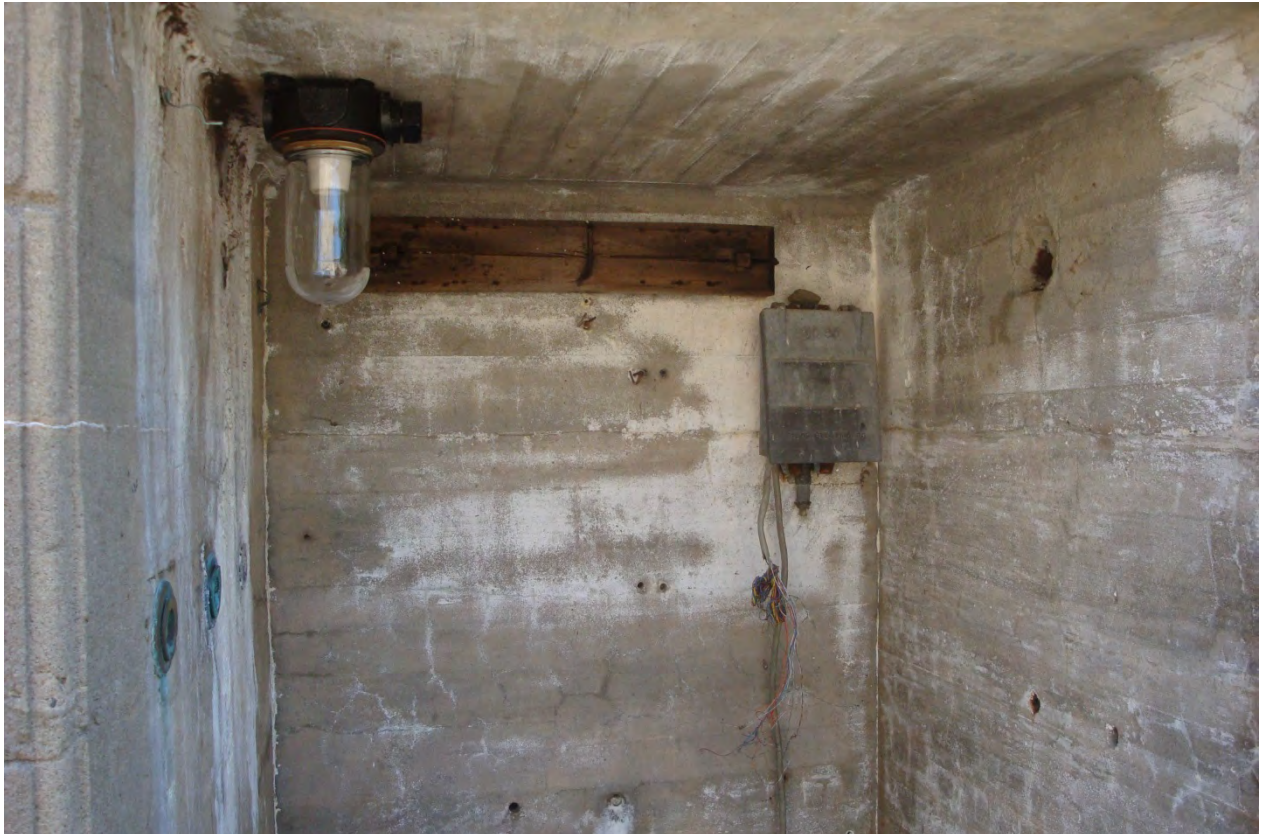
The photo below shows the light installed in Gun #2 telephone booth.

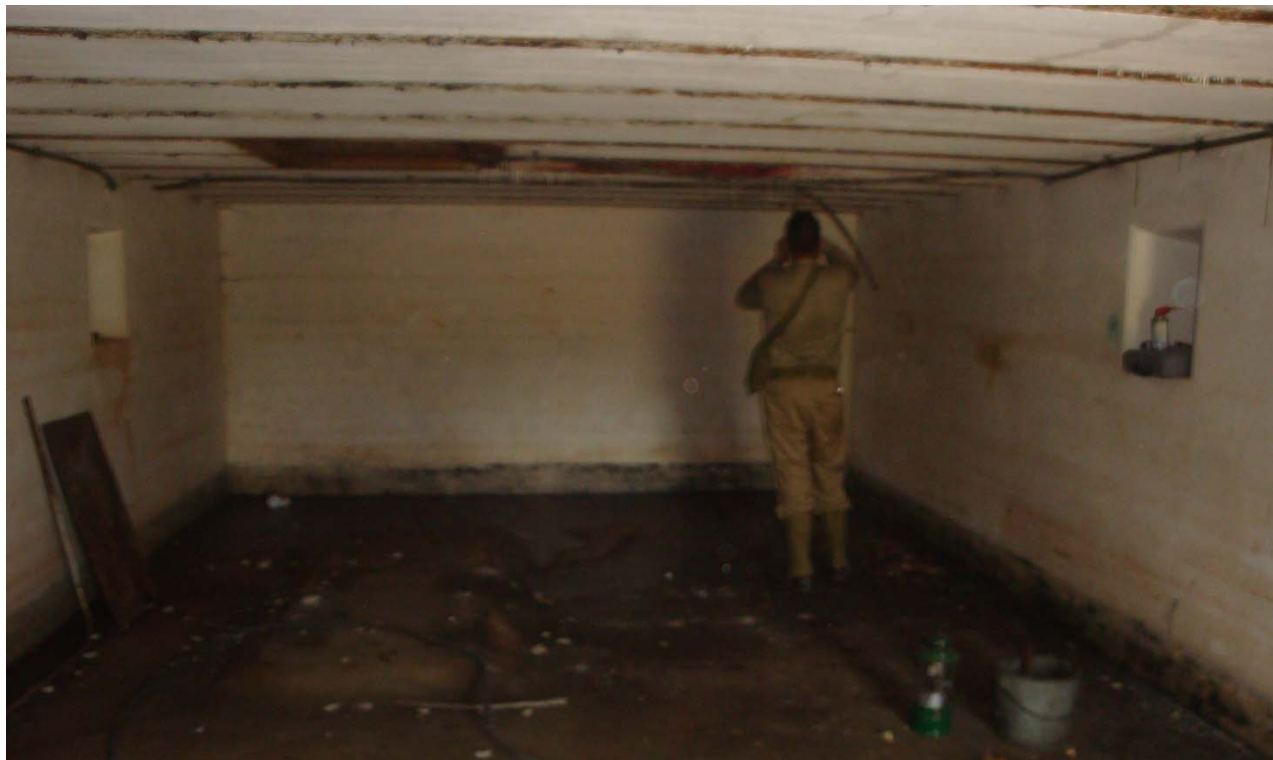
As the installation of electrical components progressed, the shortage of cable hangers became acute. As of 2014 there were not enough cable hangers on hand to initiate new installations. During the spring and early summer of 2015, AGFA coordinated with the NPS to remove and restore about 200 cable hangers from Old Battery Peck (a ruins designated battery in the GMP). In the photo below an AGFA member removes a cable hanger from the ceiling of Old Battery Peck.
