Restoring Electric System at Battery Gunnison/New Battery Peck *Ft. Hancock, New Jersey*

The reintroduction of electrical service to Battery Gunnison/New Battery Peck began in 2003 when the National Park Service introduced a 20 amp circuit with approximately nine modern interior lighting fixtures and two standard 15 amp outdoor standard receptacles. This very basic service was the starting point. Fifteen years later the system is essentially completed both interior and exterior lighting using predominantly restored and the correct historic fixtures and fittings.

This paper begins with the current status of the Electric Installation at Battery Gunnison/New Battery Peck as of May 2018. As of that date, the installation is over ninety five percent complete. The next part will give a brief chronology of the improvements beginning with NPS electrification in 2003 up to May 2018.

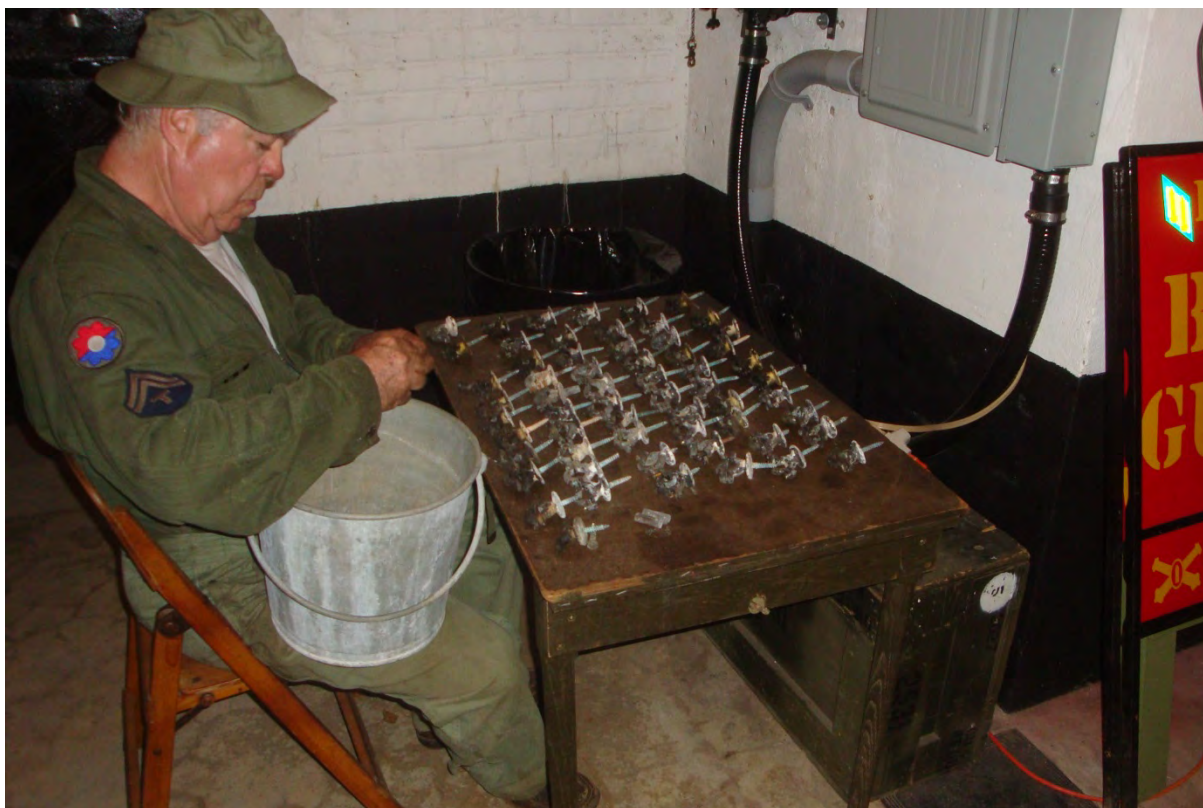
In the photo below, an AGFA member cleans and counts cable hangers and prepares them for restoration.

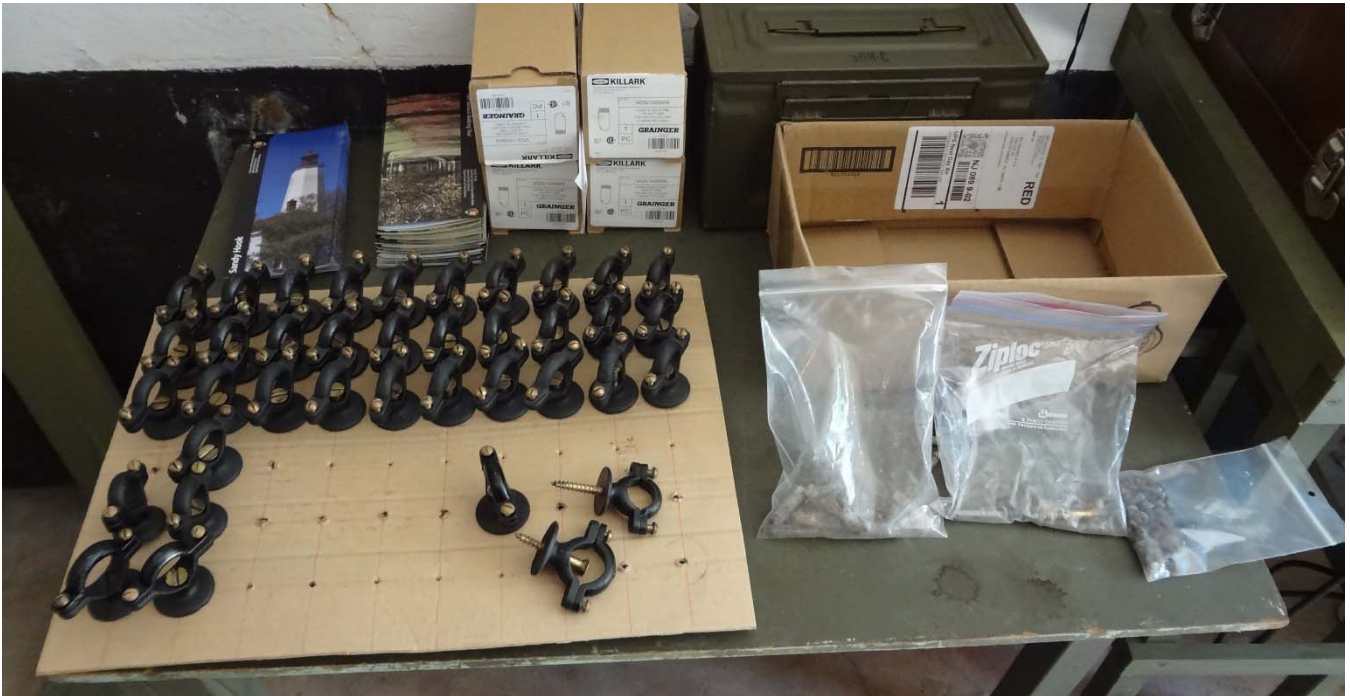
Restored cable hangers are shown below. Cable hangers were cleaned and de-rusted using various non-corrosive processes typical to automotive restoration (bead blasting or carburetor cleaning). They are then primed and painted. All screw threads are cleaned and the cable hangers are re-tapped. These cable hangers (approximately 250) enabled completion of both the interior and 90% of the exterior electrical installation for Battery Gunnison/New Battery Peck.

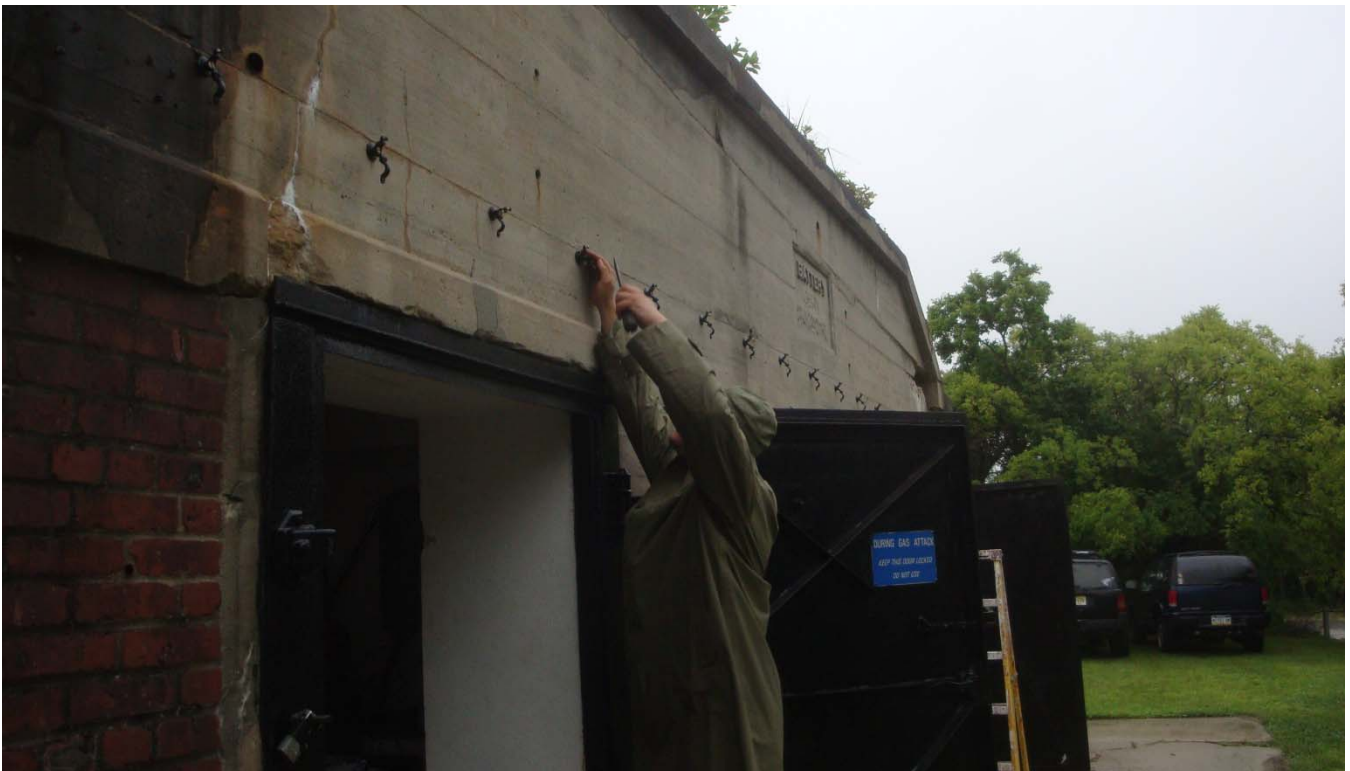
Beginning in July 2015, AGFA began installing exterior lighting. This was in conjunction with the contracting action on the Battery Commander's Station stairs and ammunition bridge reconstruction contact. In the photo below an AGFA member installs cable hangers to hold the conduit

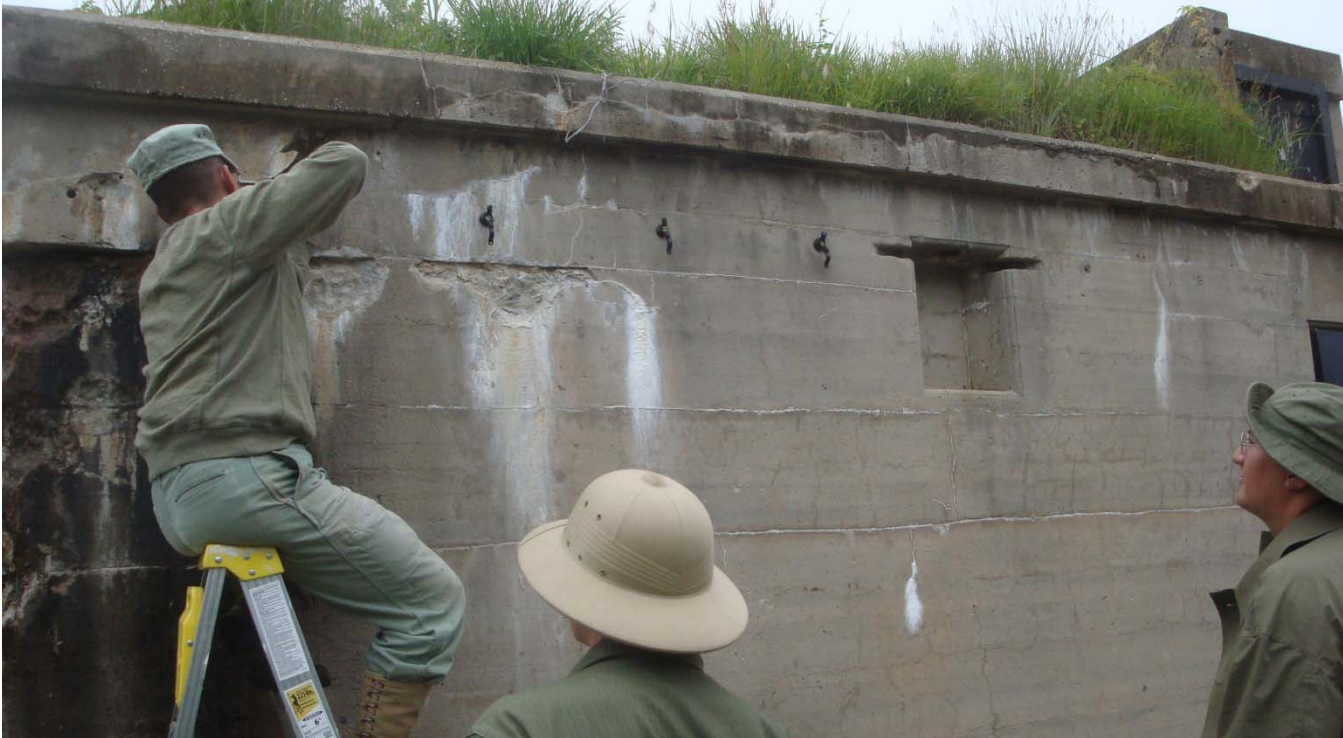
Additional cable hangers are installed on the Gun #1 side of the battery service area. In July of 2014 a total of four modern wall lights, one COE standard three line junction box with cover and one modern light/motion sensor switch were installed.

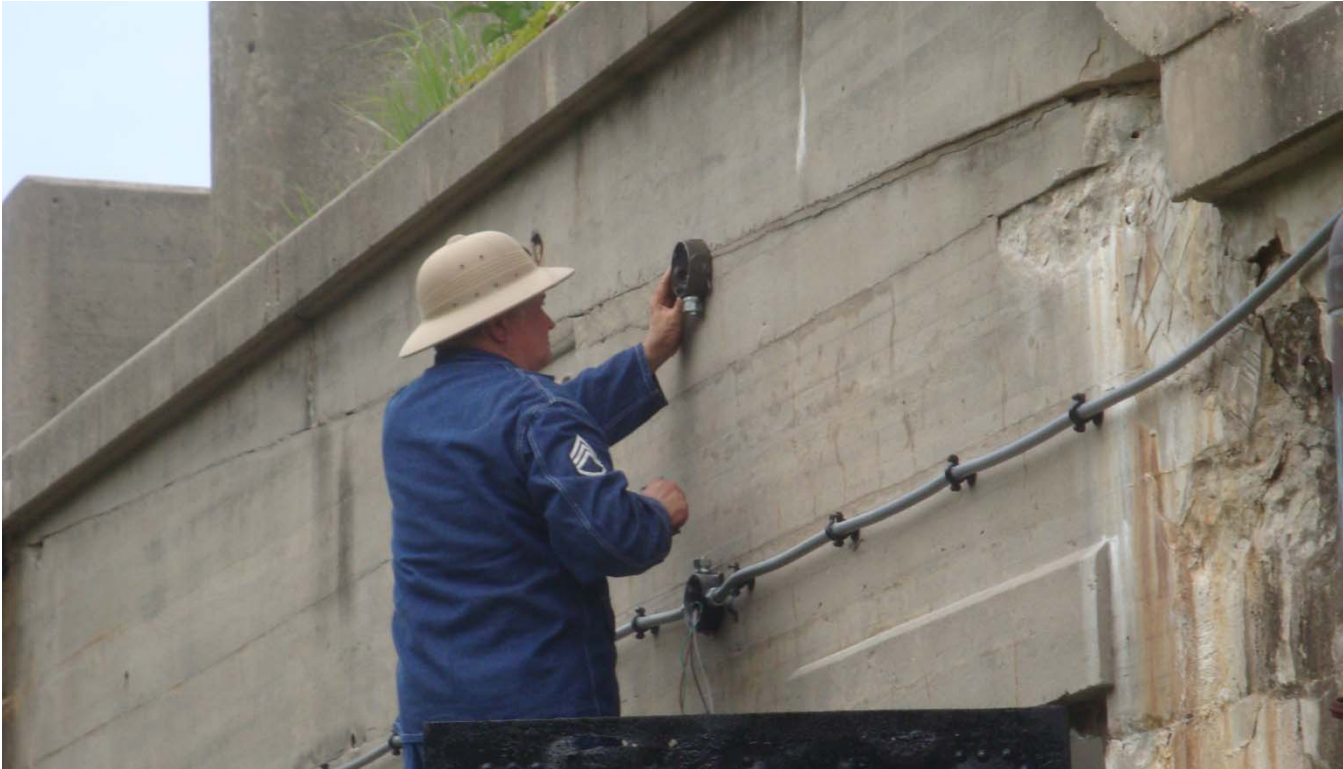
In the photo below the sensor box is being installed.

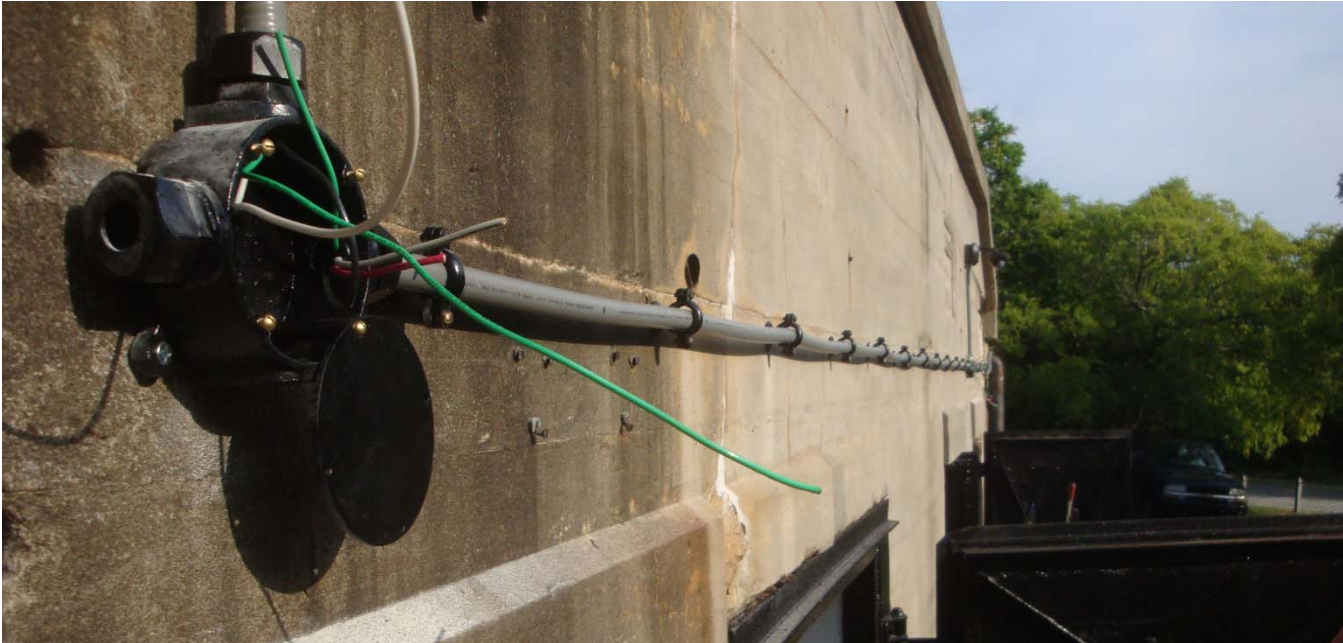
In the photo below the COE standard 3 way junction box is being wired for the sensor line. Notice the heavy cover and the large nut that is in place. These fixtures are a bronze/brass alloy and unfortunately valuable for theft. We ensure these valuable and rare fixtures are placed in areas where the public does not have easy access. This first phase of exterior lighting used approximately 50 cable hangers.

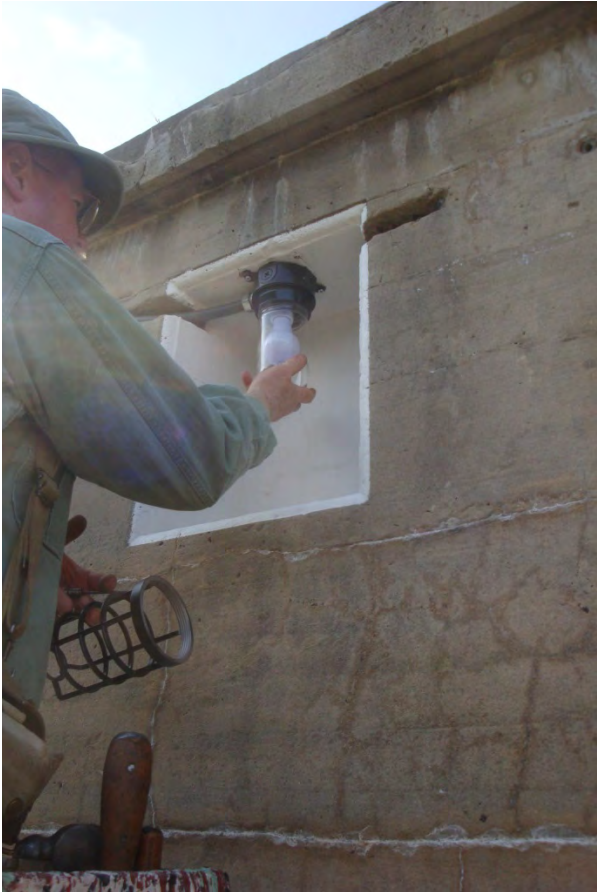
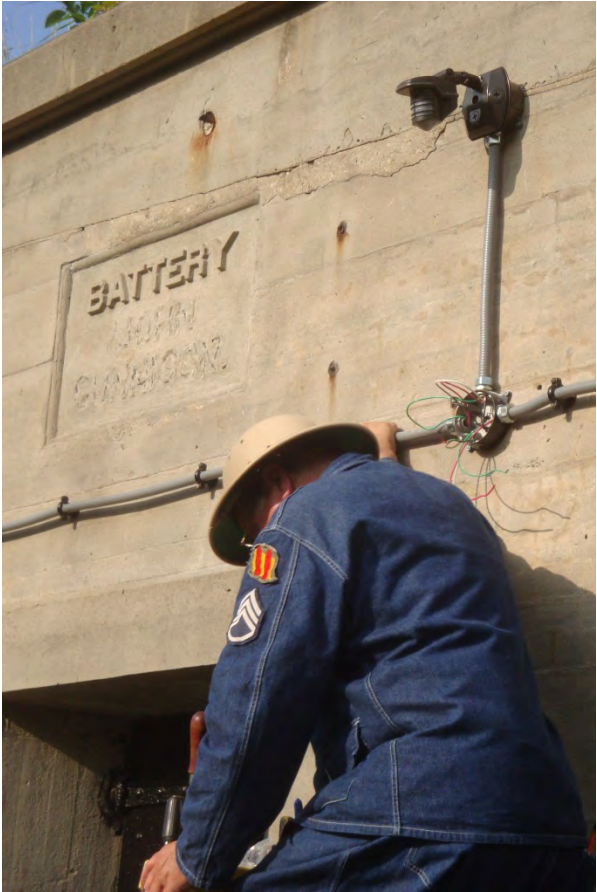
The two photos below show completion of a modern wall light on Gun #1 side (left) and the final installation of the sensor switch (right).

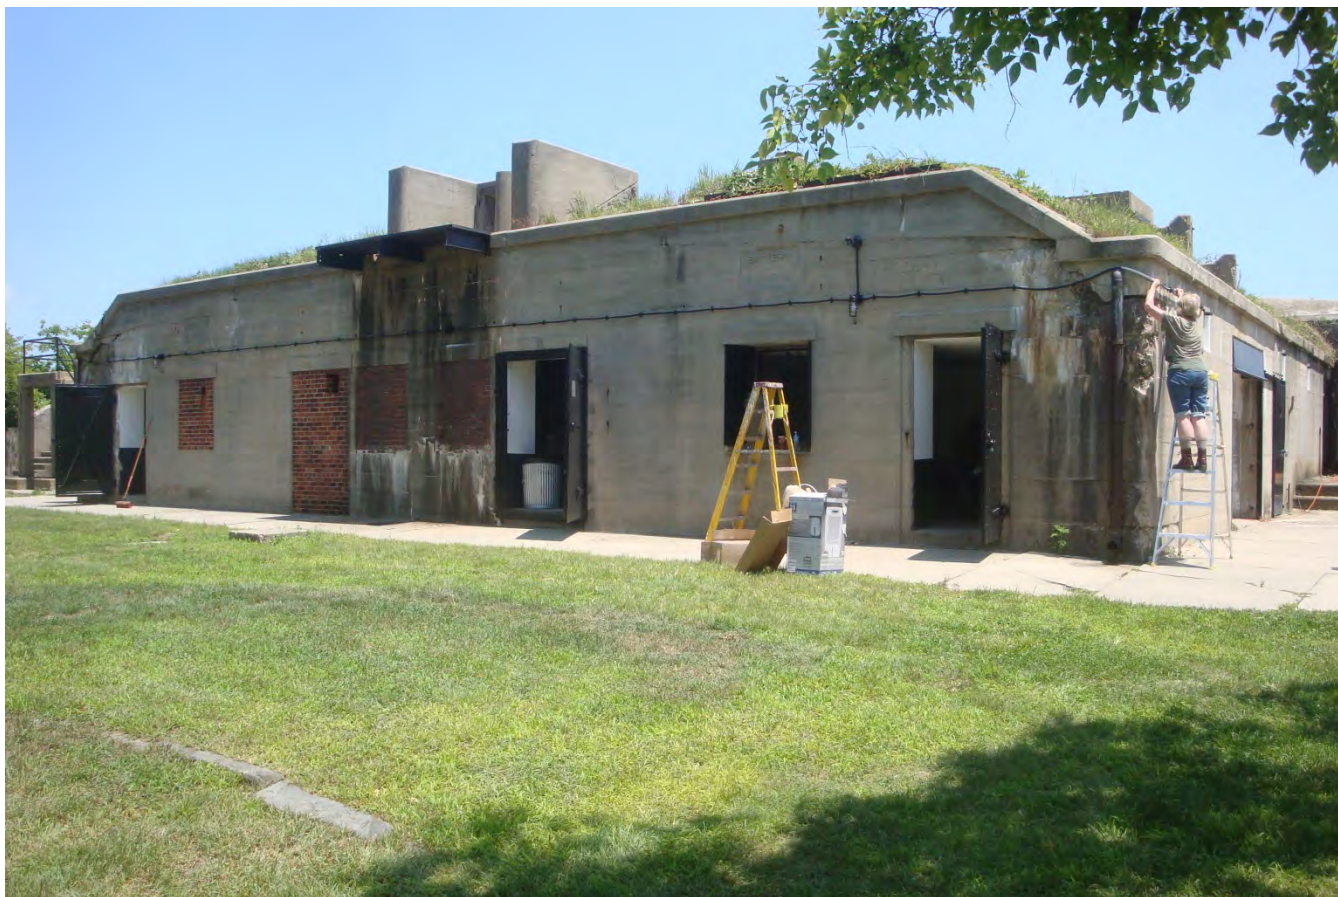
The photo below shows the July 2015 exterior lighting installation with the conduit and fixtures painted black.

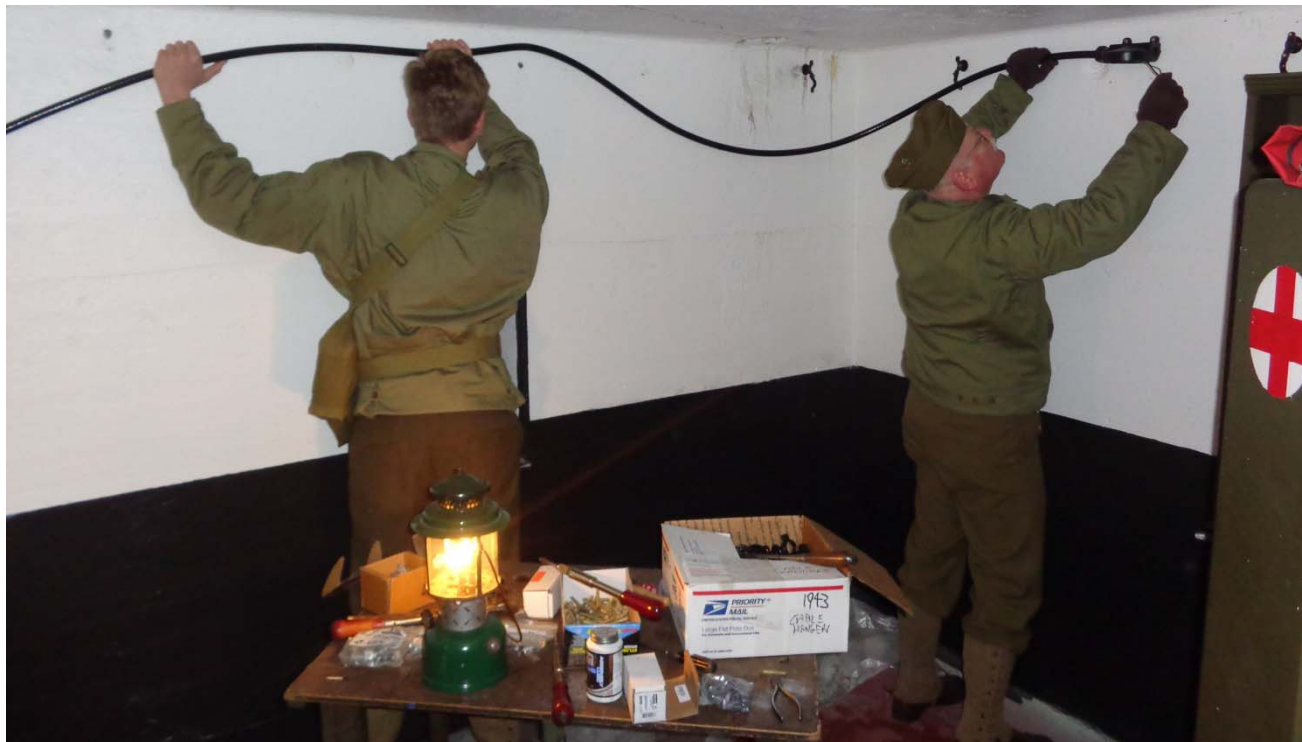
In March 2017 the Chemical Warfare room was rewired in preparation for the Chemical Warfare system reinstallation. This consisted of adding an additional COE standard wall light to the northern corner near the outside entrance and reversing the wiring on the wall light on the eastern wall of the room. The photo below shows the reversal of the wall light.

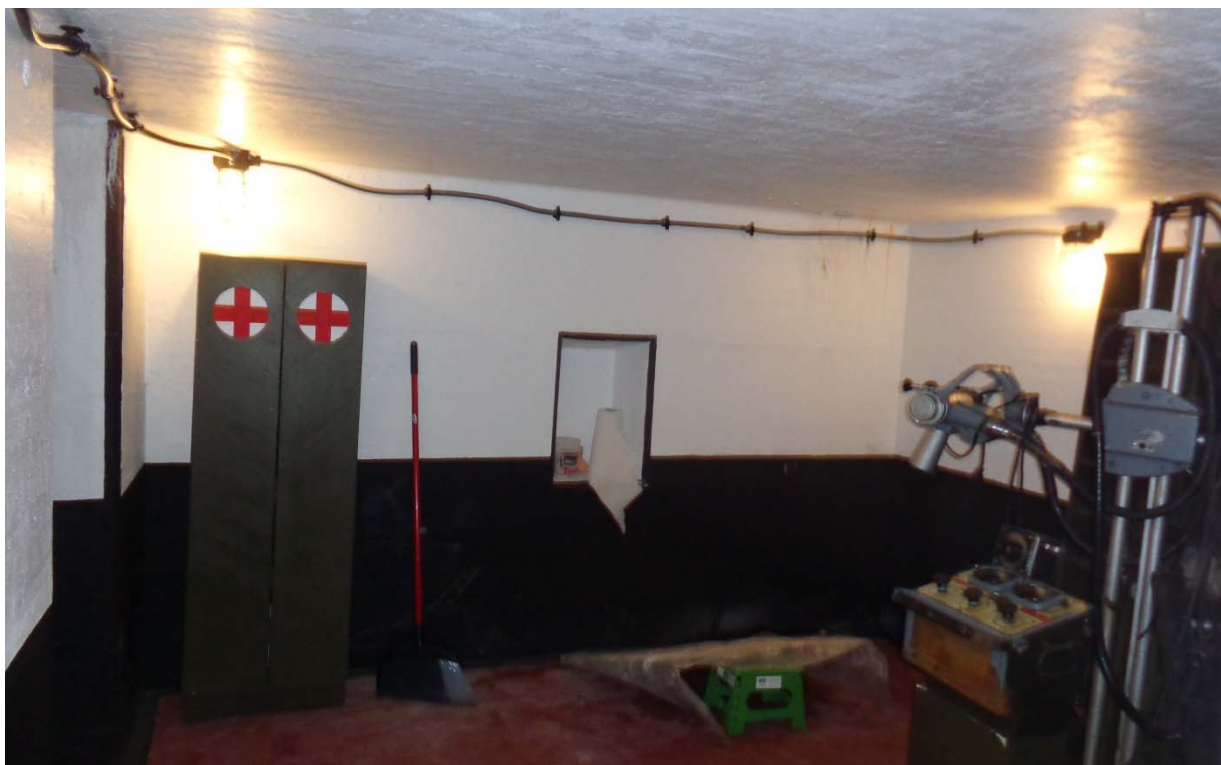
The photo below shows the full relocation of the northern COE standard lights. This required the addition of the one ceiling light on the left.

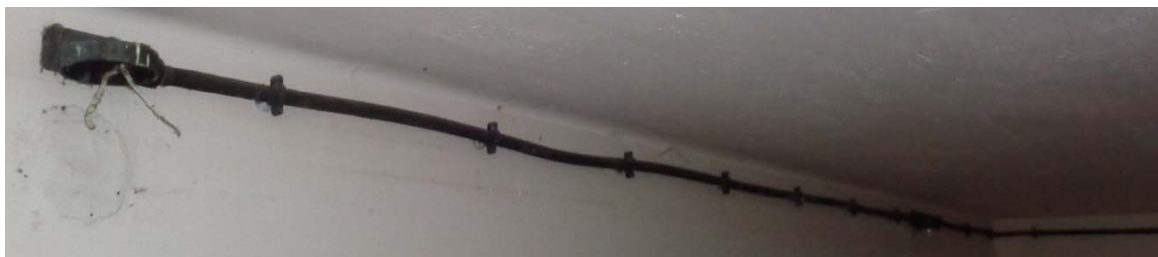
In the spring of 2017, seven wall lights were recovered from Battery Morris (a "ruins" designated battery) and restored to operating condition. Below are photographs of the Wall Lights recovered from Battery Morris and installed in Battery Gunnison/New Battery Peck. The first photo shows two wall lights inside Battery Morris. One light is missing the ceramic light component and the ceramic light mounting fixture.

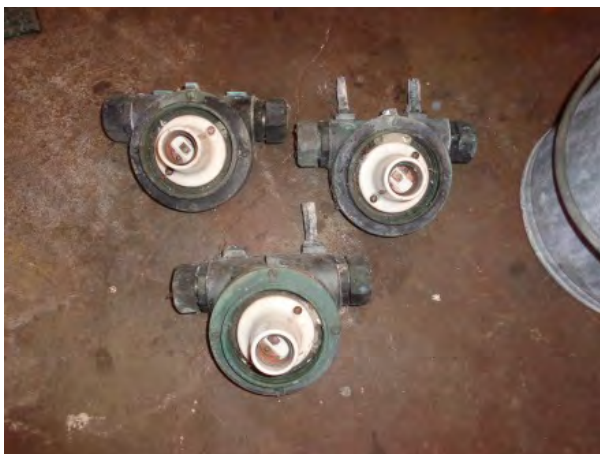
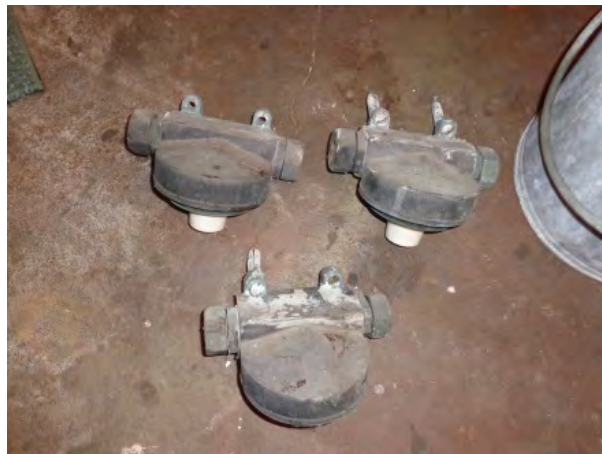
The Photos below show wall lights in various stages of restoration. The first two photos show the lights as originally recovered.

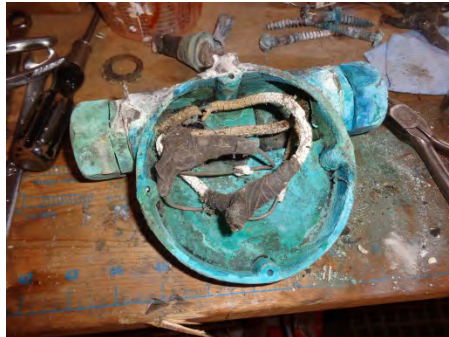
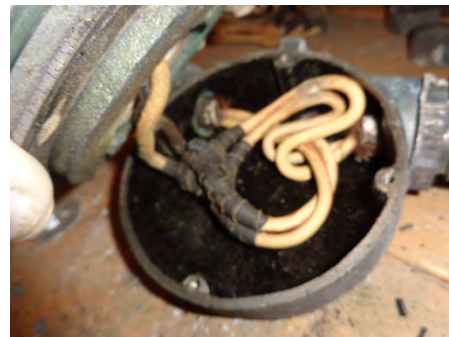
The next three photos show the lights being disassembled.

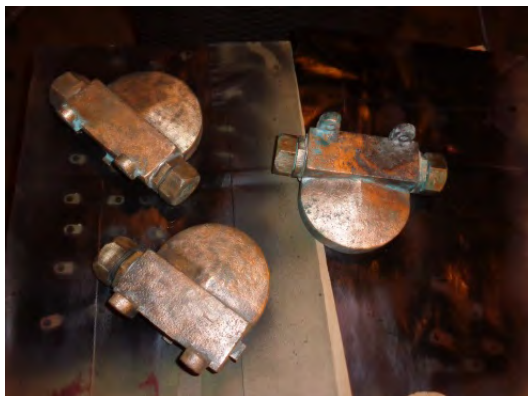
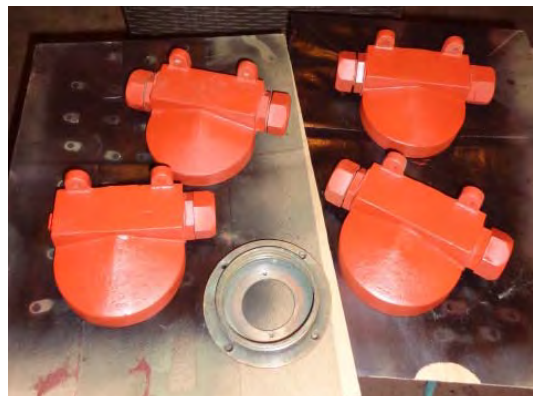
The photos below show the wall light housings being cleaned and primed.

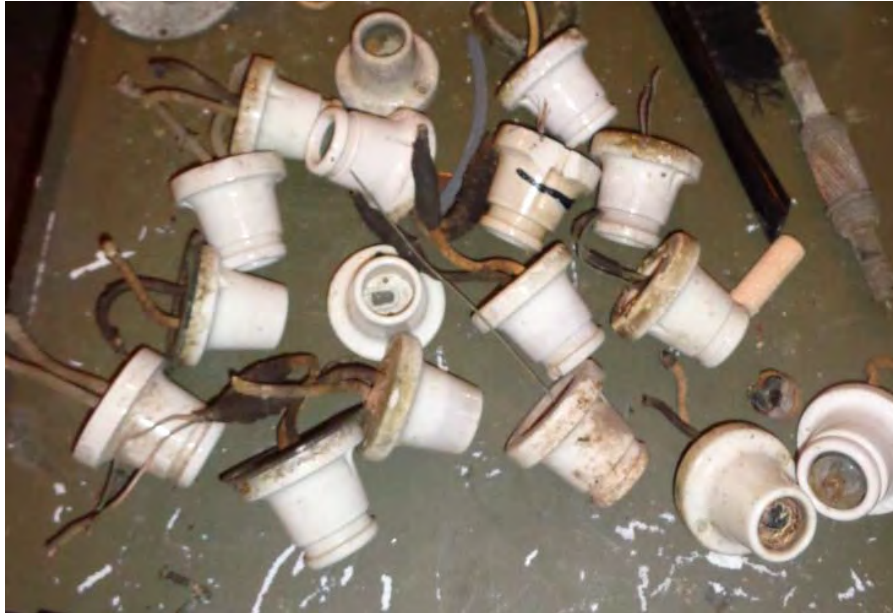
Below are a number of corroded and broken ceramic light fixtures. No modern fixtures are manufactured to these sizes. In order to reuse the historic fixtures, those that are able to be restored, must be restored.

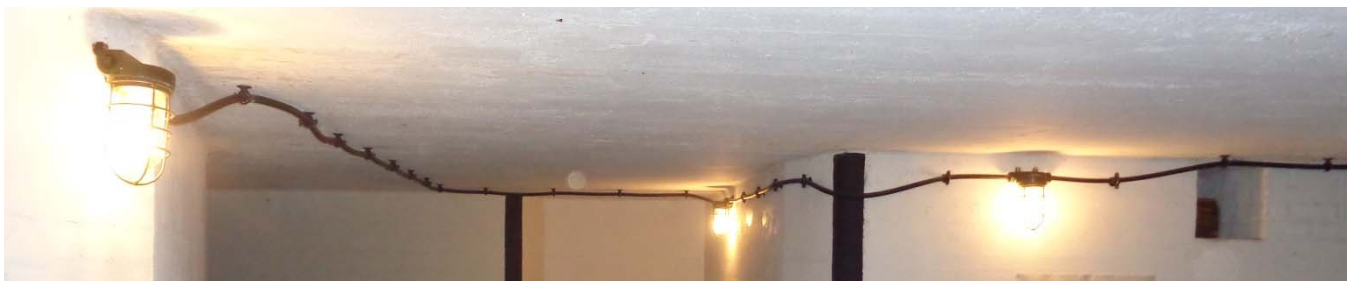
The restored ceramic fixtures are shown below rewired, polished and installed in the light housing for the junction box. Notice the fixture has a ground wire attached.

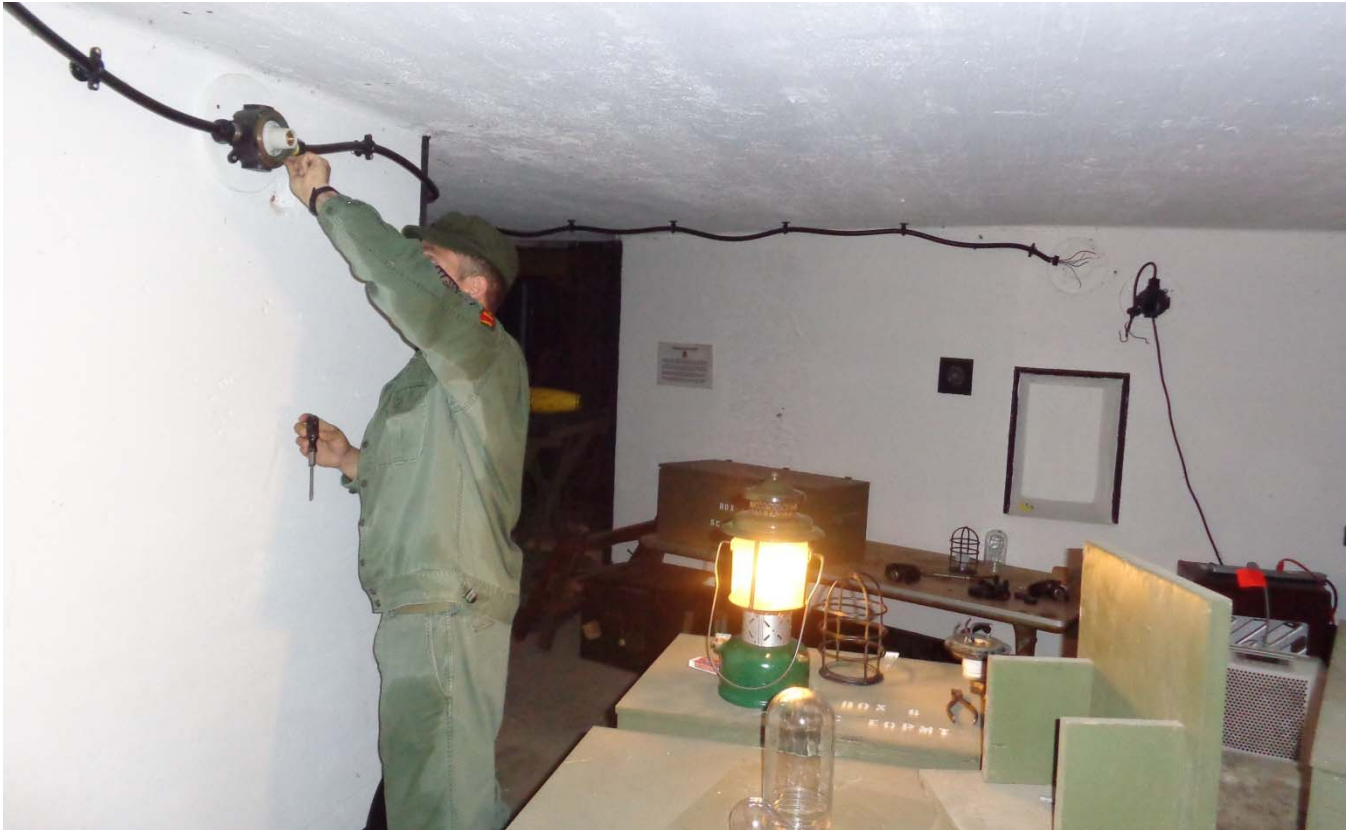
The photo below from May 2017 shows the replacement of ceiling lights with wall lights.

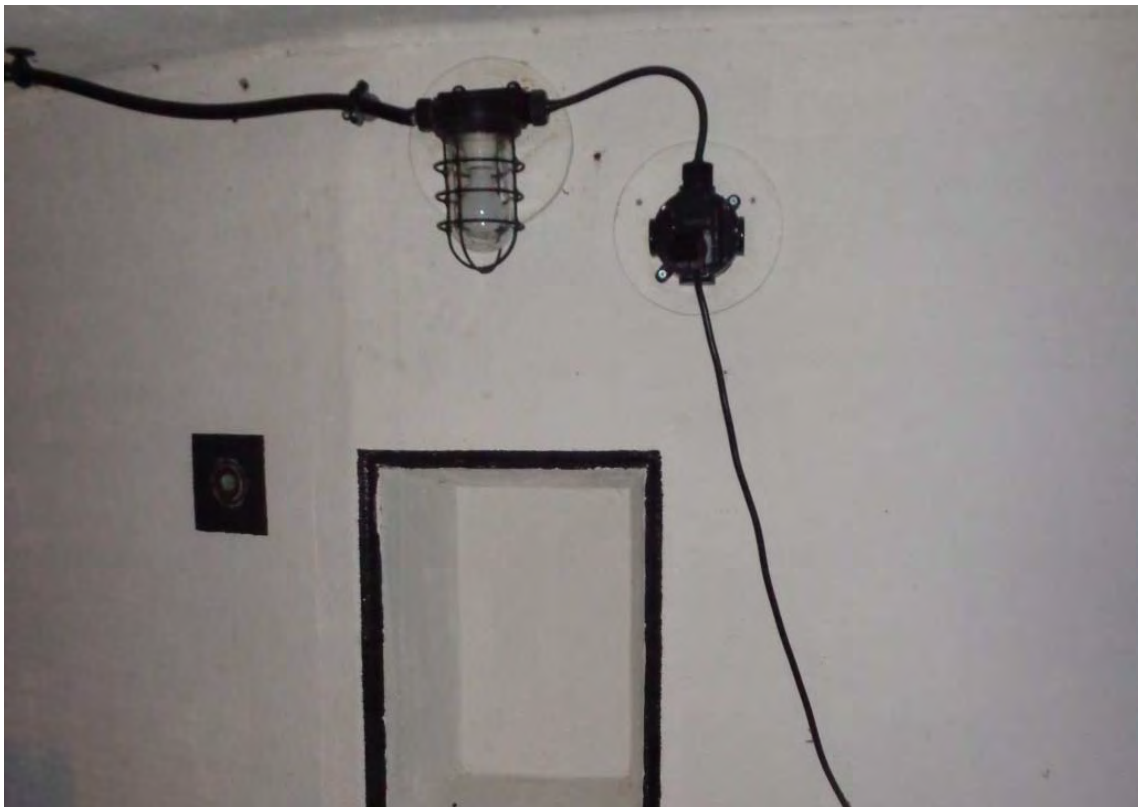
The COE standard wall light is shown on the Gun #2 side of the shell room with the dehumidifier receptacle to its right.

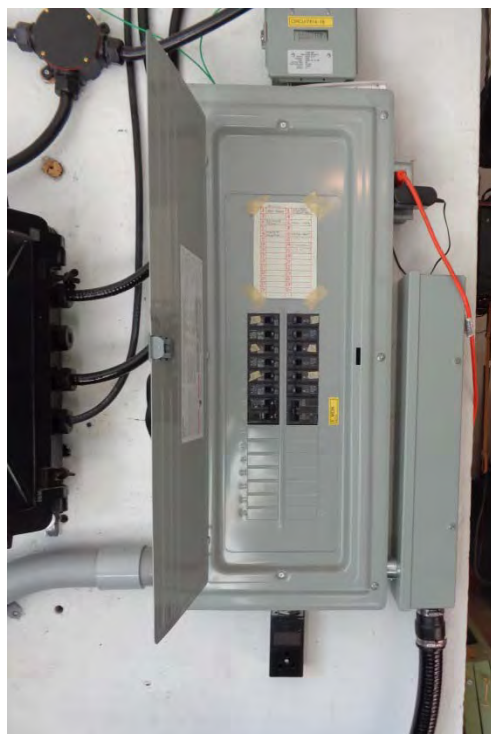
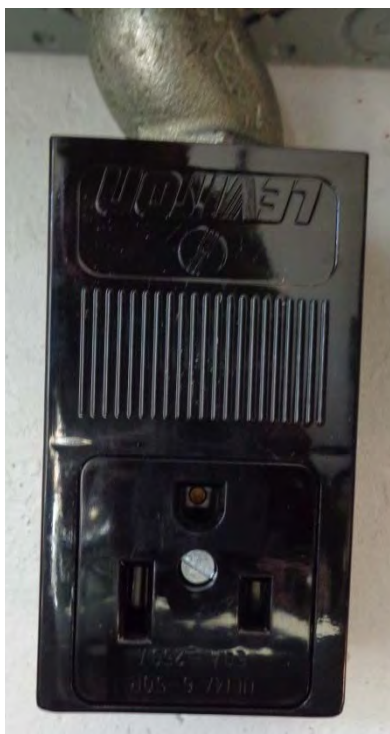
In September 2017, AGFA added a 220 volt 50 amp AC receptacle to the Siemens panel box. The left photo shows the Siemens box and the receptacle at the bottom. The right photo is a close-up of the receptacle.

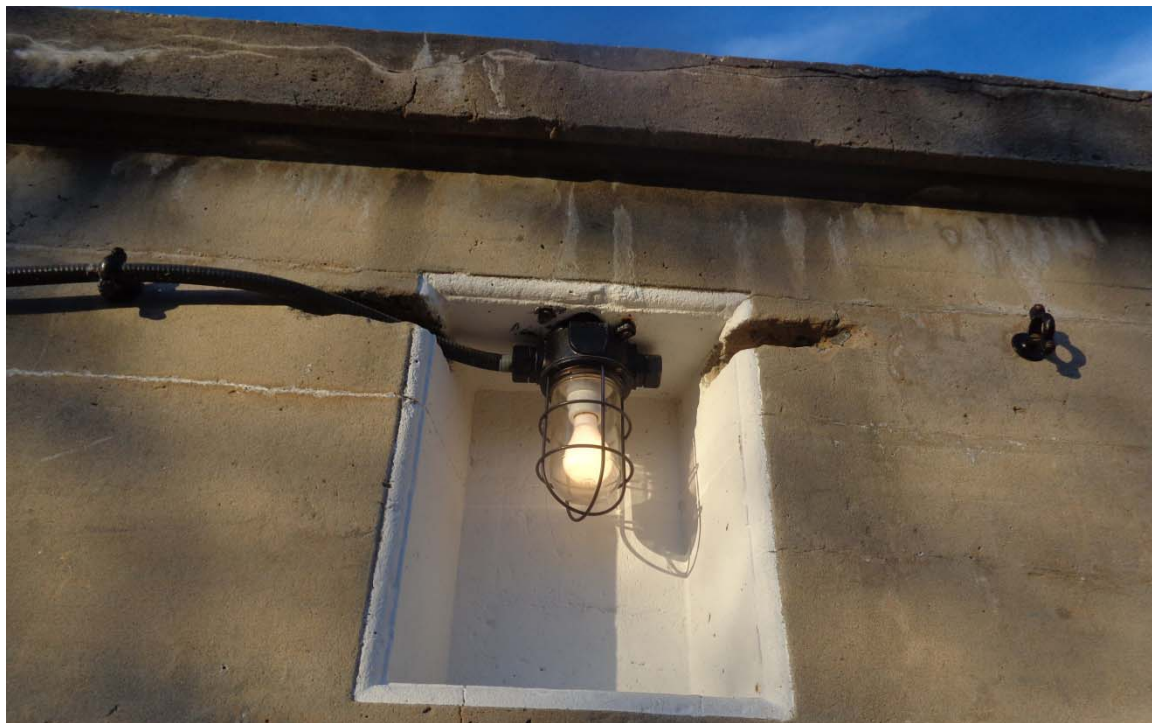
The next major focus was the exterior lighting and that effort started in earnest in December 2017 and was completed in early May 2018. This work started once the ammunition bridges and Battery Commander's Station stairs were in and the projects were accepted by the NPS. The photo below was taken on 7 December 2017 showing a COE standard ceiling light having just replaced a modern RAB ceiling light on the Gun #1 side service area. The RAB light was used in a niche that is more accessible to the public. The same action occurred on the Gun #2 side.

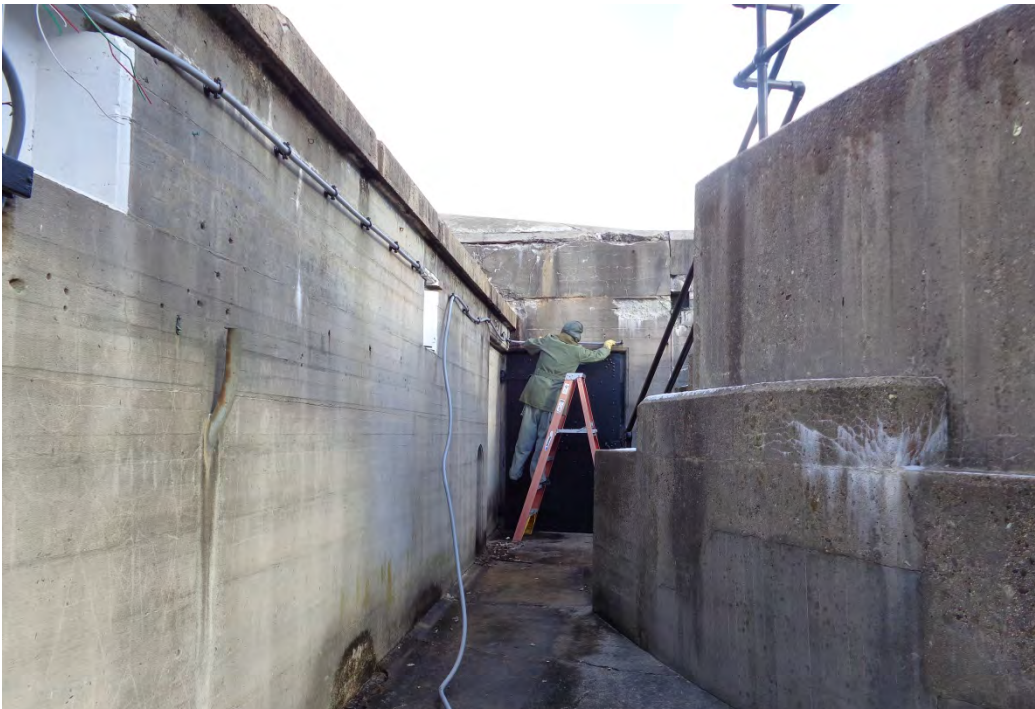
The photo below take on 14 December 2017 shows an AGFA member running conduit on the Gun #1 service area. The two niches have modern wall lights that were replaced earlier by vintage COE ceiling lights. Notice the conduit is being connected.

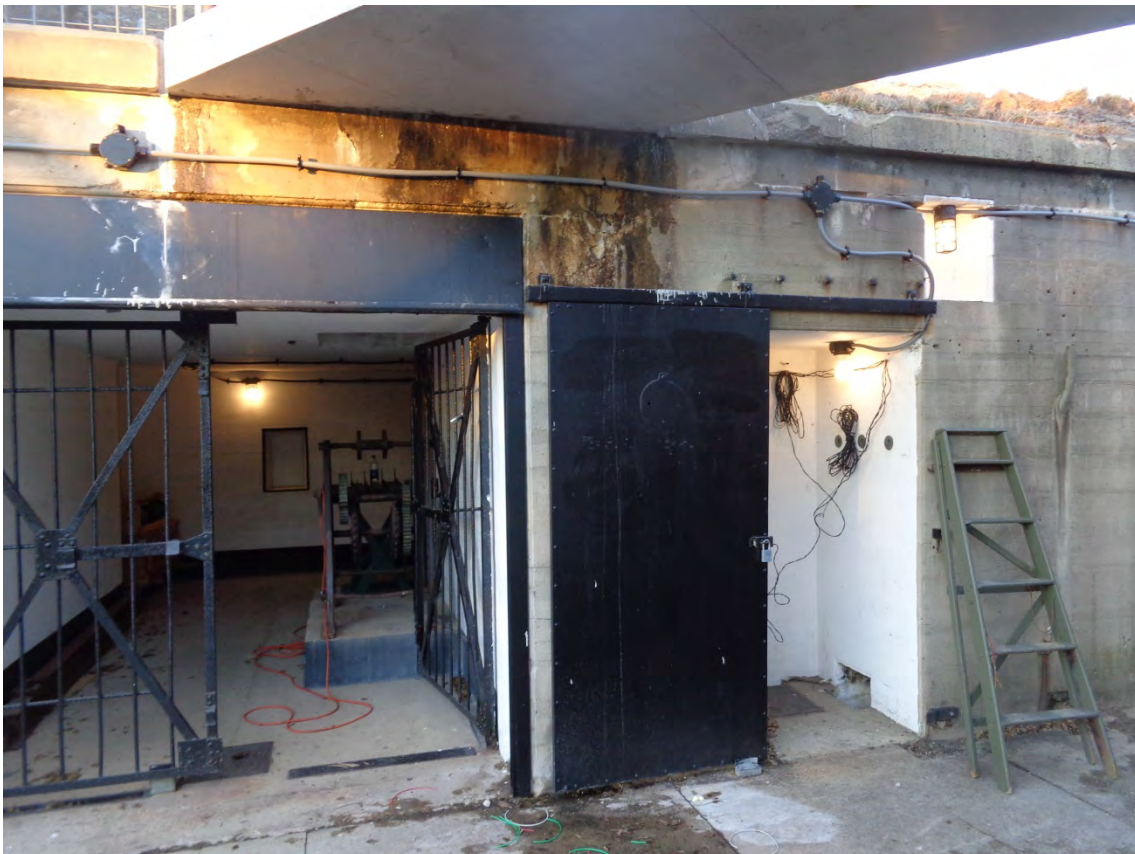
The photo below shows the exterior lights and two COE Standard junction boxes (left is three line and right is four line). The left junction box provides the connection for the stanchion platform lights.

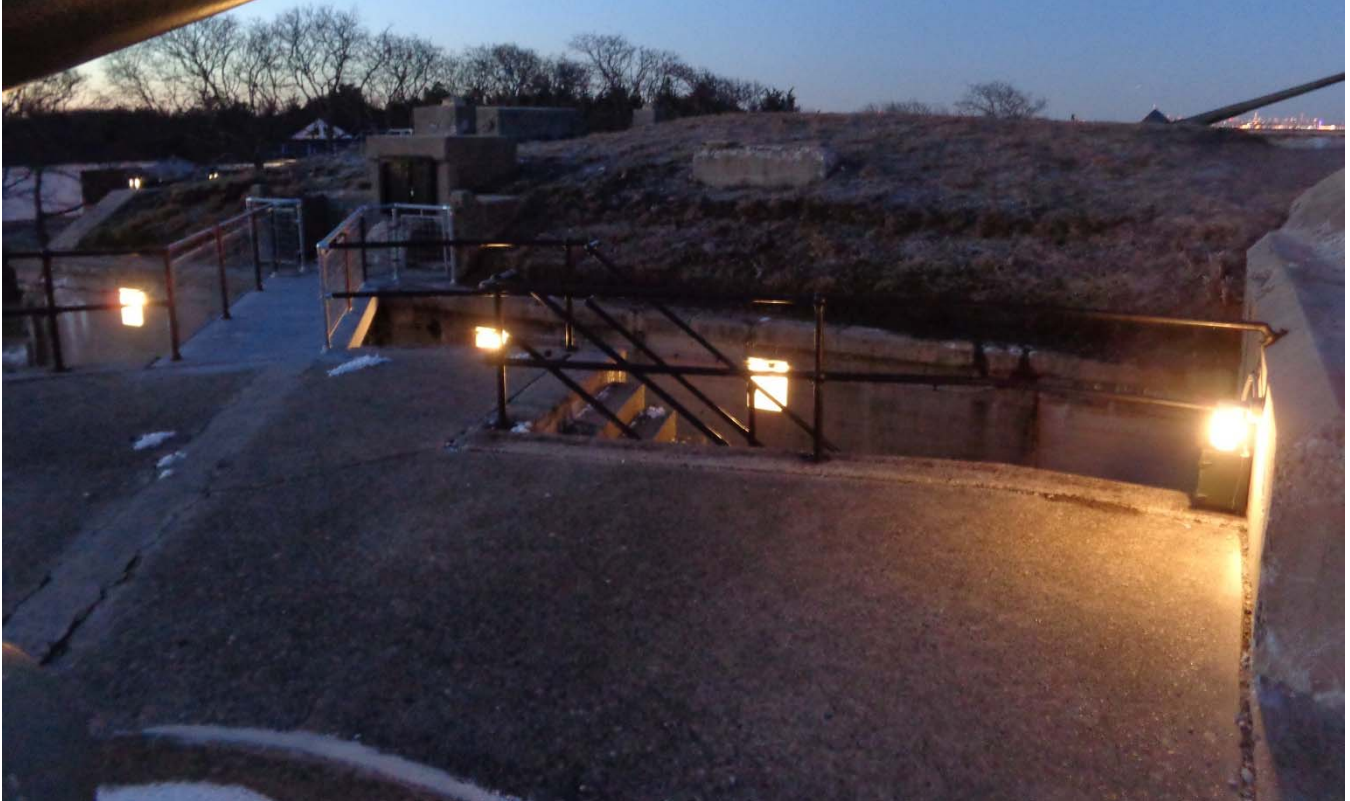
The photo below shows the three new RAB (modern) lights (two ceiling, one wall) installed on Gun #1.

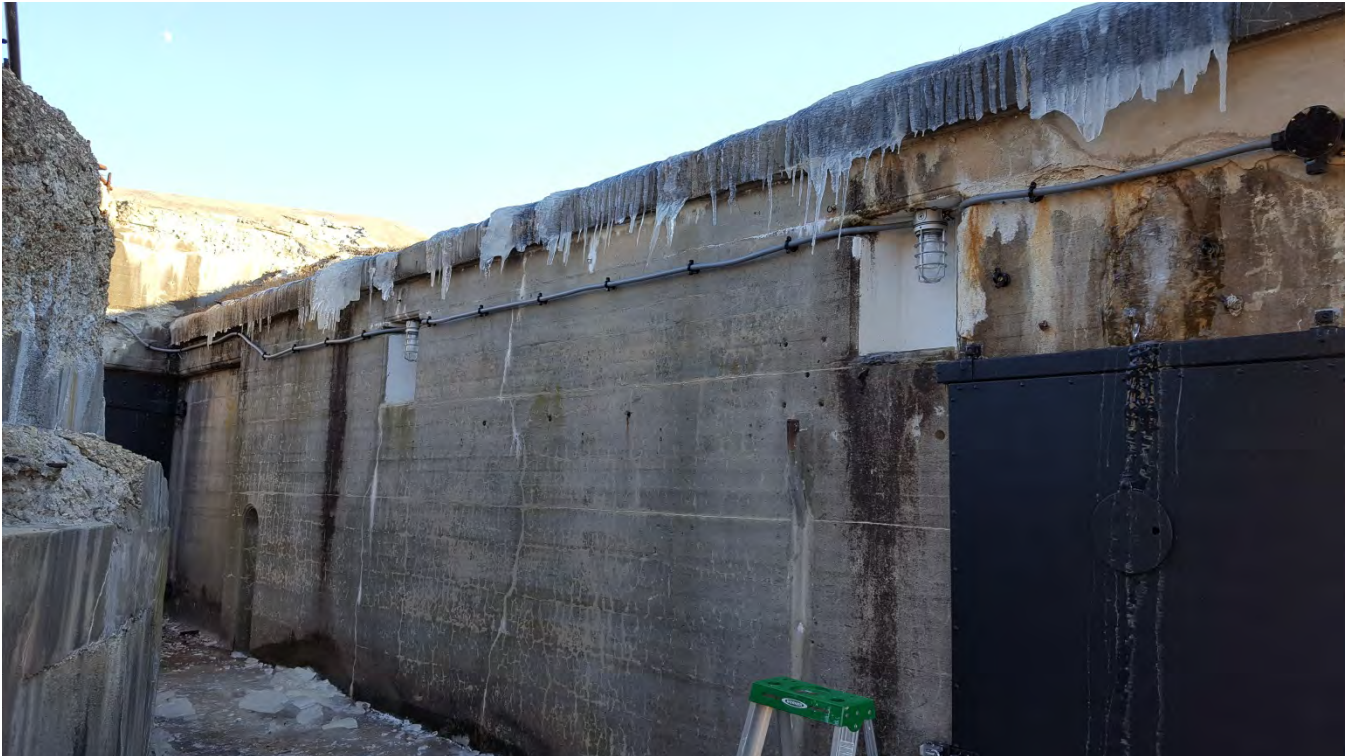
On 27 December 2017 the Gun #2 side received its three new lights. These lights have since been primed and painted black.

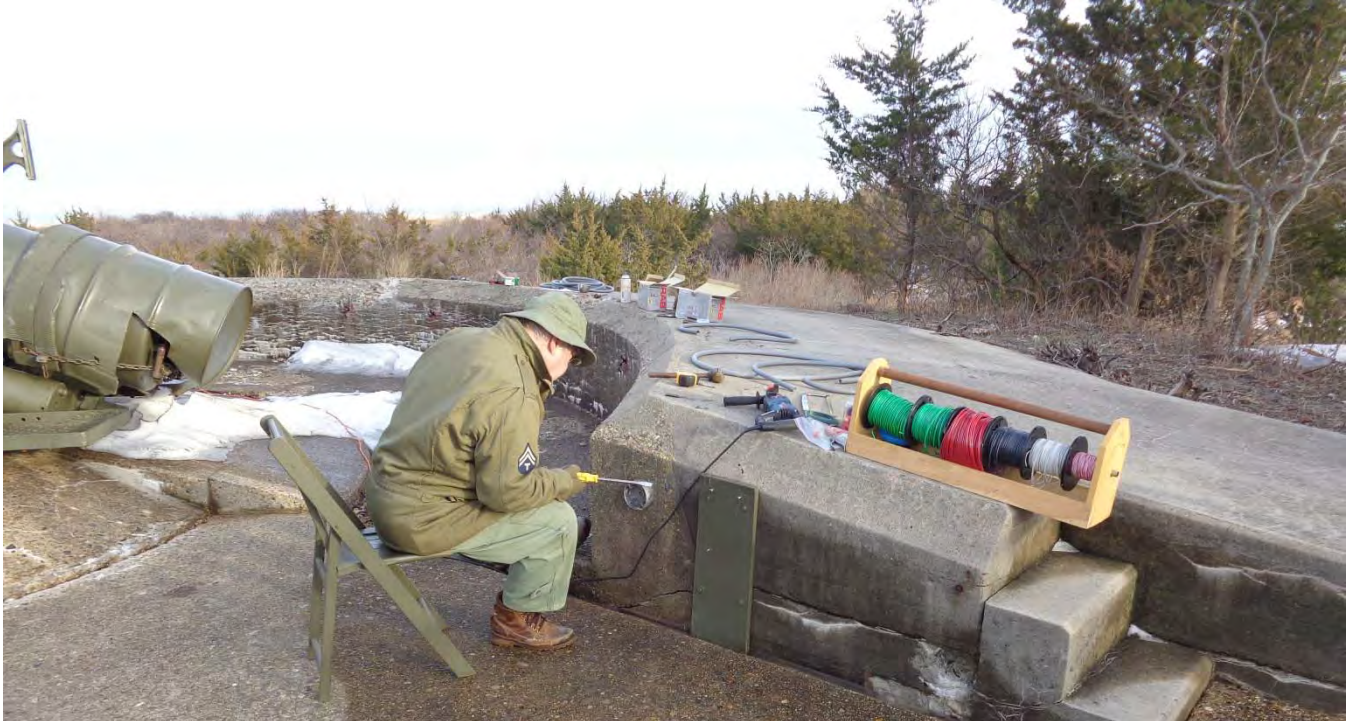
On 11 January 2018 we continued installation of exterior lights by installing the two on the front of Gun #1 platform. Below an AGFA member installs one light box.
