Restoring Electric System at Battery Gunnison/New Battery Peck *Ft. Hancock, New Jersey*

The reintroduction of electrical service to Battery Gunnison/New Battery Peck began in 2003 when the National Park Service introduced a 20 amp circuit with approximately nine modern interior lighting fixtures and two standard 15 amp outdoor standard receptacles. This very basic service was the starting point. Fifteen years later the system is essentially completed both interior and exterior lighting using predominantly restored and the correct historic fixtures and fittings.

This paper begins with the current status of the Electric Installation at Battery Gunnison/New Battery Peck as of May 2018. As of that date, the installation is over ninety five percent complete. The next part will give a brief chronology of the improvements beginning with NPS electrification in 2003 up to May 2018.

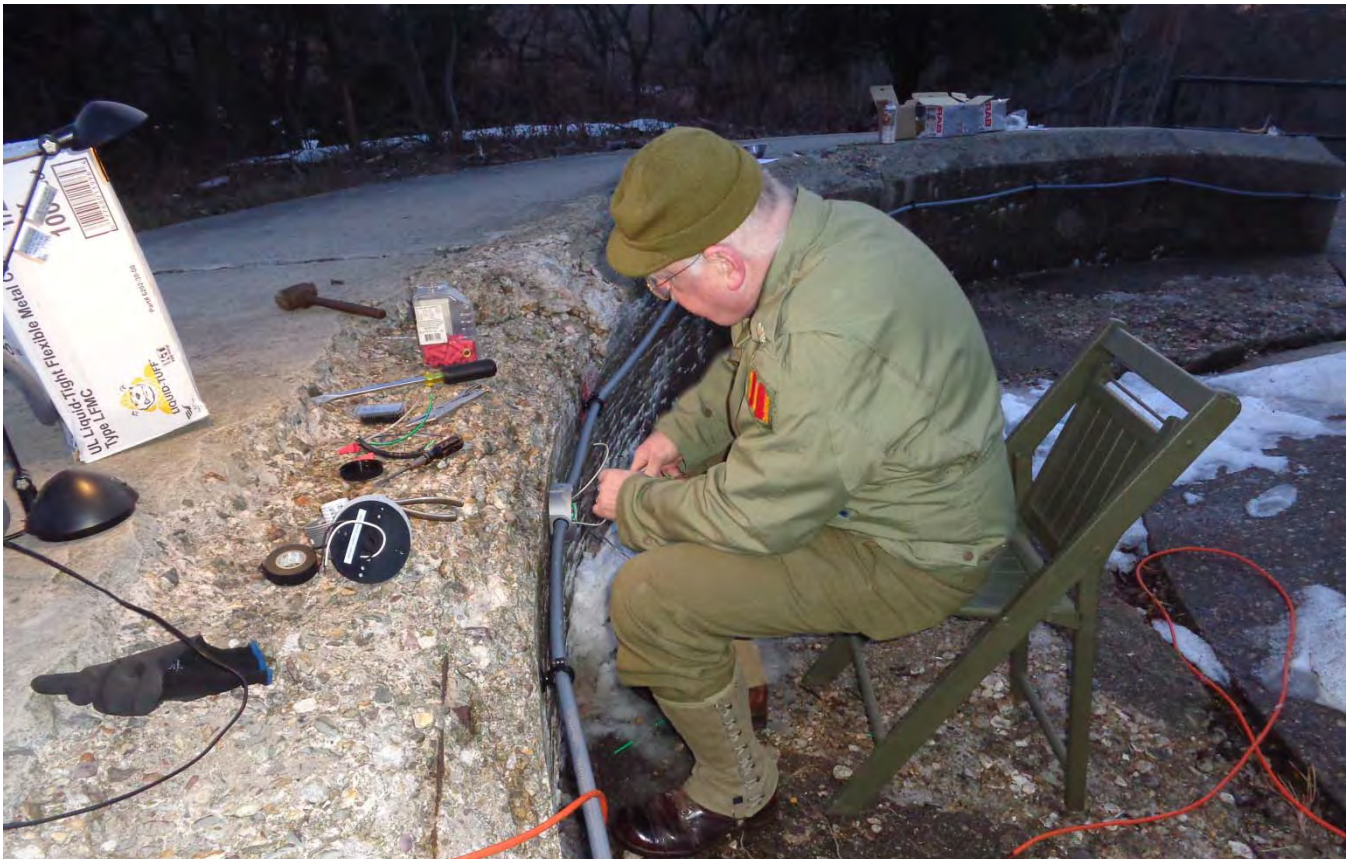
Below another AGFA member installs the center wall light box and connects the wiring. AGFA members have made many supporting tools to assist in our work. The wire basket on the gun apron is just one and has proven a massive help when pulling wire through conduit.

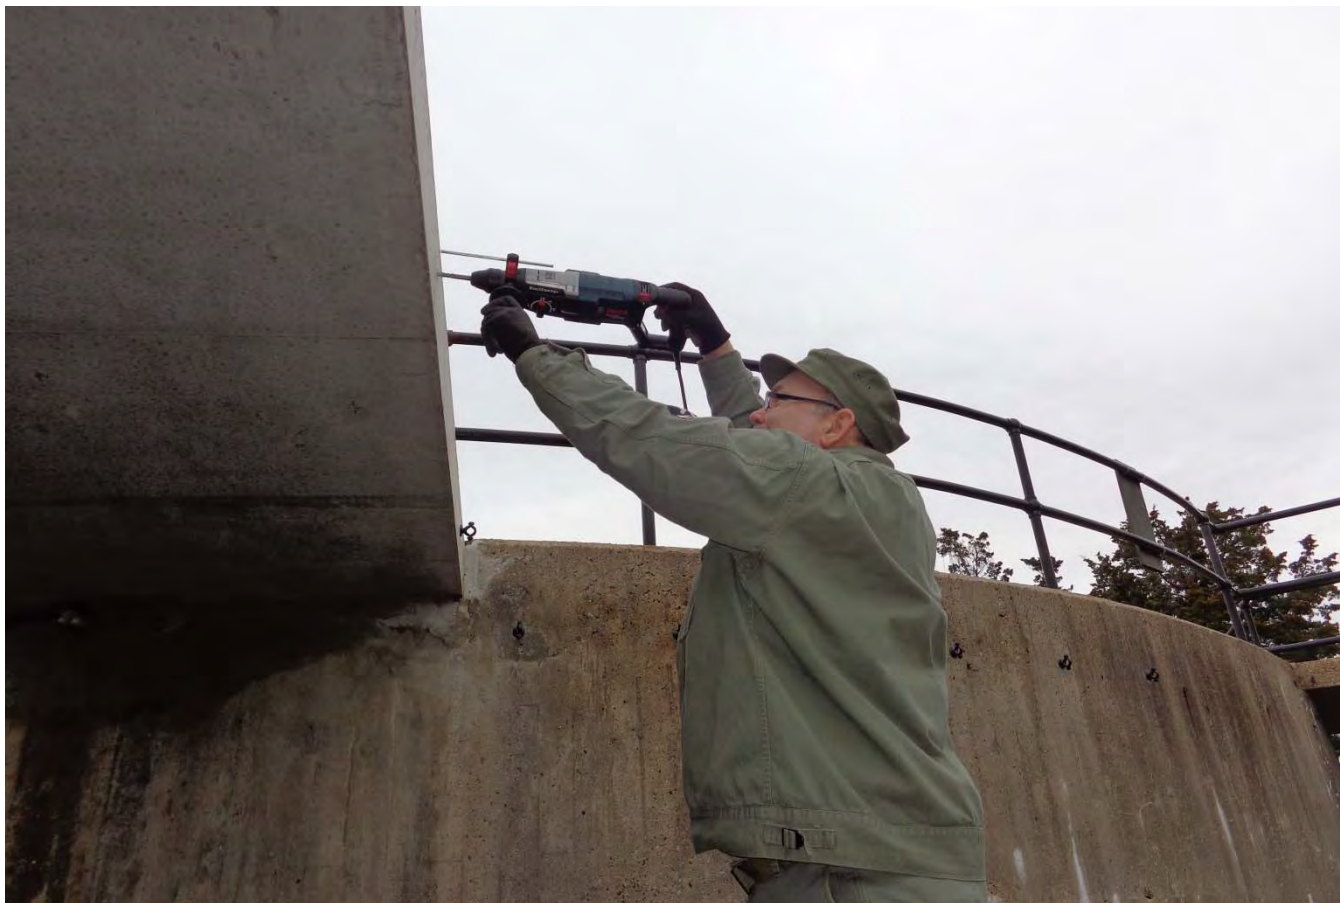
In order to connect the stanchion platform lights, we had to consult with the NPS on how best to drill the cable hanger holes in the new ammunition bridges. Once the method was settled upon, we drilled the holes on 22 February 2018 (photo below).

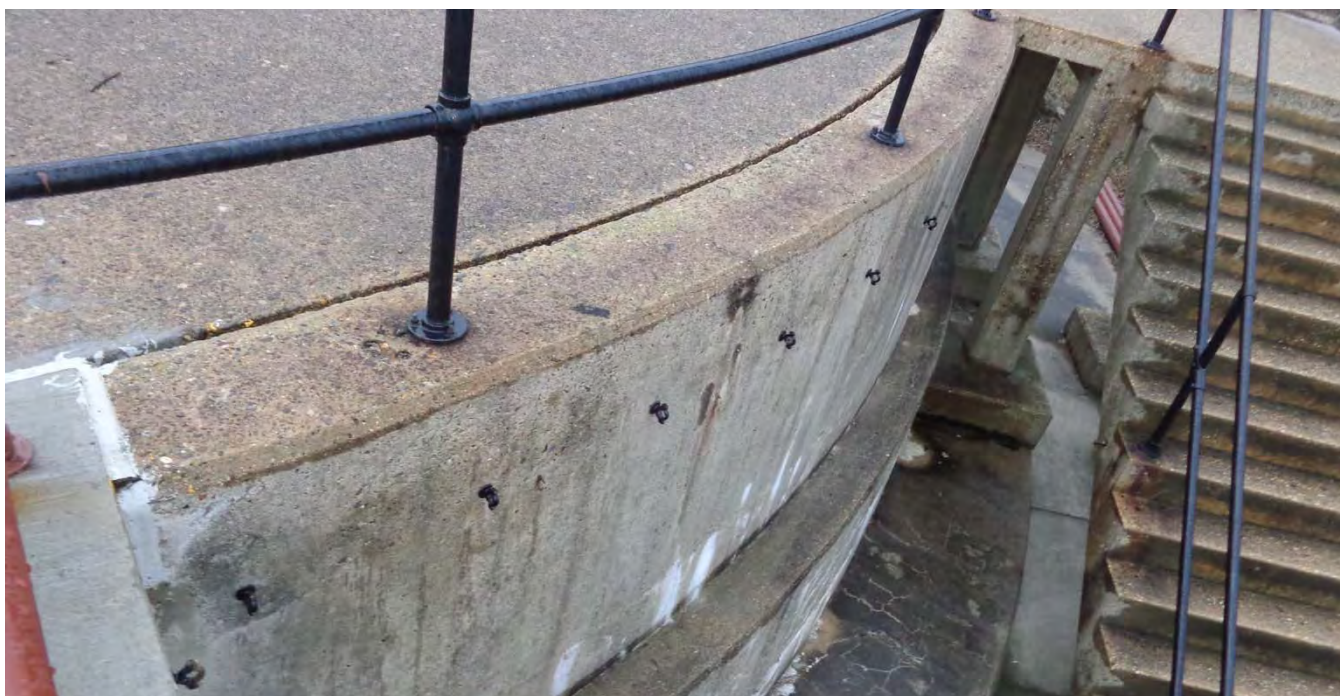
In addition to drilling the holes, we installed cable hangers on 22 February 2018.

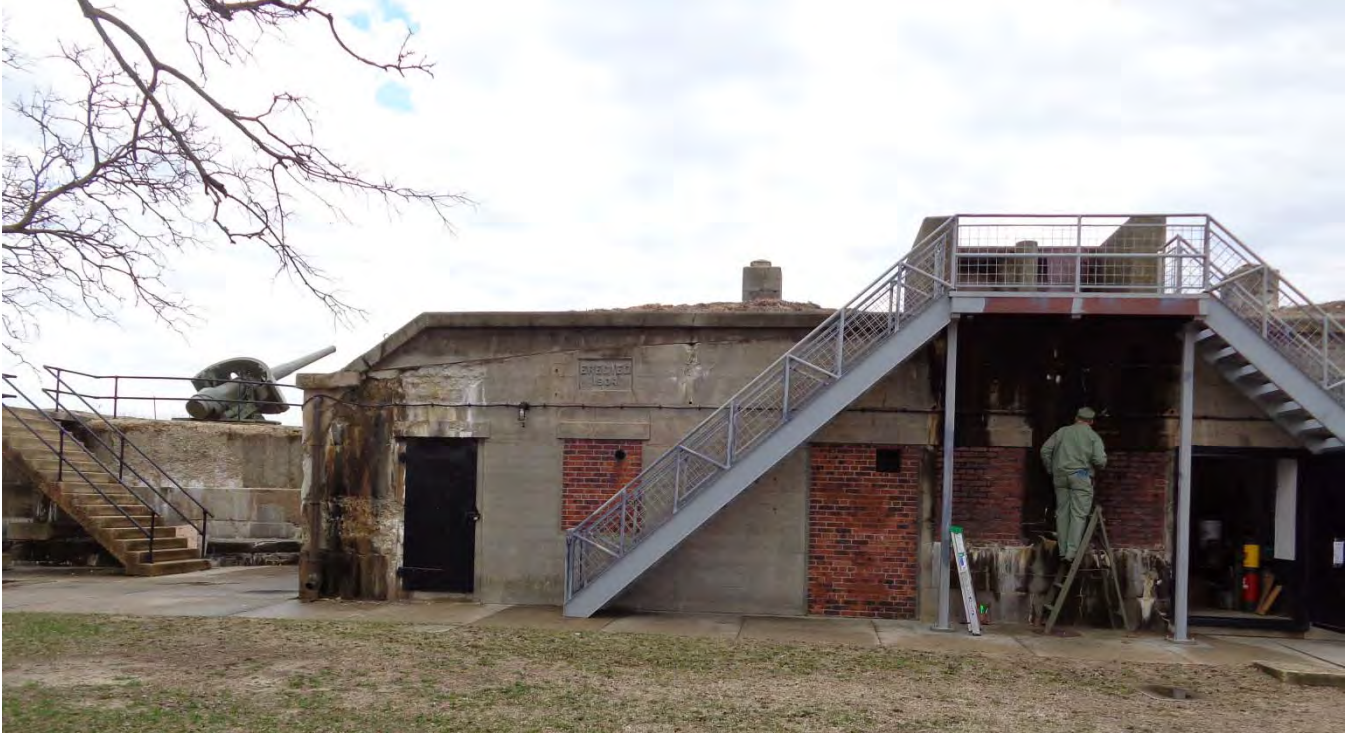
Additionally, a COE Standard Wall light was installed under the BC Station stairs. We had noticed that the area was very dark at night even when the light system was on. The photo below shows the light being installed.

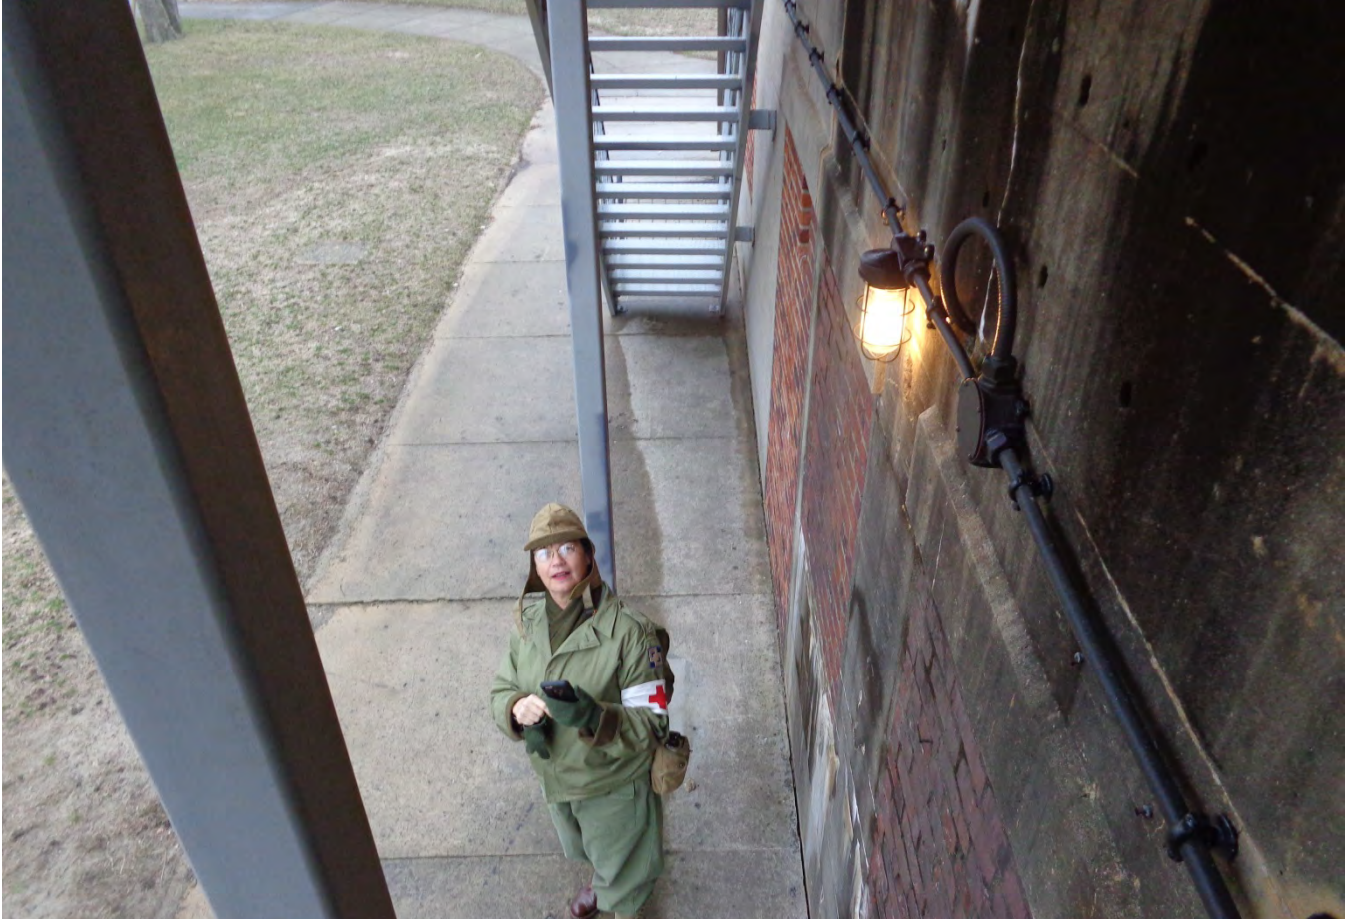
The photo below shows the installed light in operation.

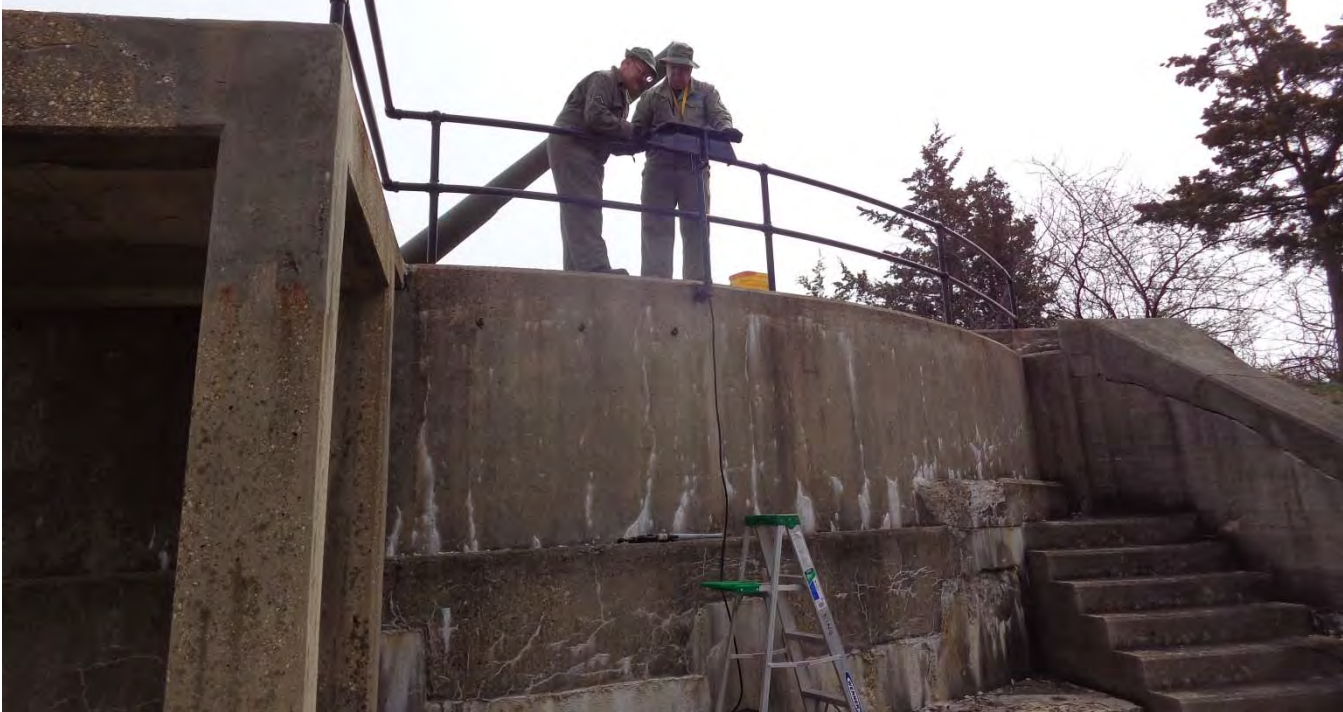
On 7 April 2018 we completed all the cable hanger installation on Gun #1 side for the stanchion lights and installed the lights on 12 April 2018. In the photo below AGFA members install the southern light.

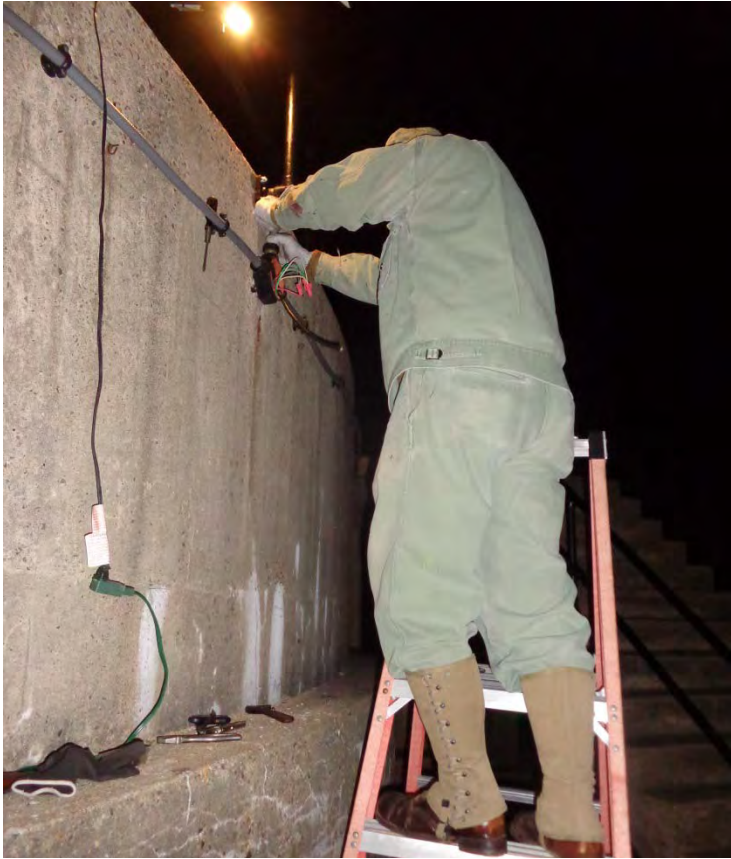
The northern light was installed after the southern light. Below an AGFA member connects the wires to the stanchion light.

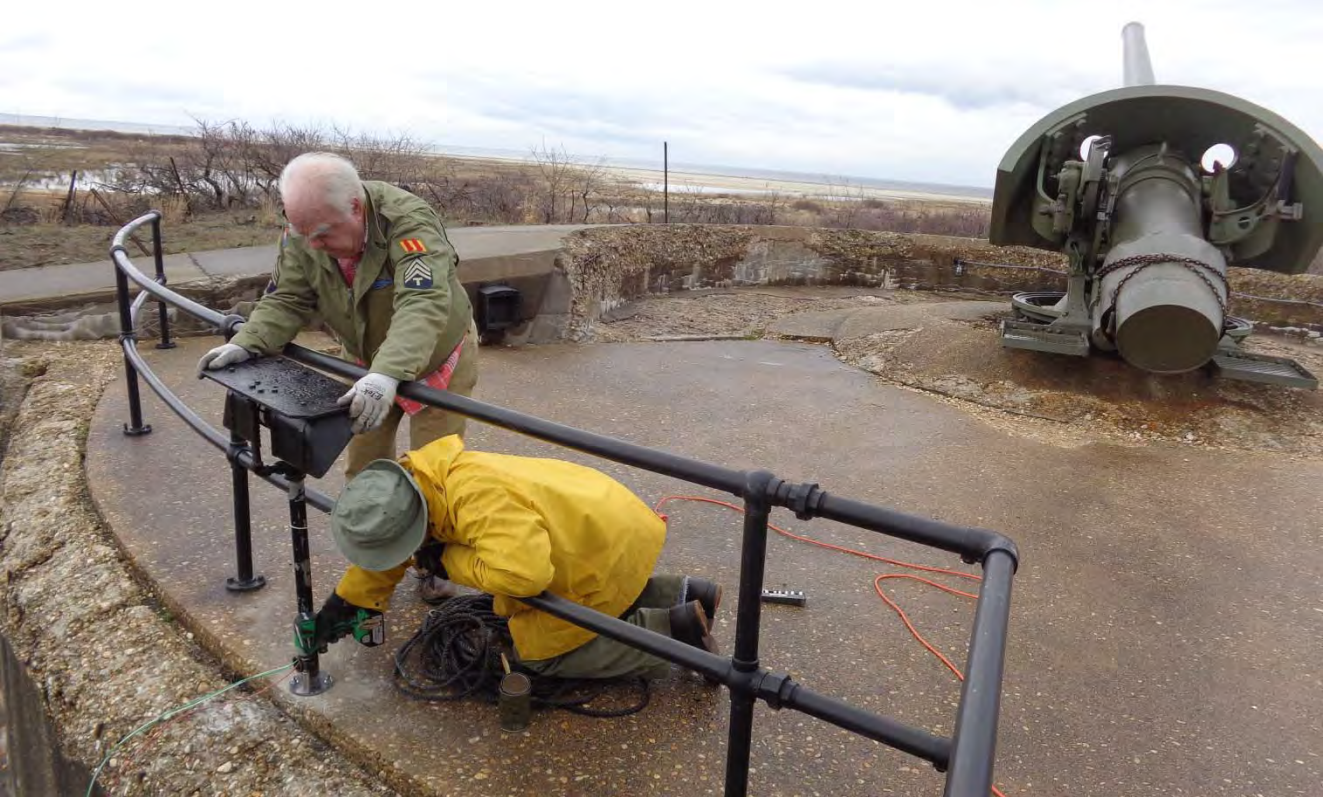
On 19 April 2018 the northern platform light for Gun #2 was installed. The photo below shows two AGFA members mounting the light on the gun platform.

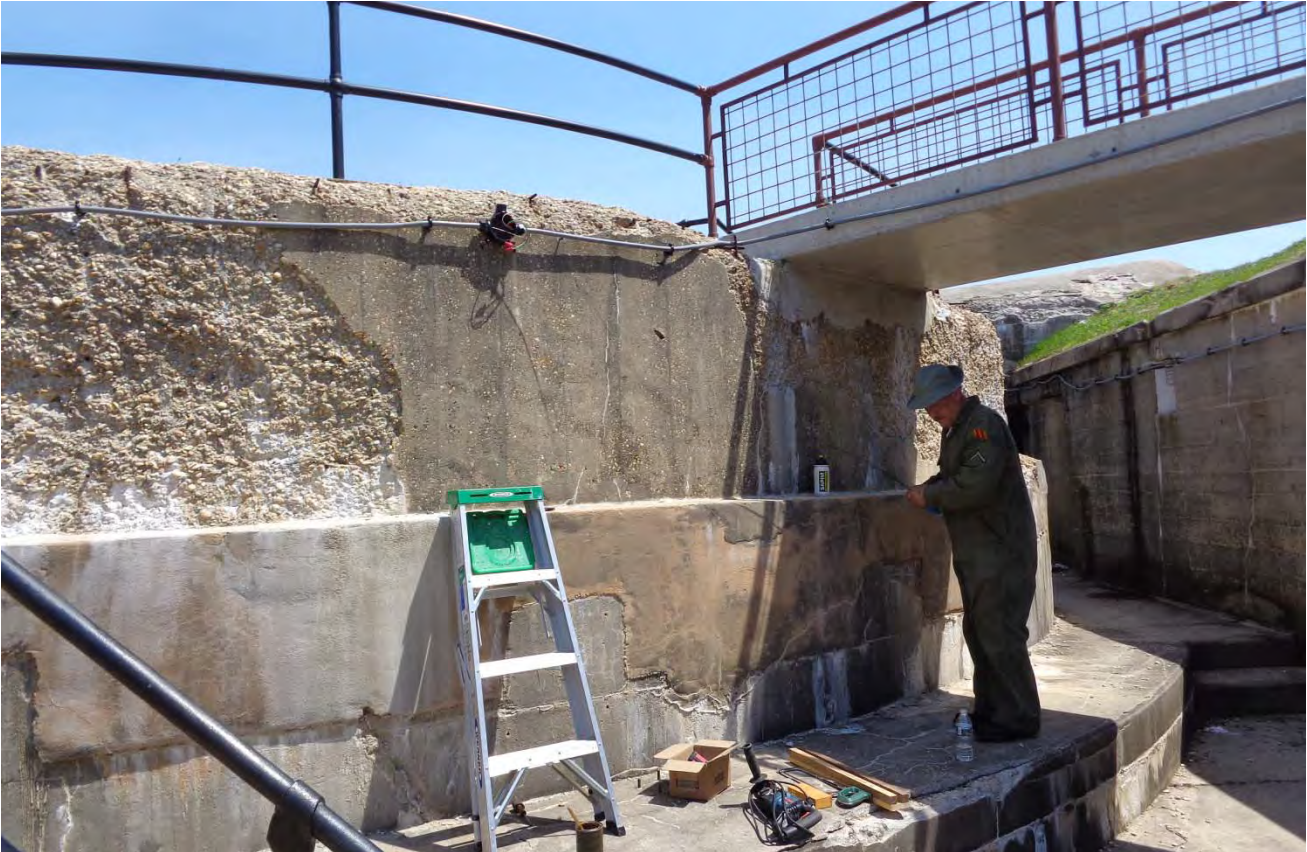
This light installation was completed on 3 May 2018. In the photo below the wiring is being installed.

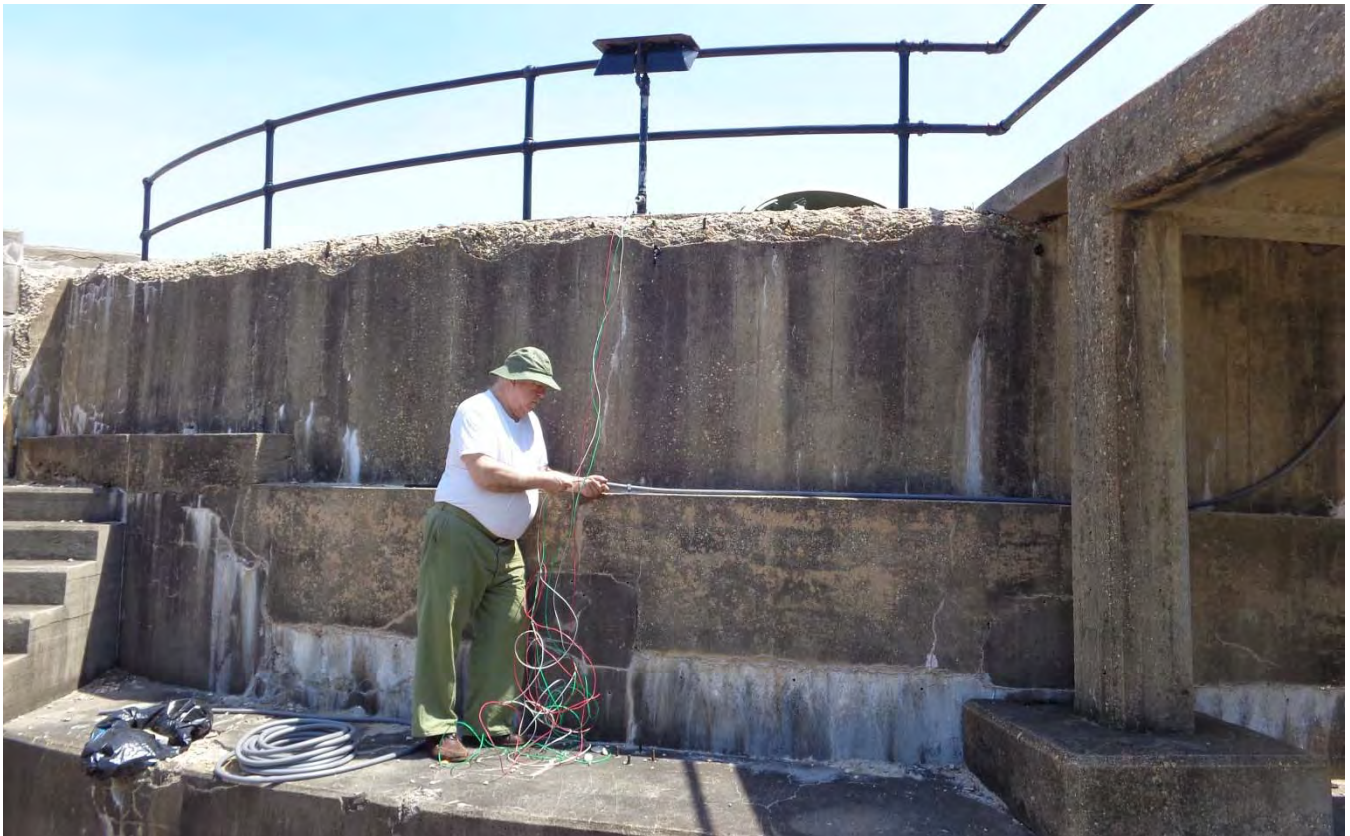
In the photo below an AGFA member is completing the wiring for the Gun #2 stanchion platform light. He is feeding the wires into the flexible metal PVC covered conduit.
