Mortar Battery/Harbor Defense Command Post
Ft. Hancock, New Jersey

Army Ground Forces Association (AGFA), in partnership with Gateway National Recreation Area, is beginning the rehabilitation of the WWII Harbor Defense Command Post (HDCP) that was located within Batteries McCook/Reynolds - the "Mortar Battery".

The project has several phases and will take about five years to complete. The first major phase was to secure the structure from intrusion and to remove the rust, prime and paint several doors within the structure. This portion of the project is approximately 98% complete.

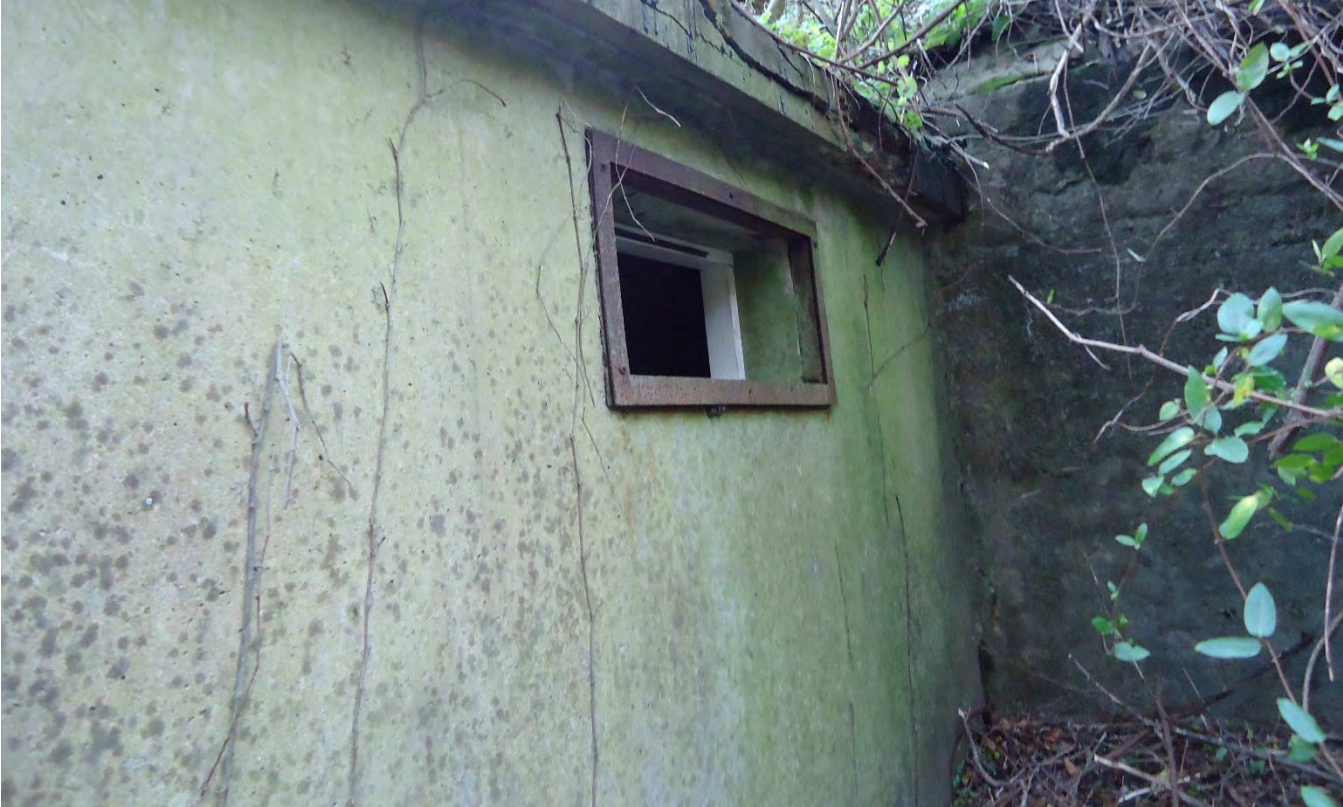
The photo below shows the third window on the north side of the boiler room of the HDCP.

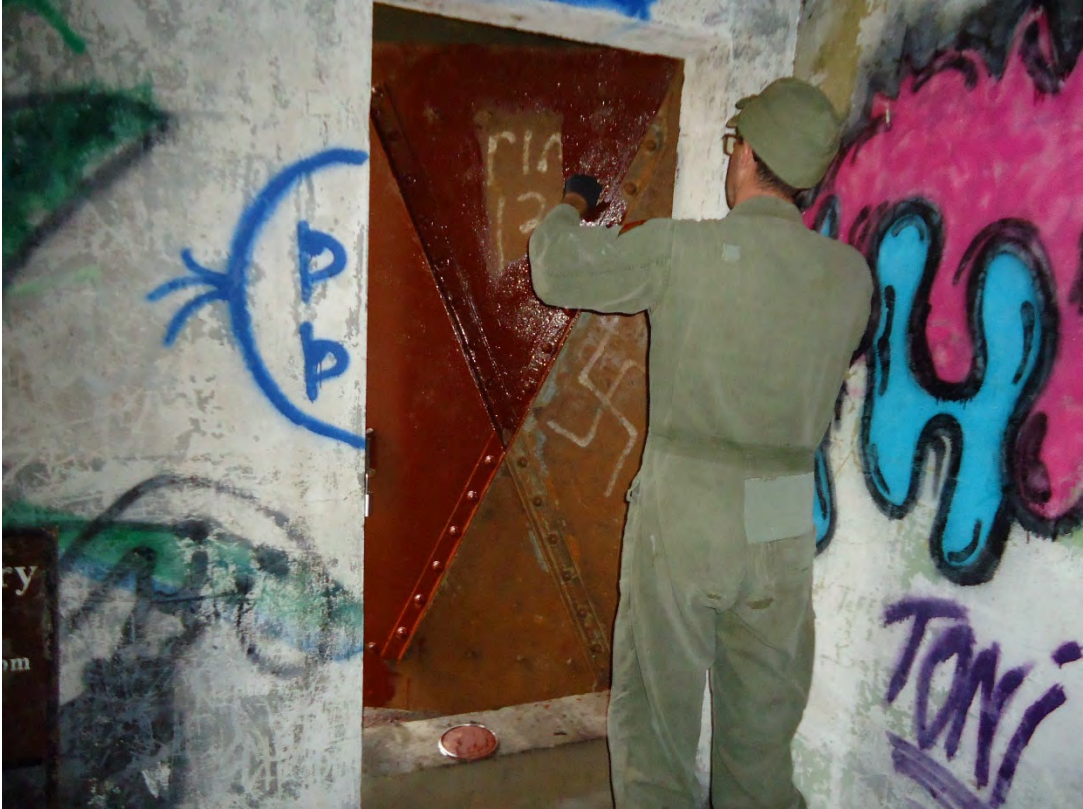
The photo below shows PVT Kleeman applying primer after having removed the rust on the door. Notice the obnoxious graffiti.

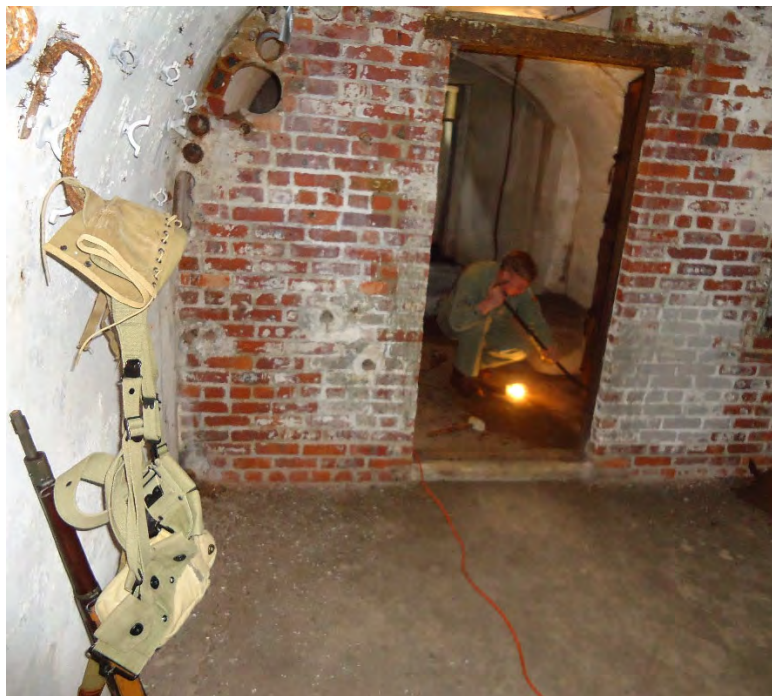
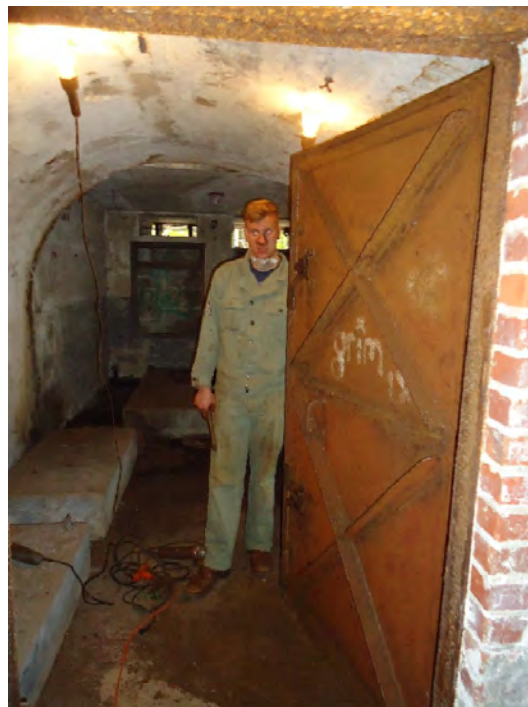
The photos below show the interior chemical warfare air lock door near the generator and boiler rooms on the north side of the Battery. Left photo shows CPL Budjos removing rust on the base of the door. This photo is looking into the generator room from the north east-west passage. All movable components were rusted and immovable. The right photo shows CPL Budjos near completion of rust removal.

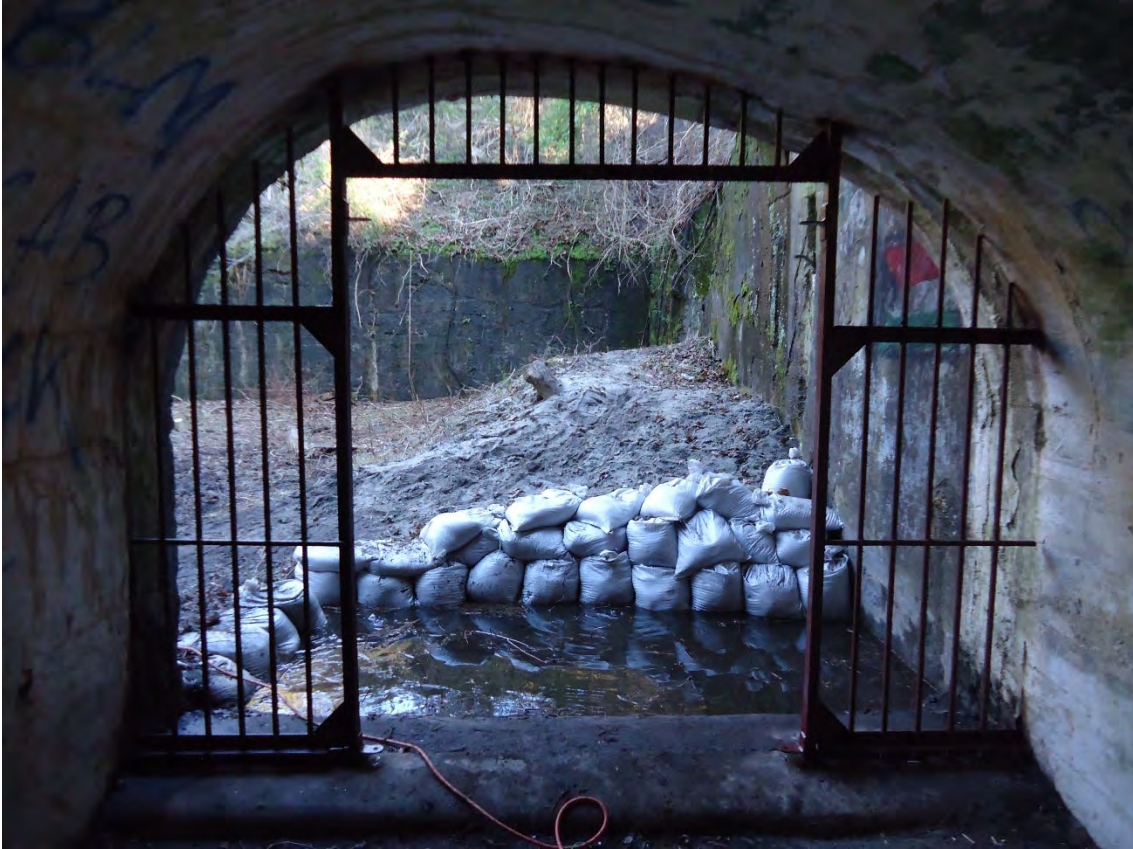
In late March 2024 the entire door frame was completed and primed in preparation for installation of the two doors in April 2024.

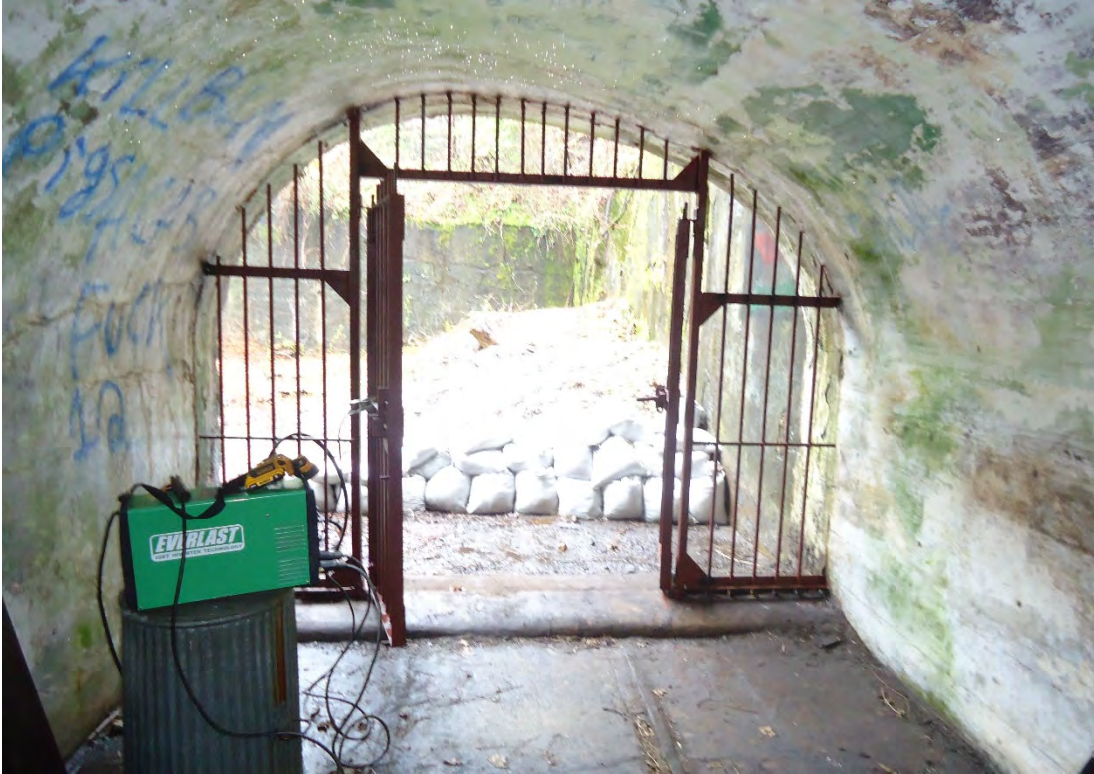
Below the two doors have been installed and the entire frame (minus the doors) has been primed with red zinc enamel primer.

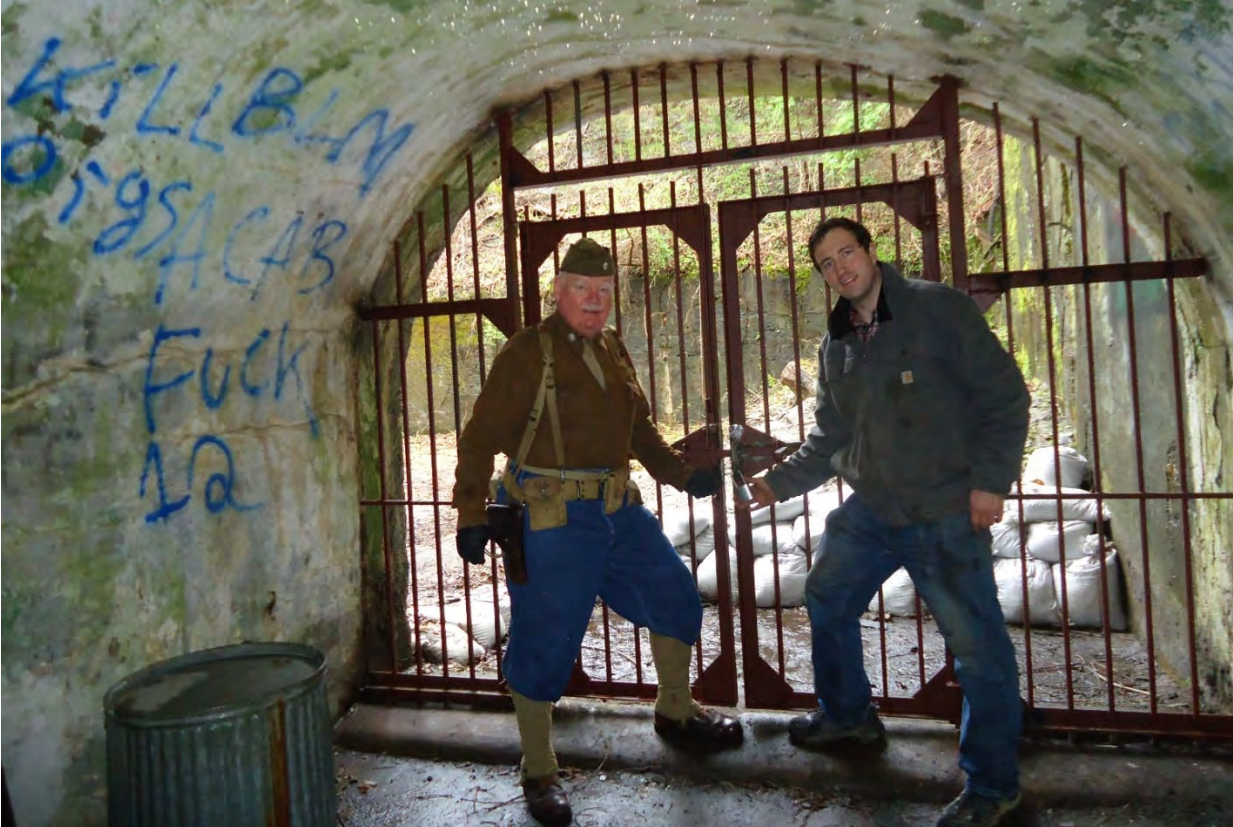
The photo below in April 2024 shows the final locking of the door with LTC Welch and Mr. Mason. This marked the first time in years that the interior access to the fortification has been positively controlled. Mr. Mason was the designer and fabricator of the door assemblies and did all the welding of the structure.

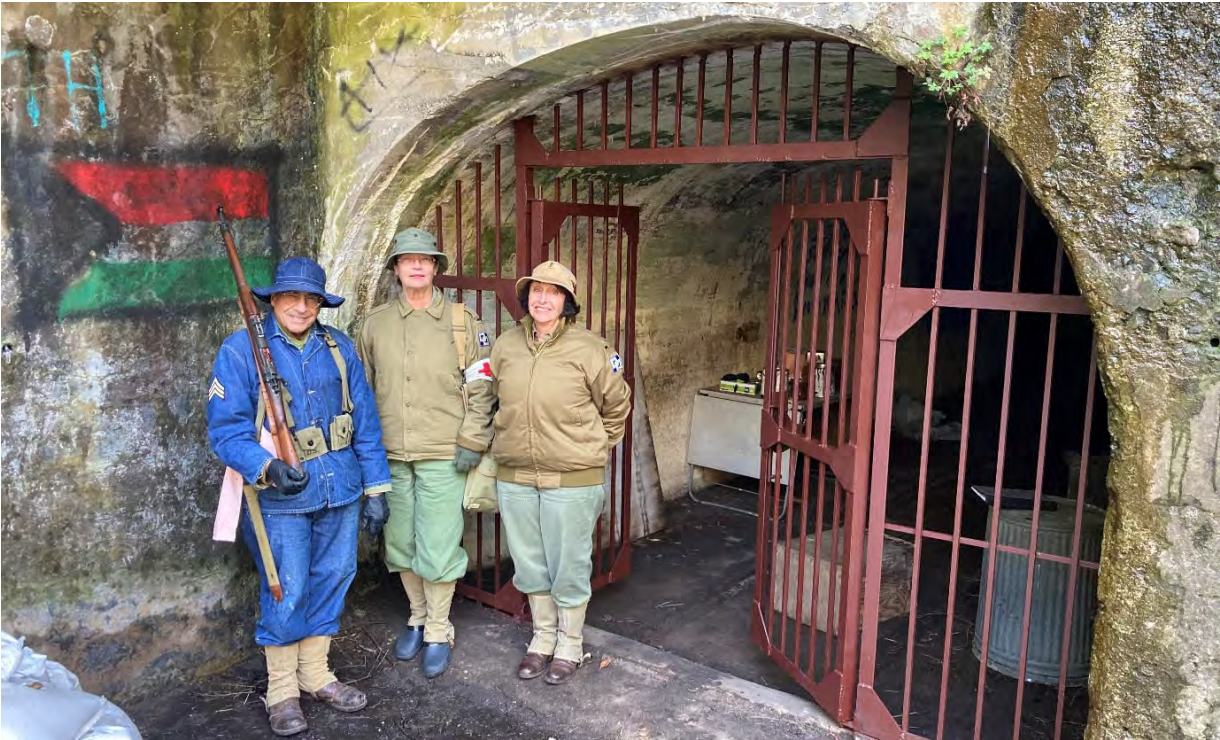
Below SGT Cusano, 1LT Lutkenhouse and 2LT Cusano stand next to the fully assembled and functional bar door.

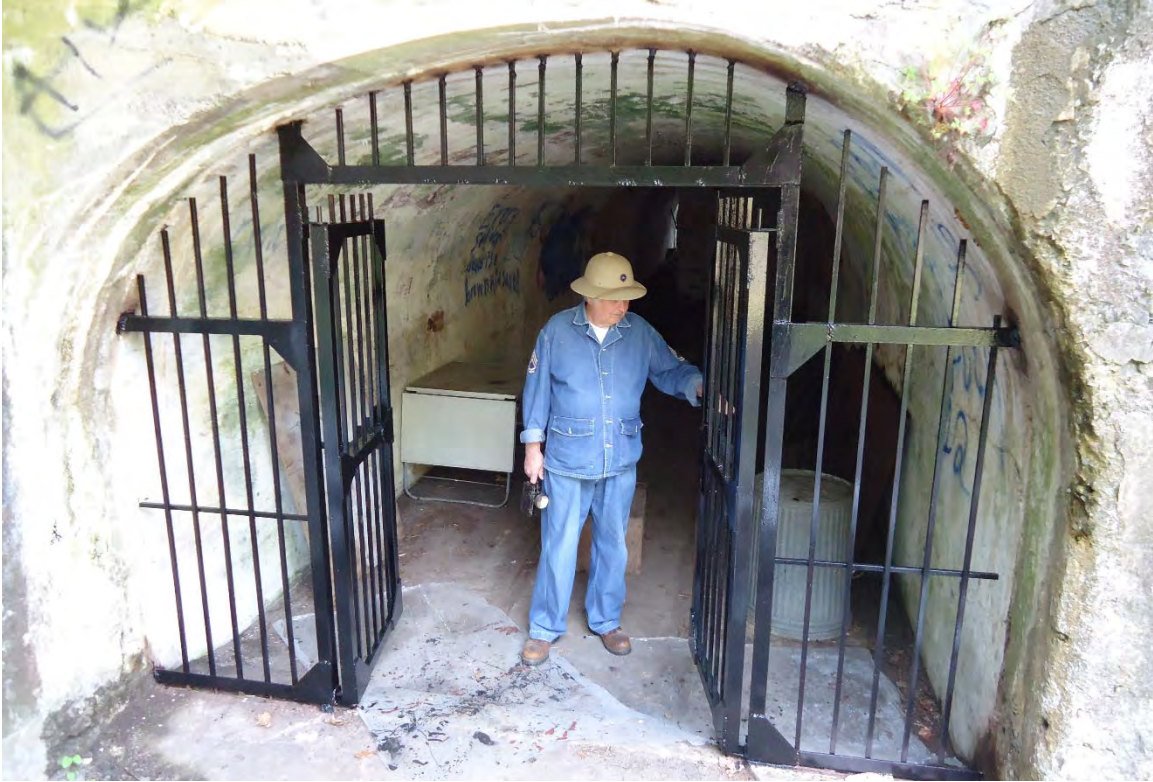
The photo below in May 2024 shows the door as painted black looking into the fortification. TSG Weaver is opening the doors for the photo.

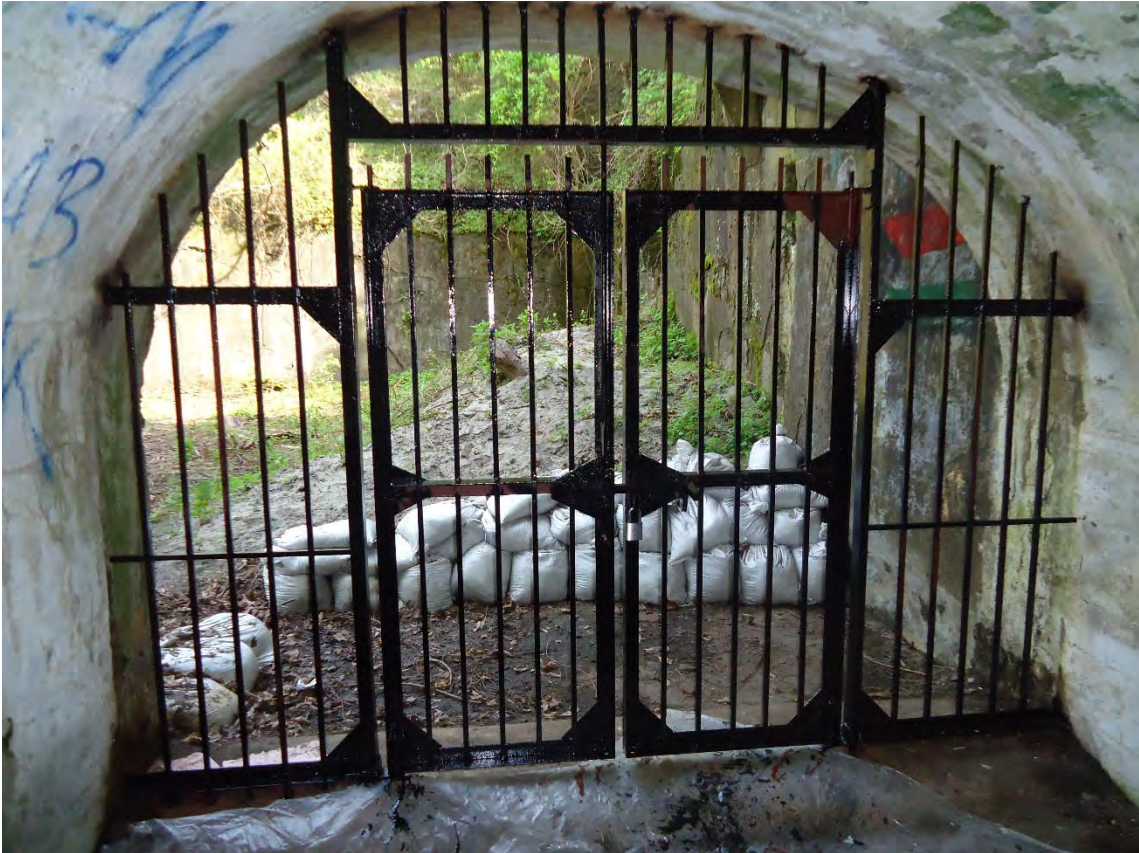
The photo below shows the door facing to the outside from the inside of the passage.

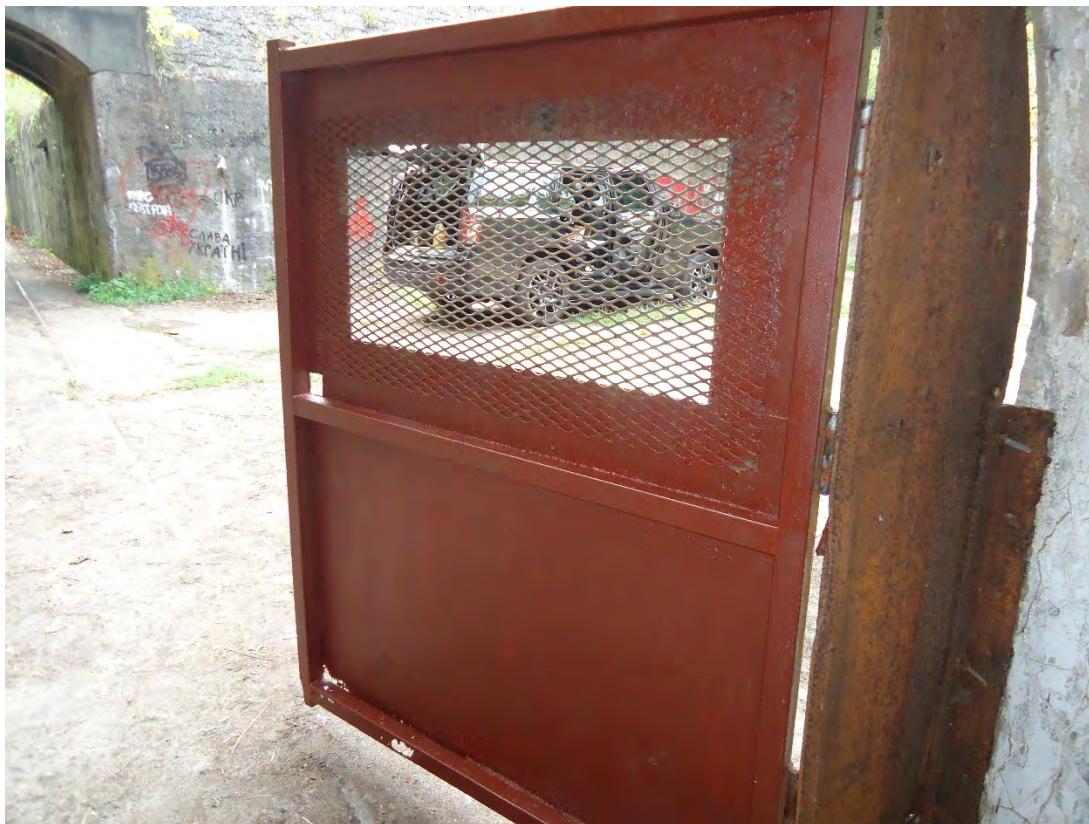
The photo below shows inside of the door panel with the rust removed and metal primed. The north panel requires rust removal and priming.

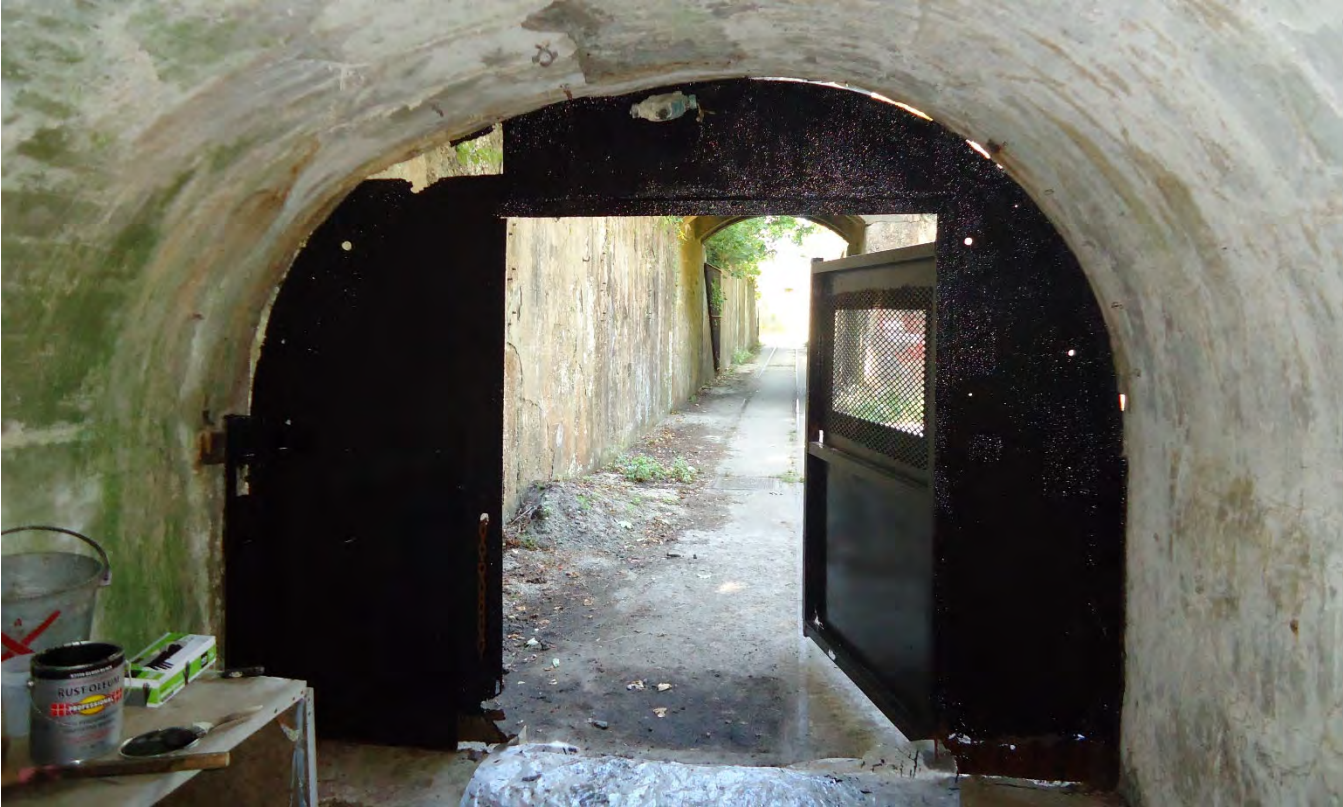
The photo below shows inside of the door panel with painting complete on 5 September 2024.

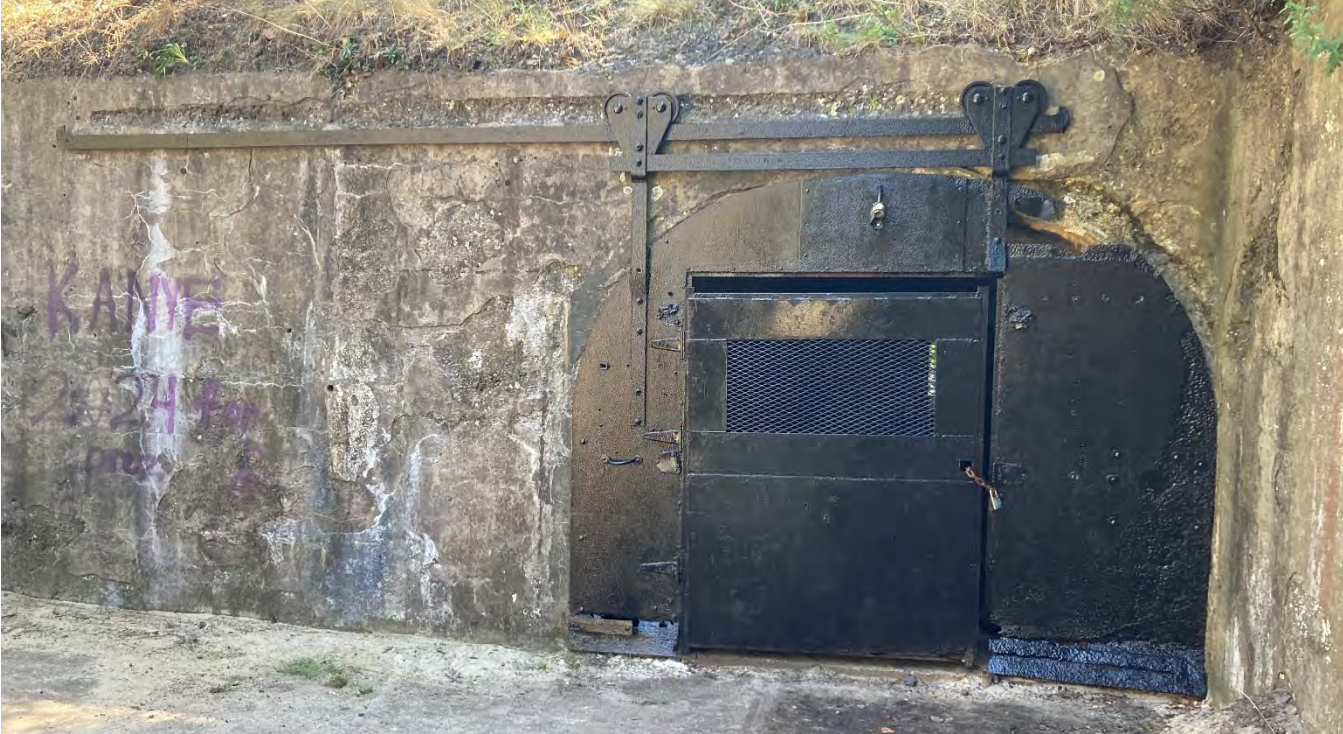
The photo below shows the exterior of the door with painting complete on 5 September 2024.

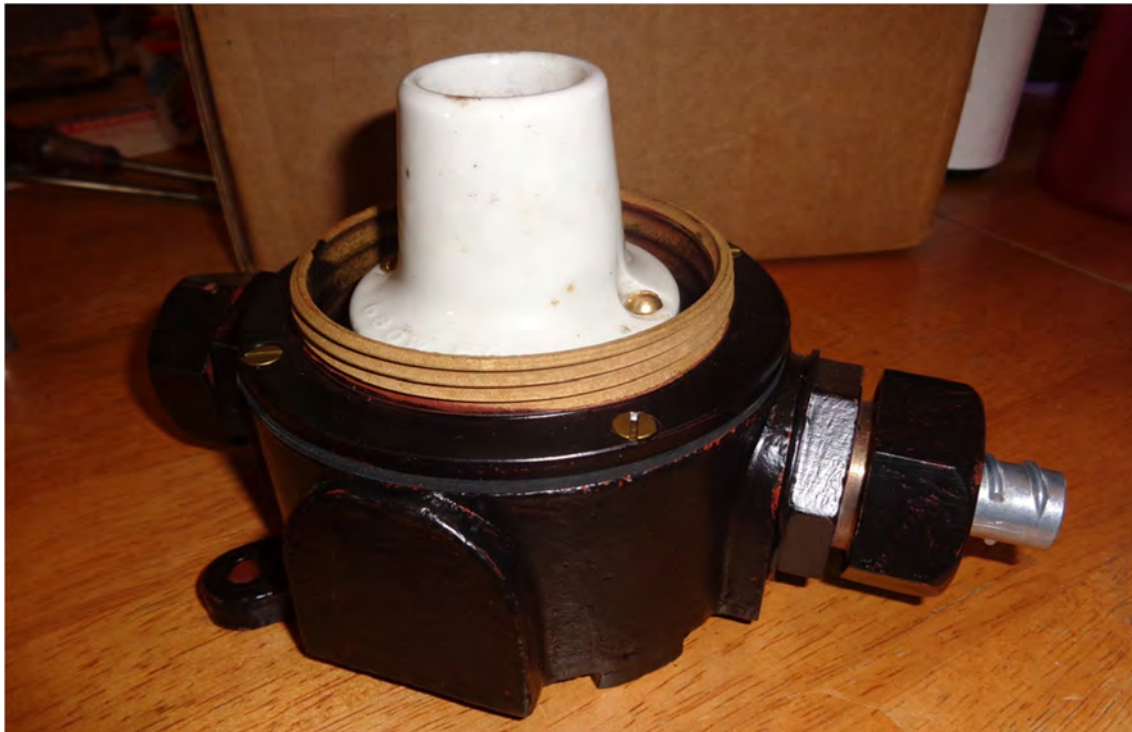
The photo below shows a restored Corps of Engineers standard 1915 ceiling light fixture. These are made of bronze and have significant scrap metal value. This makes them rare and worth restoring to working condition.

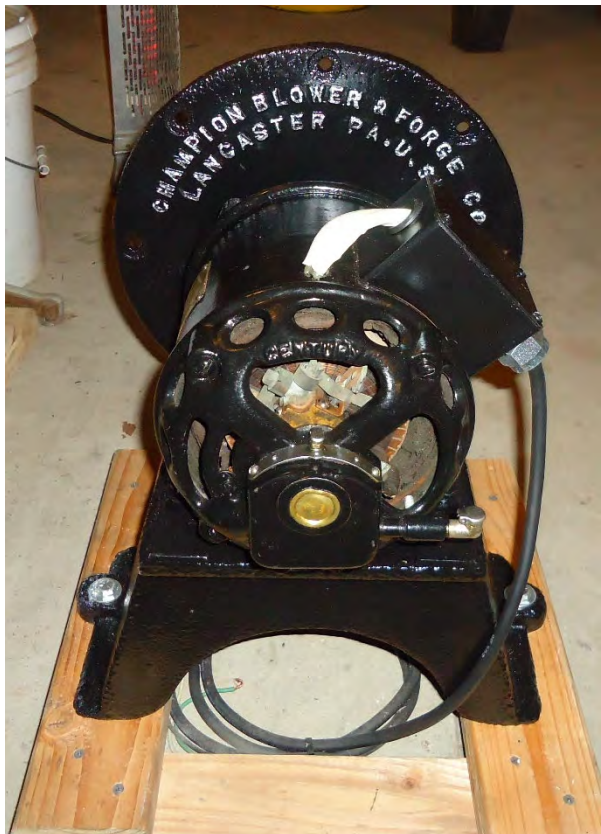
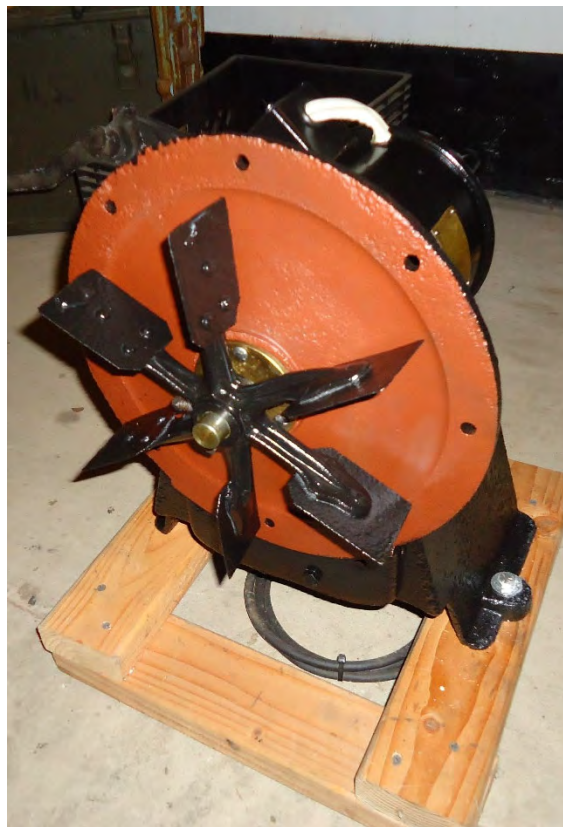
The photos below show the restored chemical decontamination blower and motor that has been prepared for installation in the north west chemical decontamination air lock. The motor is a 1,750 rpm motor from the 1920s. It is half the power of the original motor. We are using this motor because a 3,500 rpm vintage motor is not available. Notice the manufacture of the blower system on the left photo.

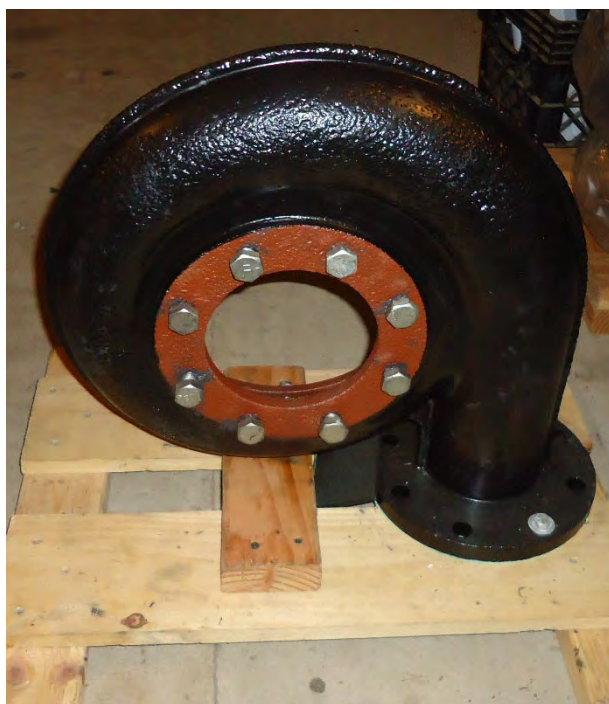
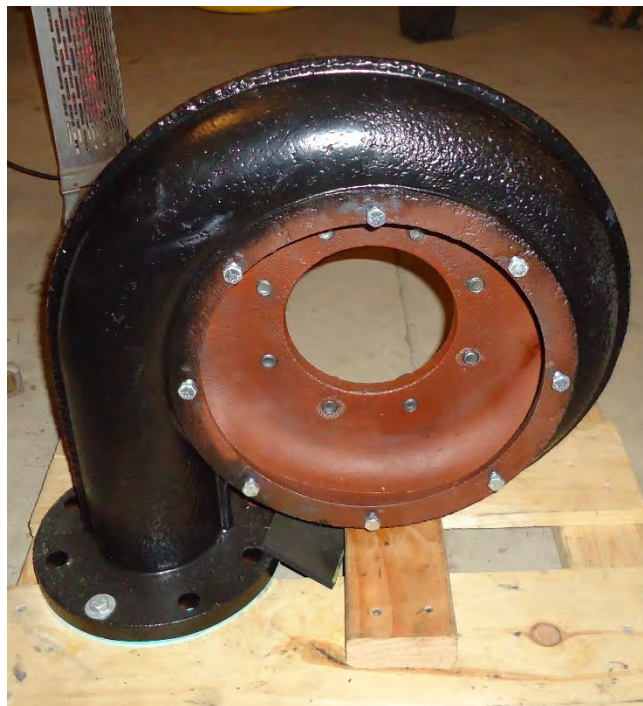
The photo below shows the restored blower housing for the assembly.

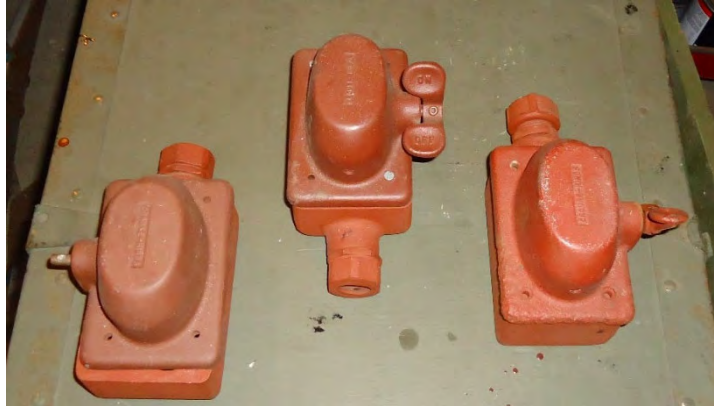
The photo below shows restored switches for the decontamination station destined to be restored in the Harbor Defense Command Post (HDCP) or "mortar battery".
